REPORT

on the implementation of the project

RESTORATION OF ECOLOGICAL CONTINUITY AND ACTIVITIES IMPROVING FUNCTIONING OF THE FREE MIGRATION CORRIDOR OF THE BIAŁA TARNOWSKA RIVER

2022

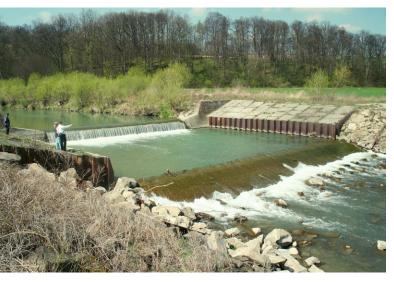
JANKOWA (61.160 km)

The weir was built to protect the multi-span bridge (Fig. 23). Above the bridge, a groyne was also built to divert the river under the bridge. However, the river went around this sill from the right side, and the sill was rendered useless. The

Fig. 23. View of the weir before modernization

bridge itself posed a flood risk because the side spans were blocked by deposited material, vegetation and overhanging vegetation. In 2019, it was demolished and replaced with a new single-span bridge. As part of the upgrade of the weir below the bridge, a honeycomb fish ladder was built. At the same time, the deposited sediments that narrowed the riverbed and impeded the flow of high water were removed (Figs. 24 and 25).

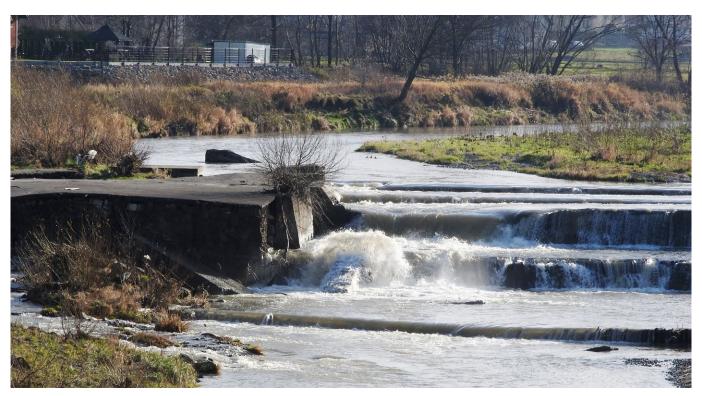
STRÓŻE (69.105 km)

The old weir in the form of a cascade of four dams dammed up the water for the town's water supply. Later, the construction of a small hydroelectric power plant was started but never completed. During the flood in 2010, the weir was heavily damaged (Fig. 26). As part of the modernisation of the weir, the power plant was demolished and the sill dismantled. The damming height was lowered by about 1 m. A new water intake was constructed in the form of a drainage intake from under the riverbed. The sill was replaced by a honeycomb fishway (Figs. 27 and 30). In addition, an observation room, equipped with a glass window, a fish coun-

Fig. 26. The weir before reconstruction.

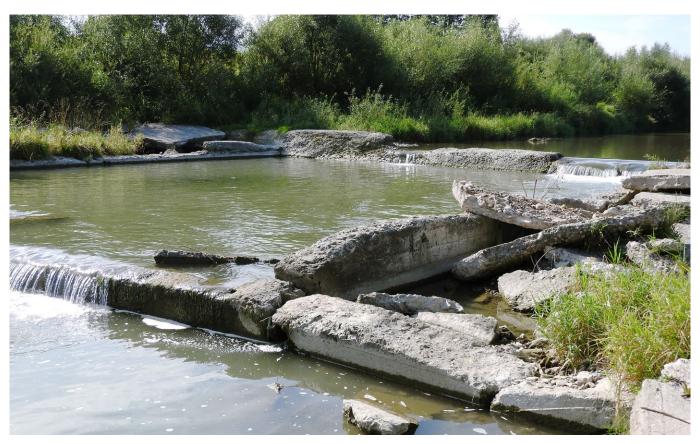
BIAŁA NIŻNA I (70.200 km)

In Biała Niżna, there was a concrete dam with a stilling basin, whose drop of 1.3 m constituted a migration barrier (Fig. 31). Due to its poor technical condition, the structure was not functional. As part of the modernisation, a solution was adopted consisting in the partial elimination of the weir. The upper part was removed, and the basin was filled with gravel. Three stone bottom gourds in the form of

Fig. 31. The weir before decommissioning.

arches were added to protect the channel against excessive erosion, as well as stone ripraps on the banks (Fig. 32).

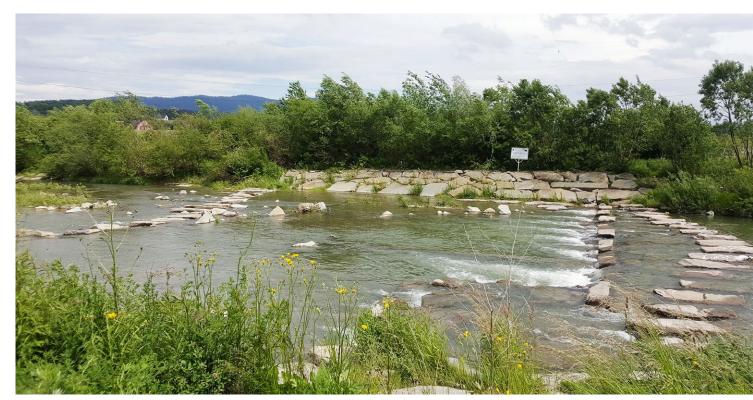
Fig. 32. Weir after decommissioning and rebuilding.

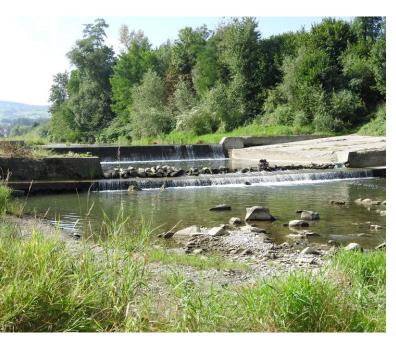
BIAŁA NIŻNA II

Fig. 33. Weir before modernization.

A concrete damming weir with a stilling basin was constructed in Biała Niżna to prevent channel incision (downcutting) (Fig. 33). The damming-up height was 1.2 m. The stilling basin was replaced by a fish ladder as part of the upgrade. Three concrete baffles with alternating triangular cuts were built across the basin. The whole stage was supported by a stone girder (Figs. 34 and 35).

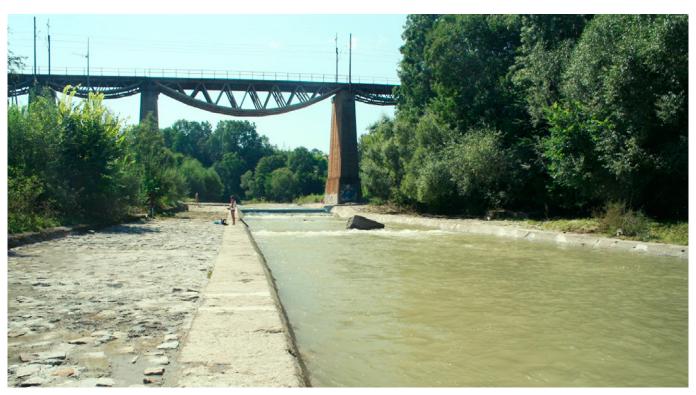
GRYBÓW I (72.050 km)

At the beginning of the 20th century, the railway and road bridges located in the centre of Grybów were secured (Fig. 36). These were concrete weirs to slow down the water flow and concrete boulevards supporting the banks for a length of 300 m. Part of these concrete weirs below the road bridge were converted into a fish ladder during the first stage of the project in 2013. The remaining part of the protection, a cascade of six weirs stabilising the channel under the railway bridge (72.050 km), was rebuilt during

Fig. 36. The weir cascade before reconstruction. View upstream.

the second stage of the project. The old concrete bank reinforcement was left in place, the weirs were removed and a close-to-nature fishway in the form of a honeycomb was constructed in their place (Figs. 37, 38, 39, 40).

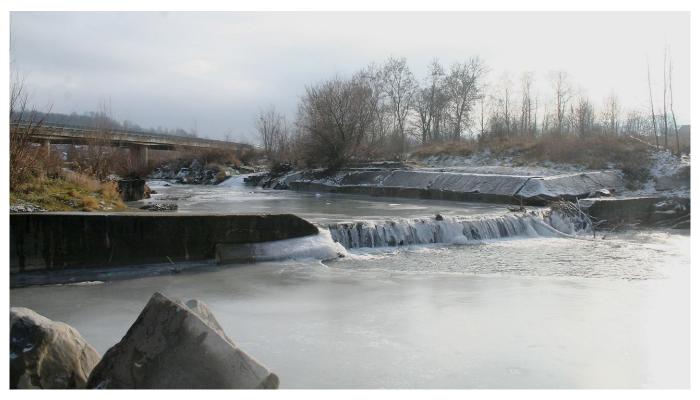
GRYBÓW II AND MOUTH OF THE PŁAWIANKA RIVER

Many years ago, a cascade of weirs was built here to secure the road bridge (Fig. 41). Above, the left-bank tributary of the Pławianka stream flows into the Biała. This stream, in its lower course, was regulated in the form of a concrete culvert. As part of the modernisation, the cascade of weirs on the Biała and the mouth section of the Pławianka were rebuilt. Some of the concrete weirs were removed, cut-outs for low water were made and a close-to-nature honeycomb fish ladder was added below (Figs. 42 and 44). The

Fig. 41. Weir before reconstruction (visible mouth of the Pławianka River).

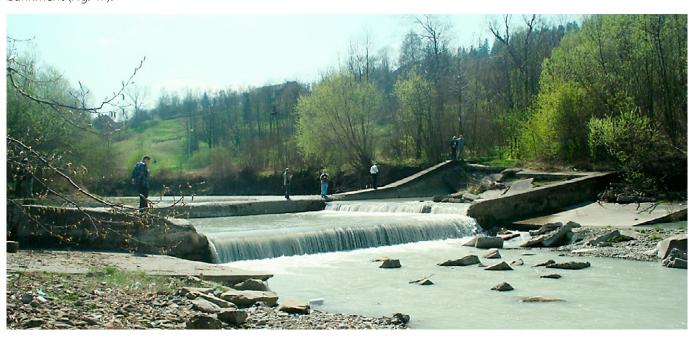
KĄCLOWA

Fig. 45. Weir before decommissioning.

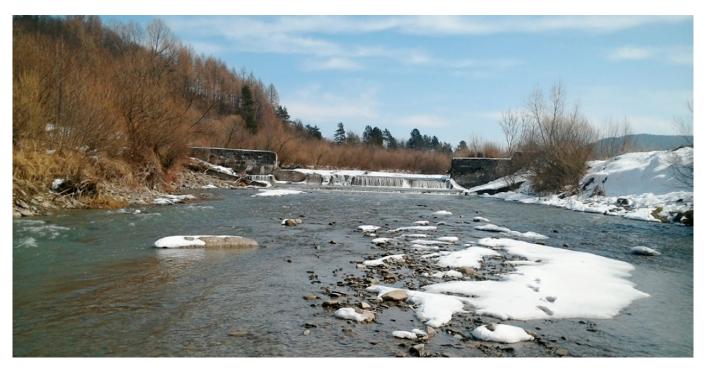
Both structures are located close to each other at a distance of 224 m. The upper weir (Florynka II), with a height of 1.75 m, was built in the middle of the 20th century by a private investor in order to dam up water for a planned hydroelectric power plant or a sawmill. It was a classic anti-rubble dam. This purpose was never realised (Fig. 48). The task of the lower stage (Florynka I), with a height from the bottom of 1.25 m, was to support the anti-rubble dam

Fig. 48. The Florynka II weir before reconstruction.

(Fig. 49). The technical condition of both weirs was very poor, and these low-head dams constituted an impassable barrier for fish. As part of the modernisation, the rebuilding of both weirs was planned so that fish migration would be possible while maintaining the damming ordinate. At the Florynka I, the whole weir was left together with the stilling basin. The upper weir crest was lowered, and a close-to-nature honeycomb fish ladder was built on the downstream side (Figs. 50 and 52). In the upper weir (Florynka II), the stilling basin was eliminated, and on the downstream side, a close-to-nature honeycomb fishway was added (Figs. 51 and 52). Above the weir crest three gourds were constructed to protect the ford.

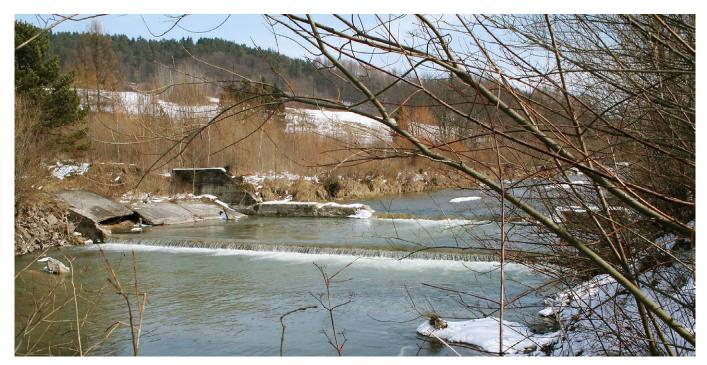
Fig. 49. The Florynka I weir before reconstruction.

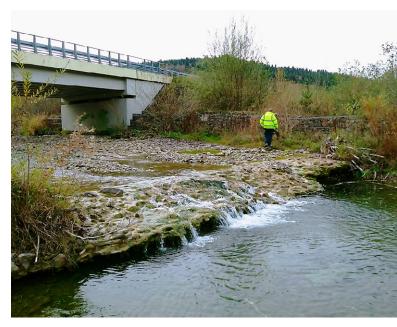
ŚNIETNICA I (92.680 km)

The retrofitted reinforcement of the bed of the channel under the bridge was made to protect this new single-span bridge. The concrete-and-stone reinforcement resulted in a small waterfall that no fish could traverse (Fig. 57). The decision was made to leave this reinforcement in place and use the difference in height to build a fish ladder. A 2-m-wide and 0.8-m-deep trench was cut in the old bottom reinforcement under the bridge, and several stone deflectors were installed. This resulted in a micro-mandrel effect (Fig. 58). After one year of operation, the river backfilled these micromanders with gravel. A fan-shaped fish ladder was constructed below. Each of these fans has a cut-out for small water (Figs. 59 and 60).

Fig. 57. View of the waterfall from the bottom reinforcement under the bridge.

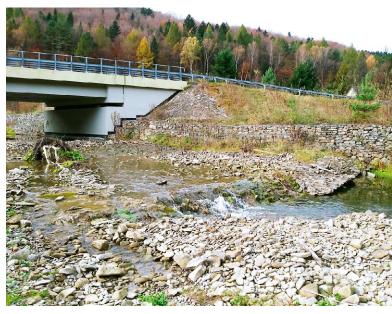
ŚNIETNICA II (94.190 km)

Similar to the bridge at Śnietnica I, the upgraded concrete riverbed reinforcement was made to protect the road bridge (Fig. 61). A cut was made in the bottom reinforcement under the bridge, into which stones were inserted to form several small meanders (Fig. 62). A fish ladder with several pools was added below (Figs. 63 and 64). After a year of operation, the cut in the reinforcement under the bridge was slightly backfilled with gravel. The lack of gravel in this section of river causes severe erosion. For this reason, the last elements of the fish ladder were washed out after the floods. The problem was solved by adding additional concrete and stone shafts to stabilise the riverbed at the necessary height.

Fig. 61. A waterfall under the bottom reinforcement under the road bridge.
