# REPORT

## RESTORATION OF ECOLOGICAL CONTINUITY AND ACTIVITIES IMPROVING FUNCTIONING OF THE FREE MIGRATION CORRIDOR OF THE BIAŁA TARNOWSKA RIVER

National Water Holding Polish Waters  
Regional Water Management Board in Kraków

2022

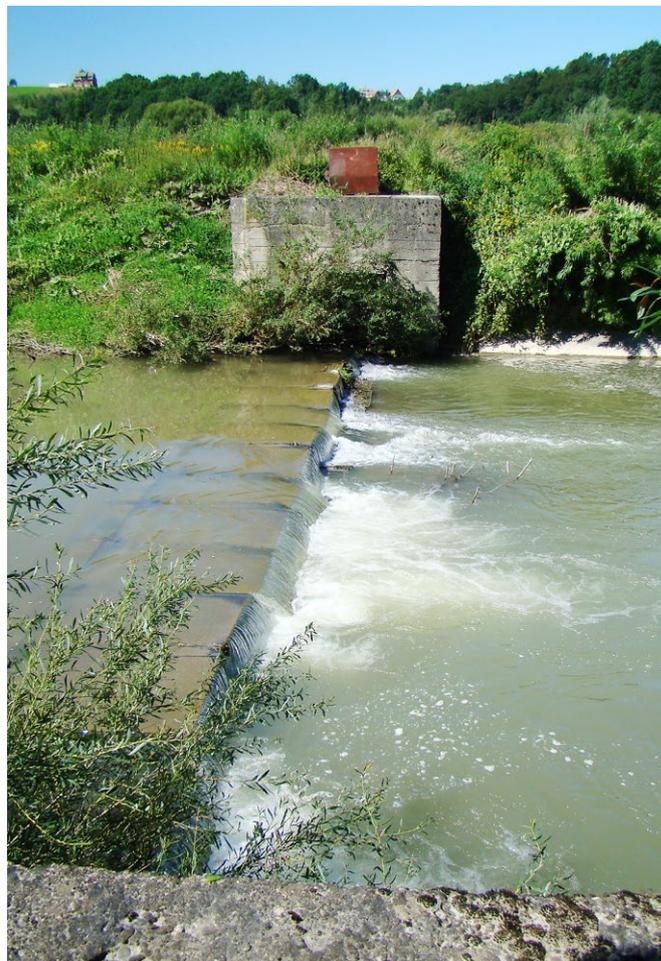
Fig. 11. Weir in Ciężkowice before modernisation. Reconstructed in the 1st stage of the project.

(3 barriers), Biała Niżna (2 barriers), Stróże, Jankowa and Bobowa (Figs. 11, 12, 13, 14). In practice, the reconstruction consisted in building fish ladders in places of weirs (Fig. 15). In total, 80 km of river were unblocked.

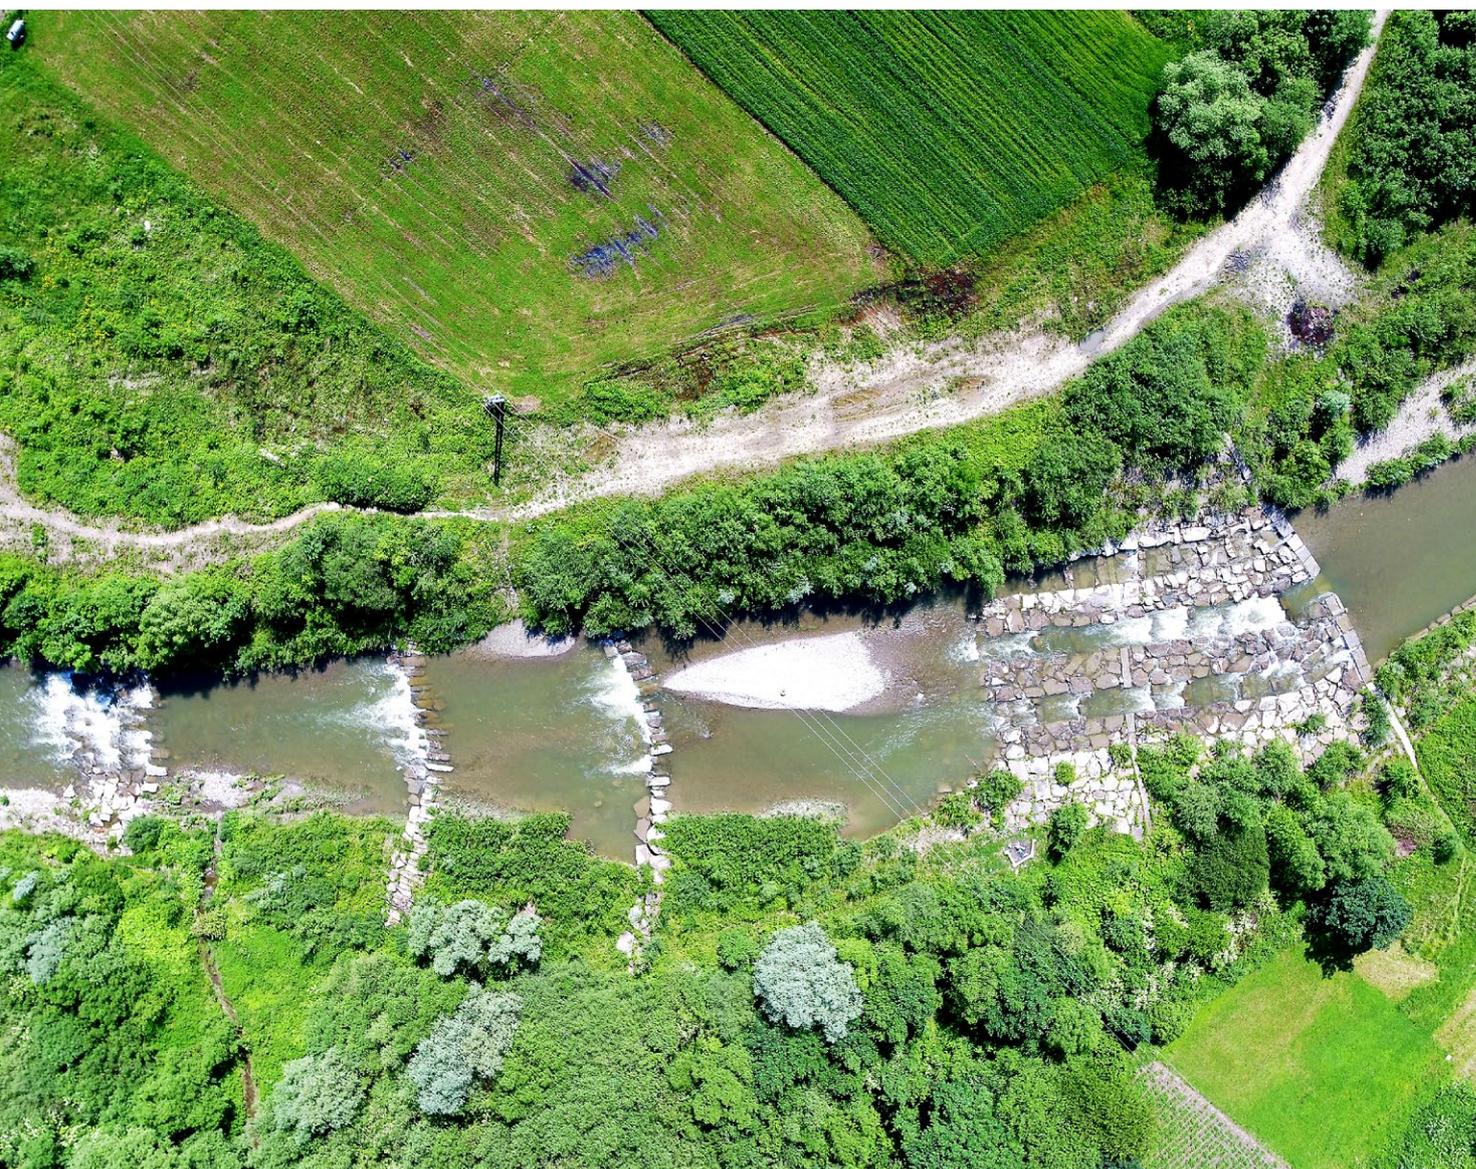
*Fig. 14. The fish ladder in Kąclowa after modernization in the 1st stage of the project.*

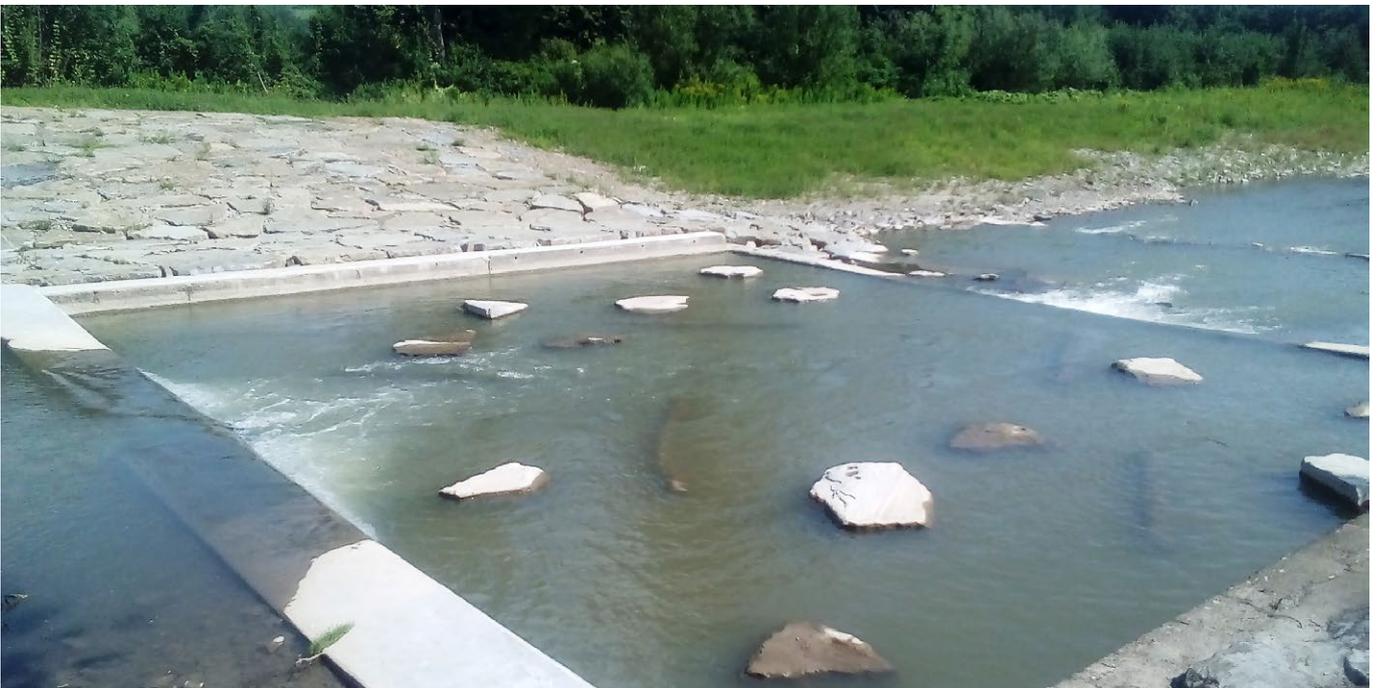
Fig. 17. Boulders and logs as microhabitats for fish.

The barrage was built in the 1950s (Fig. 16). The purpose of the barrage was to protect a three-span bridge and to create an accumulation of water for drinking purposes in Bobowa village. Before modernisation, the height of the dam from the river surface to its crest was about 0.9–1.0 m. Below it, there was a stilling basin to dissipate the energy of the flowing water. Before the reconstruction, the light of the bridge under the two spans was blocked by a thick layer of sediment deposited over decades. As part of the modernisation of the dam, these sediments were removed, thus increasing the free passage of floodwater. The damming weir itself was rebuilt. The damming height was lowered, and triangular cut-outs for low water were added. The pool between the sills was fitted with boulders and wooden beams to provide temporary shelter for the fish (Figs. 17 and 20). Above the weir and bridge, a new fish ramp in the form of a honeycomb was built (Figs. 18, 19, 21, 22). More than 600 stones with a total weight of about 3,300 tonnes were used in the construction, with individual weights of up to 12 tonnes.

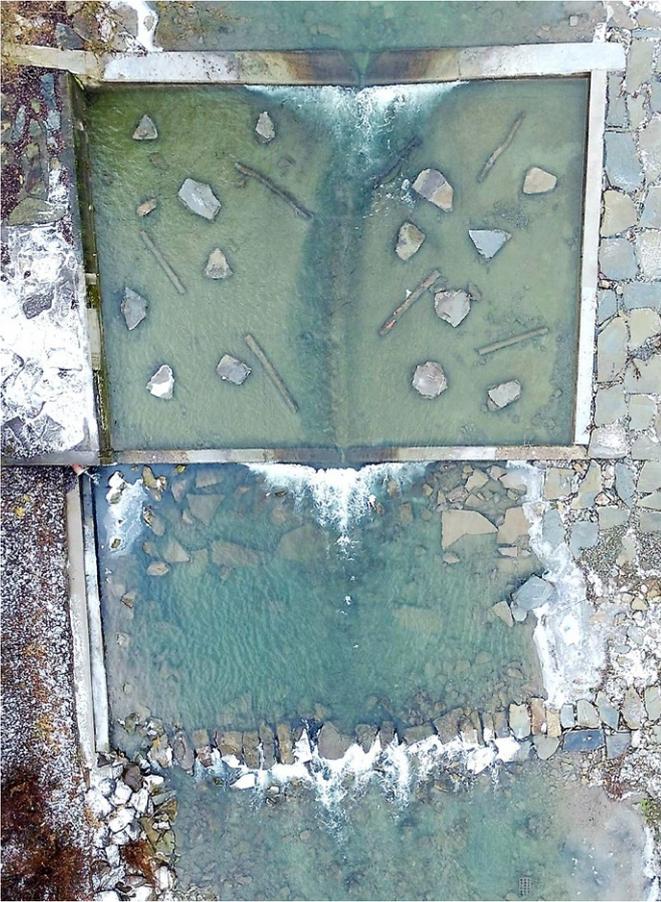
*Fig. 20. The weir after reconstruction.*

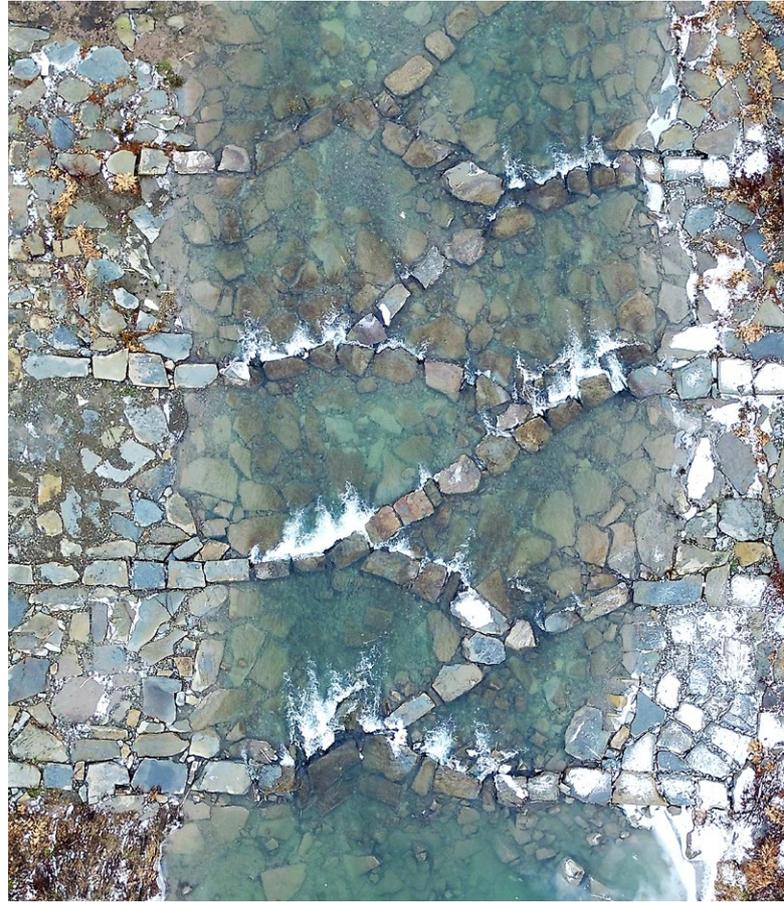
*Fig. 21. Riffle in the shape of a honeycomb.*

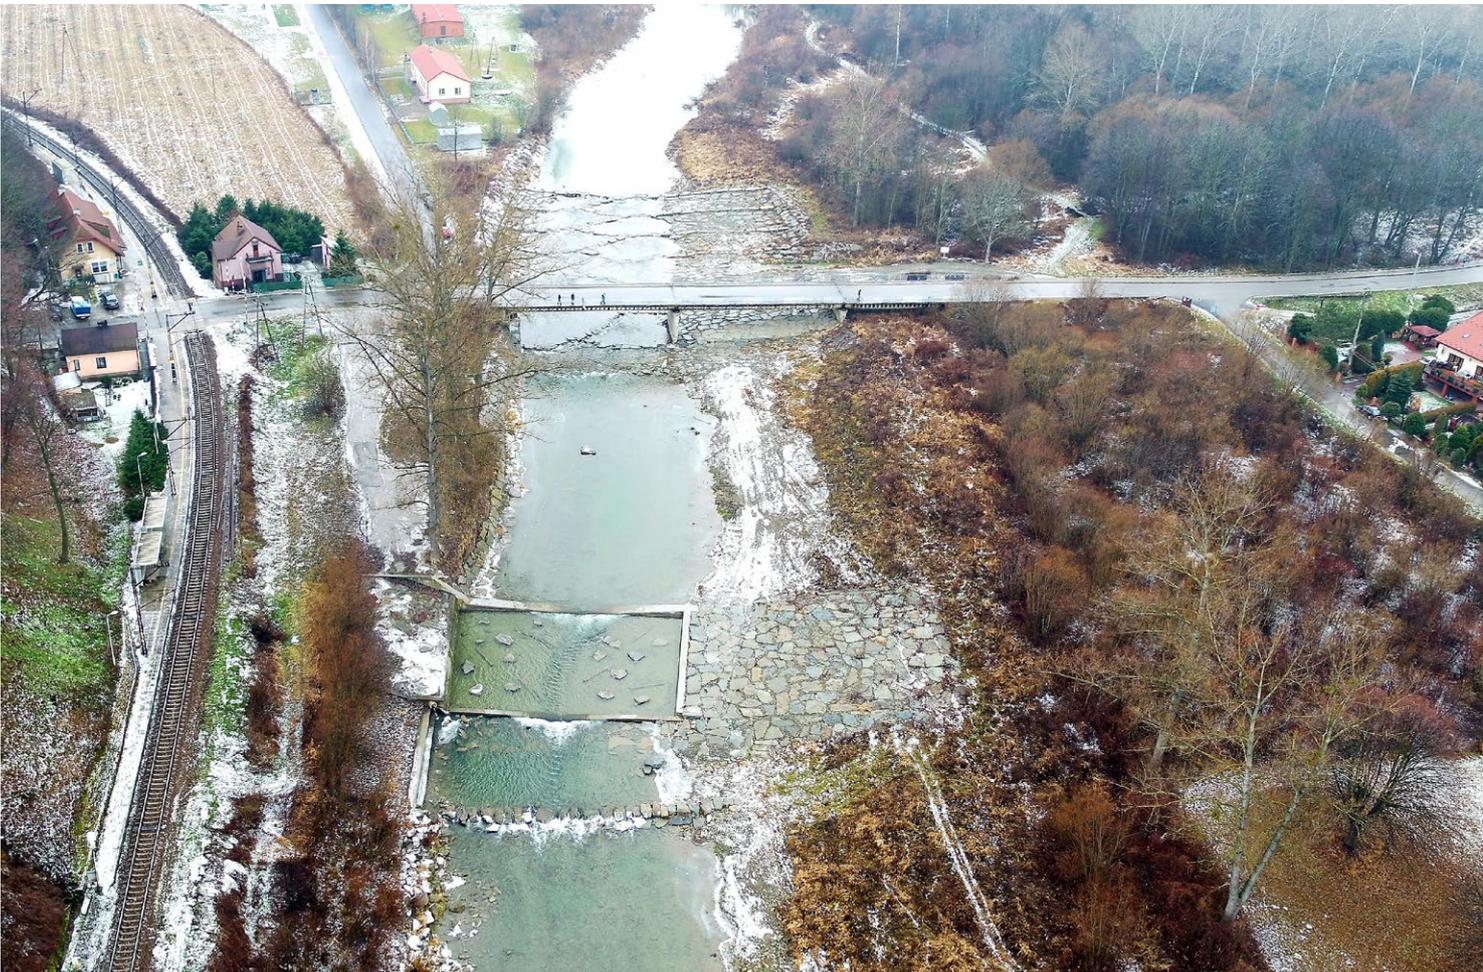
*Fig. 22. The weir after reconstruction and new fish ladder close to nature.*

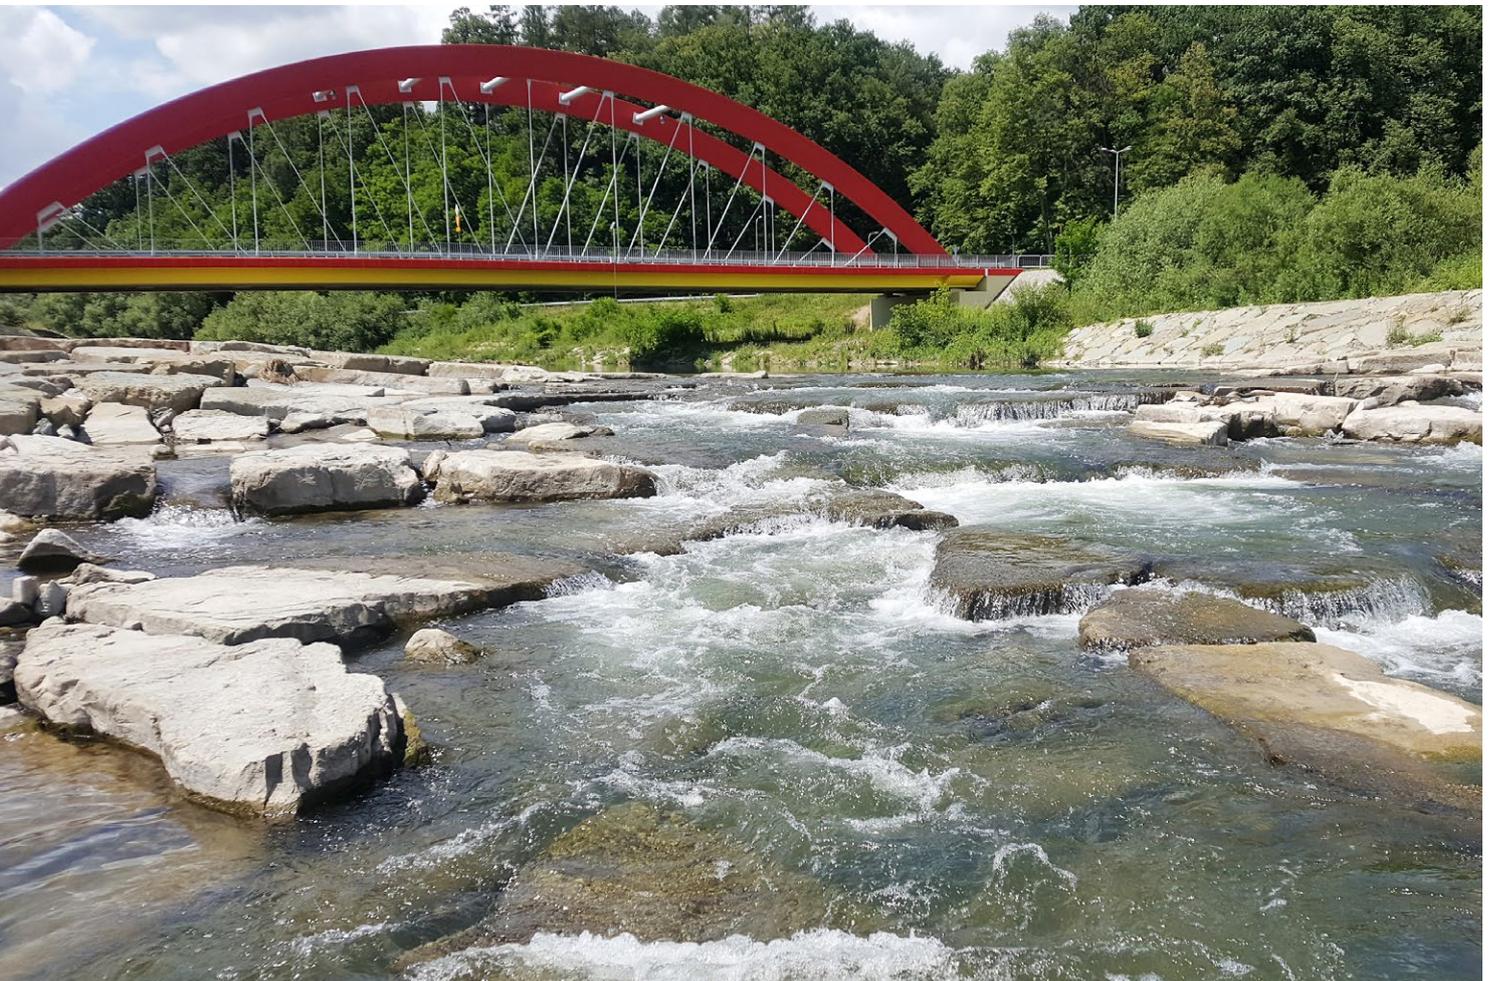
Fig. 25. Weir after reconstruction.

bridge itself posed a flood risk because the side spans were blocked by deposited material, vegetation and overhanging vegetation. In 2019, it was demolished and replaced with a new single-span bridge. As part of the upgrade of the weir below the bridge, a honeycomb fish ladder was built. At the same time, the deposited sediments that narrowed the riverbed and impeded the flow of high water were removed (Figs. 24 and 25).

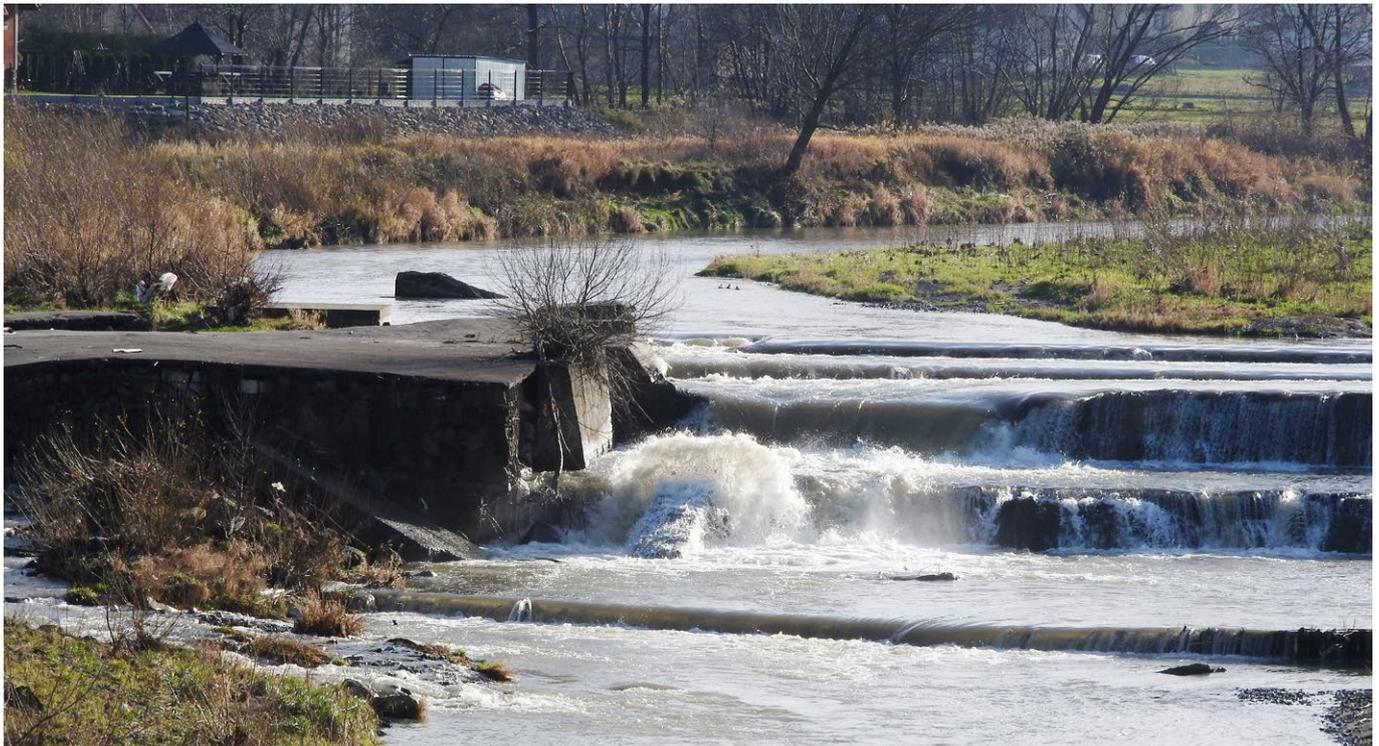
The old weir in the form of a cascade of four dams dammed up the water for the town's water supply. Later, the construction of a small hydroelectric power plant was started but never completed. During the flood in 2010, the weir was heavily damaged (Fig. 26). As part of the modernisation of the weir, the power plant was demolished and the sill dismantled. The damming height was lowered by about 1 m. A new water intake was constructed in the form of a drainage intake from under the riverbed. The sill was replaced by a honeycomb fishway (Figs. 27 and 30). In addition, an observation room, equipped with a glass window, a fish coun-

Fig. 26. The weir before reconstruction.

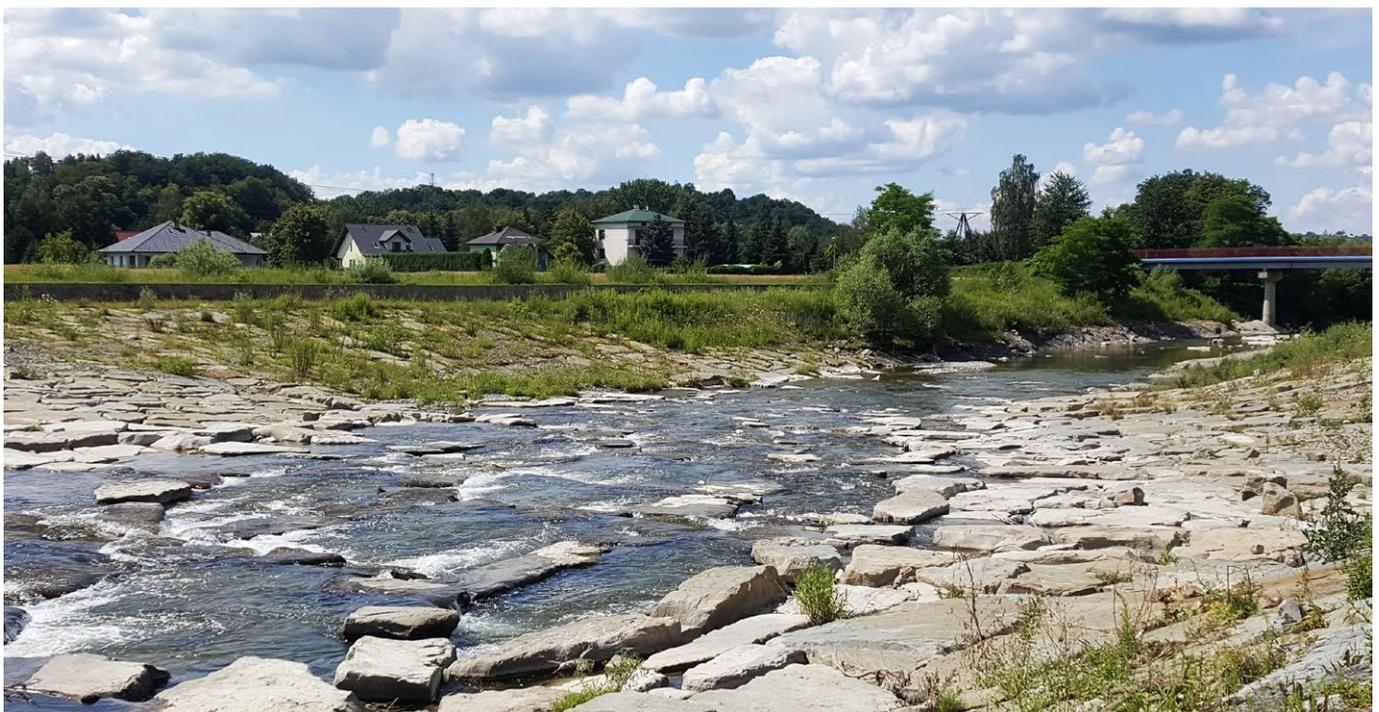
Fig. 27. View of the fish ladder.

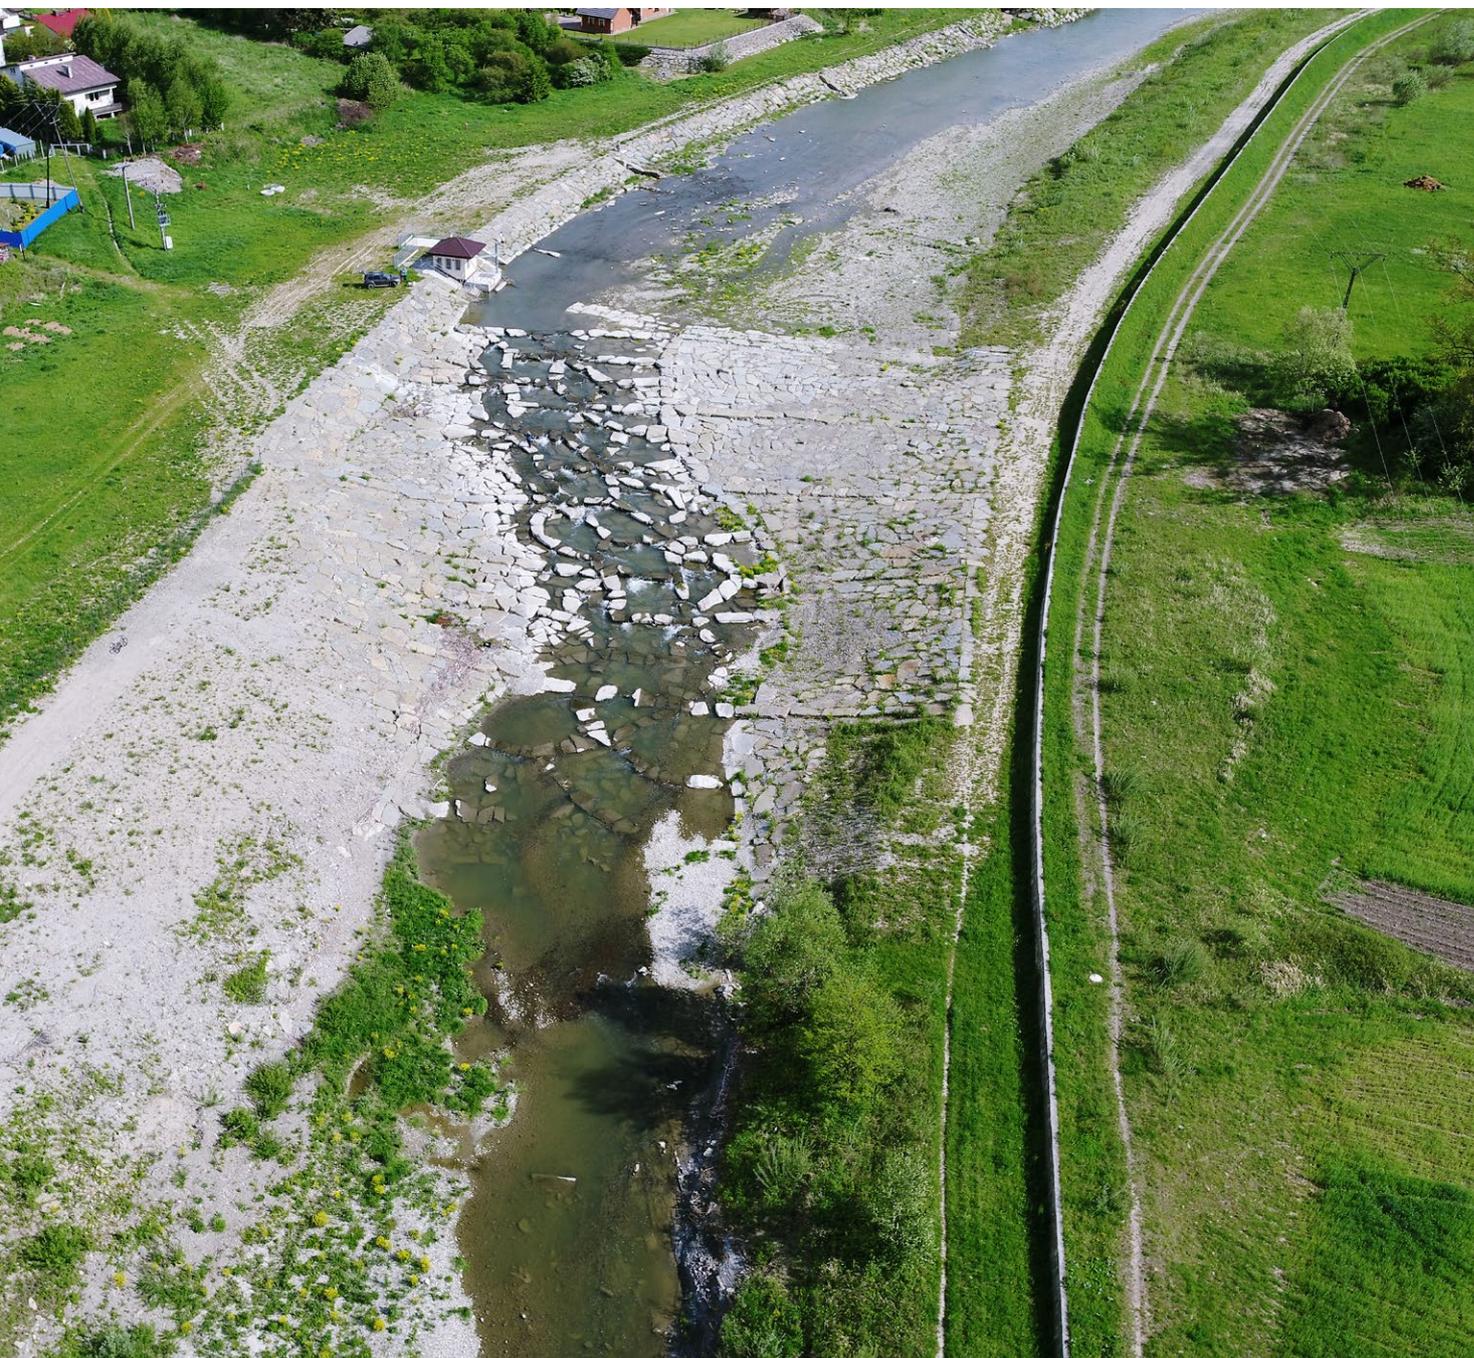
Fig. 30. The fish ladder after reconstruction of the weir.

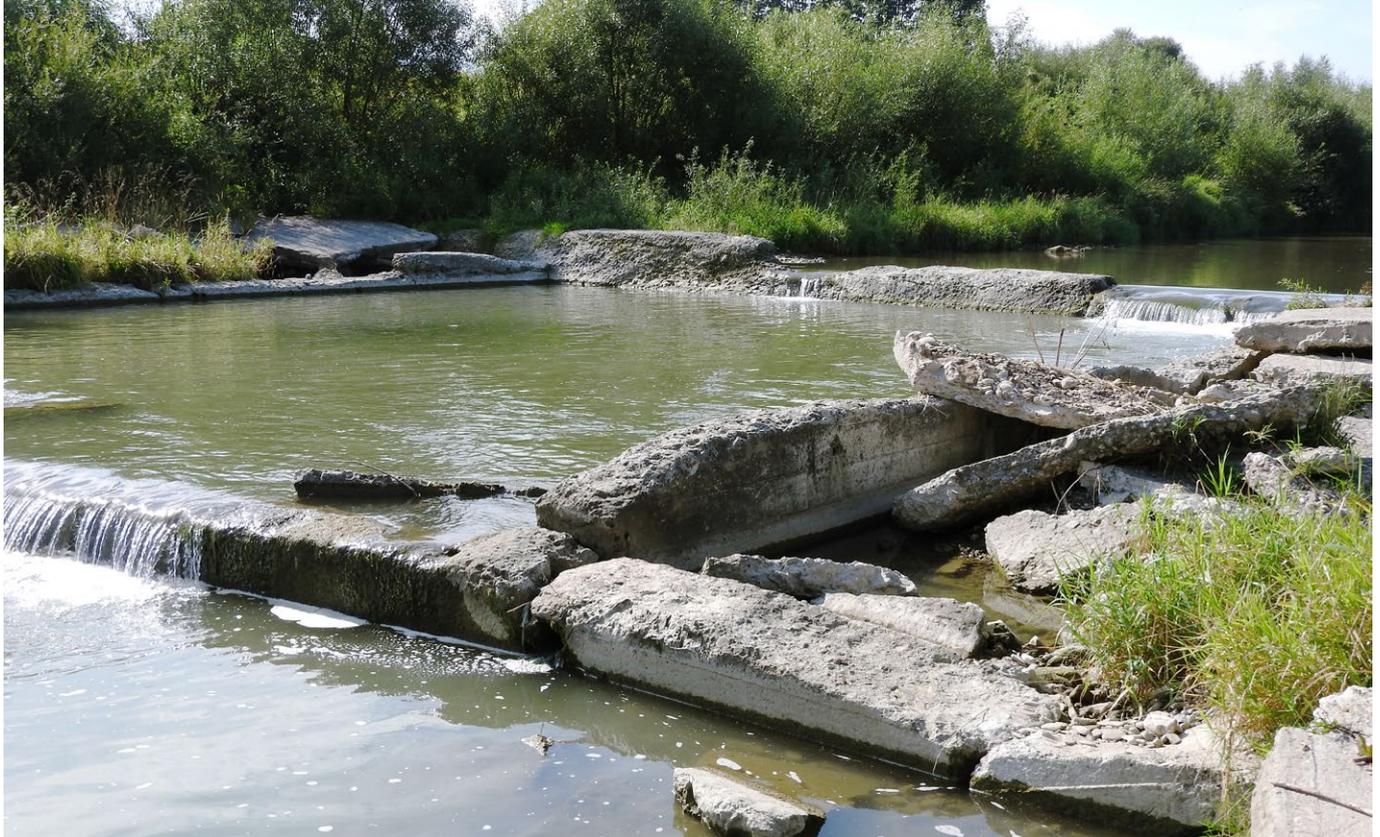
In Biała Niżna, there was a concrete dam with a stilling basin, whose drop of 1.3 m constituted a migration barrier (Fig. 31). Due to its poor technical condition, the structure was not functional. As part of the modernisation, a solution was adopted consisting in the partial elimination of the weir. The upper part was removed, and the basin was filled with gravel. Three stone bottom gourds in the form of

*Fig. 31. The weir before decommissioning.*

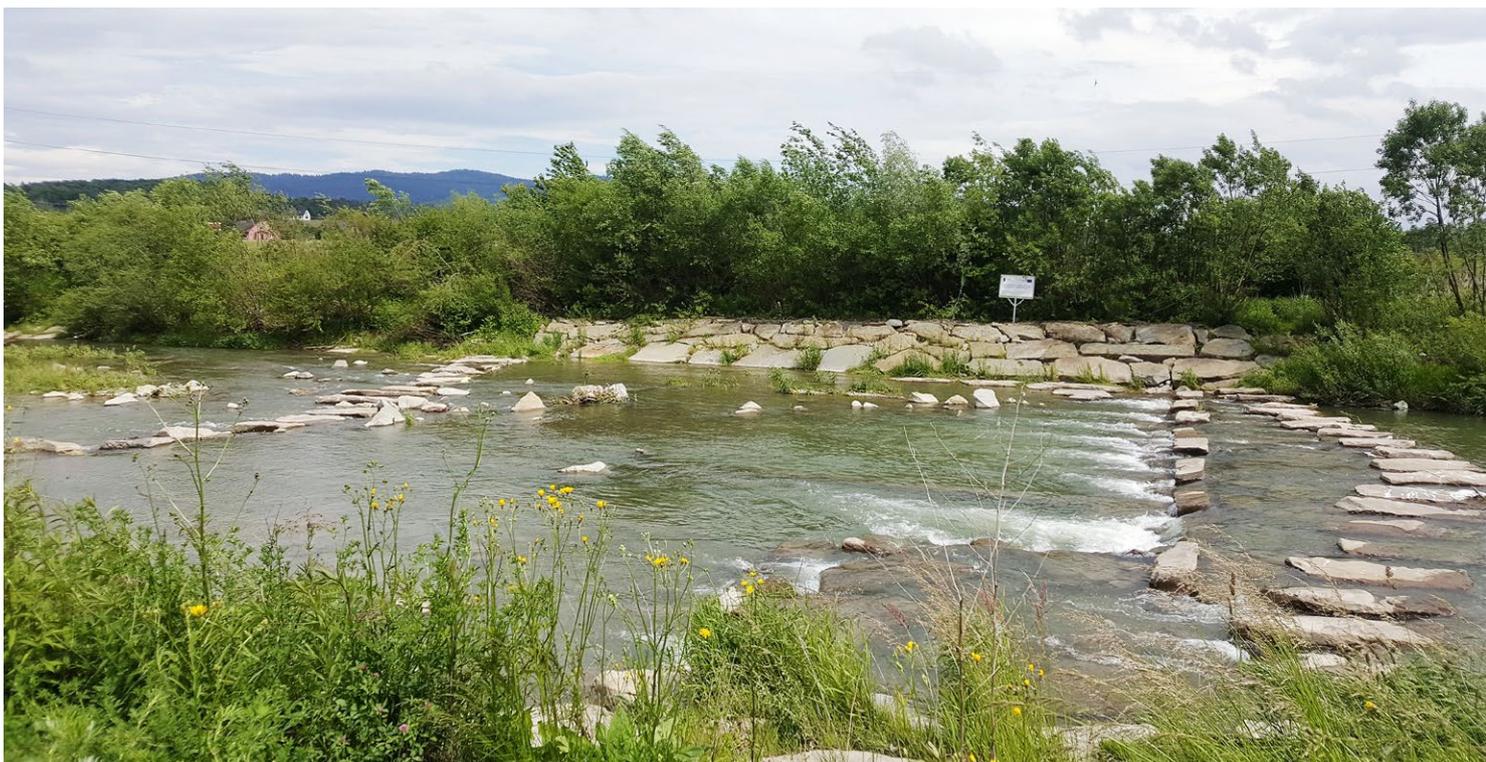
*Fig. 32. Weir after decommissioning and rebuilding.*

arches were added to protect the channel against excessive erosion, as well as stone ripraps on the banks (Fig. 32).

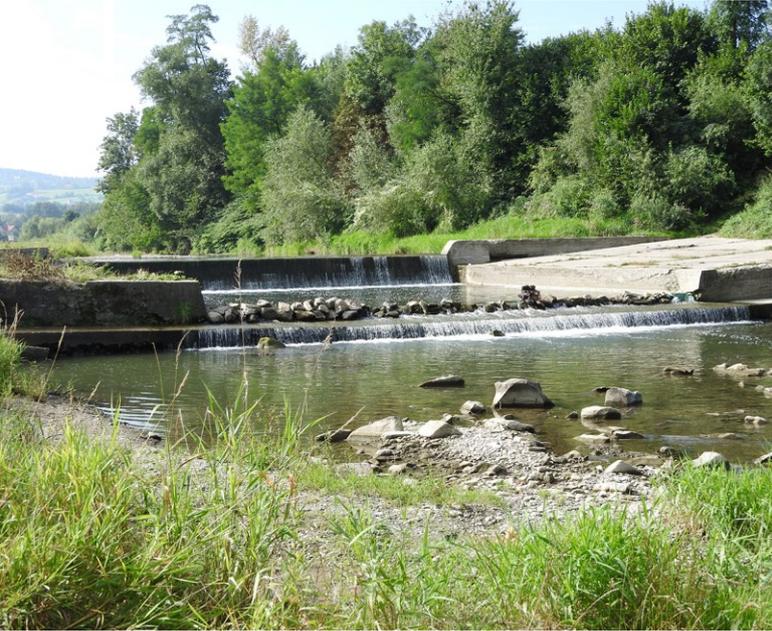
A concrete damming weir with a stilling basin was constructed in Biała Niżna to prevent channel incision (down-cutting) (Fig. 33). The damming-up height was 1.2 m. The stilling basin was replaced by a fish ladder as part of the upgrade. Three concrete baffles with alternating triangular cuts were built across the basin. The whole stage was supported by a stone girder (Figs. 34 and 35).

Fig. 33. Weir before modernization.

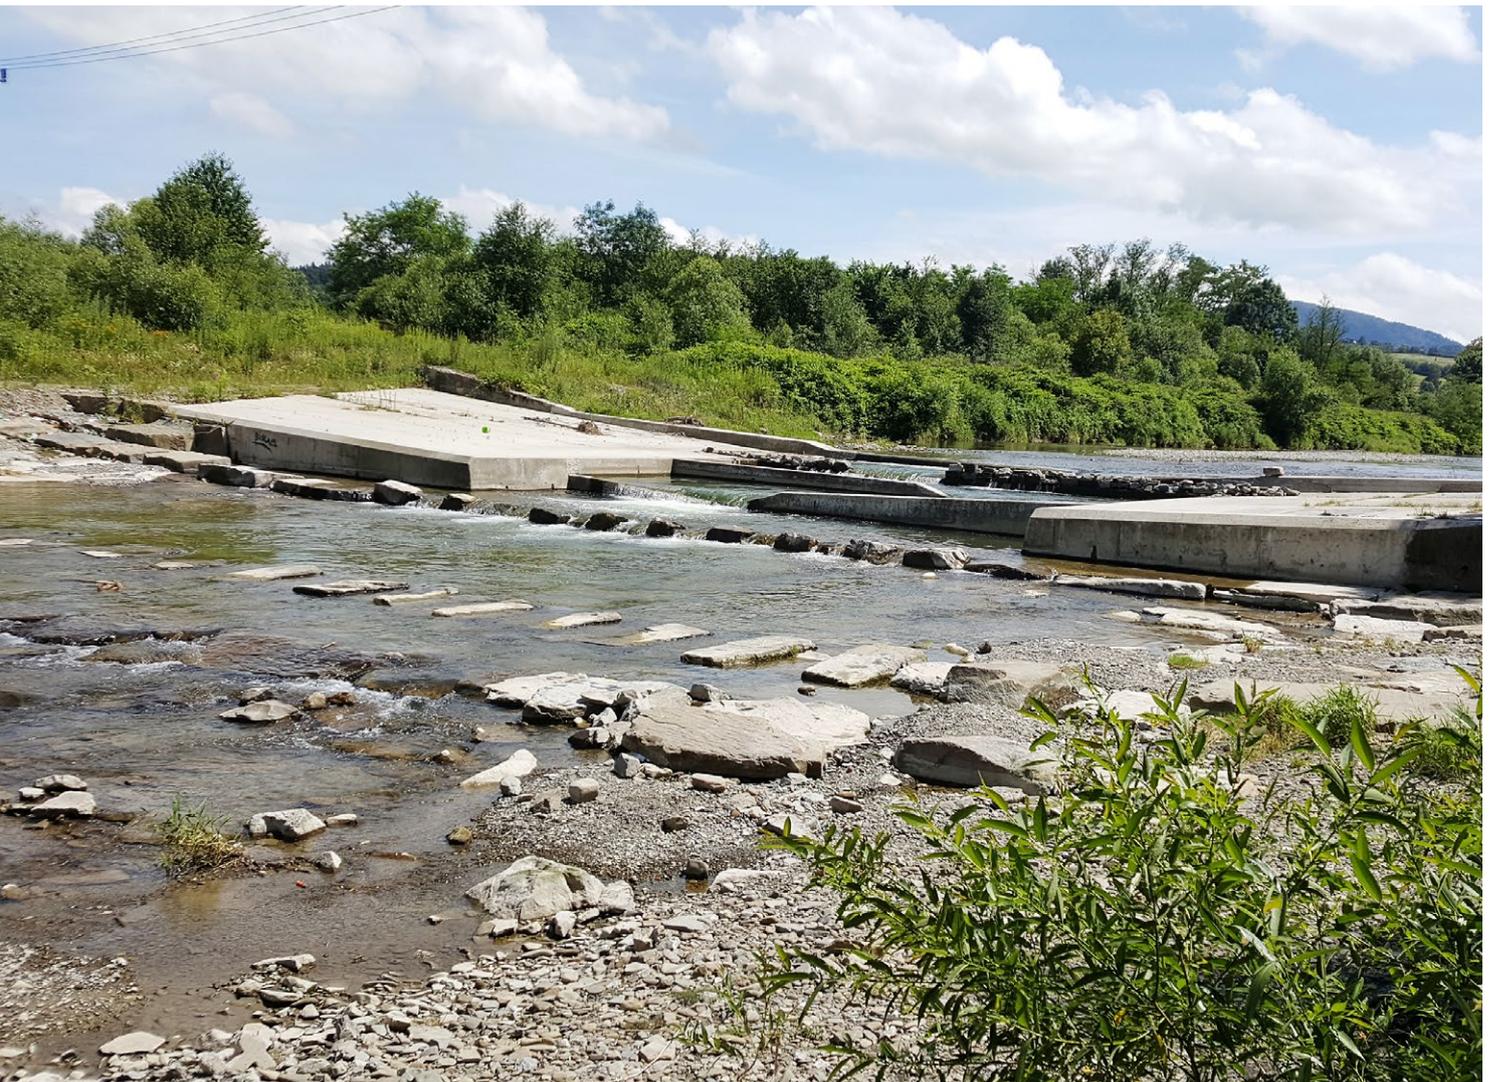
Fig. 35. Weir after modernization.

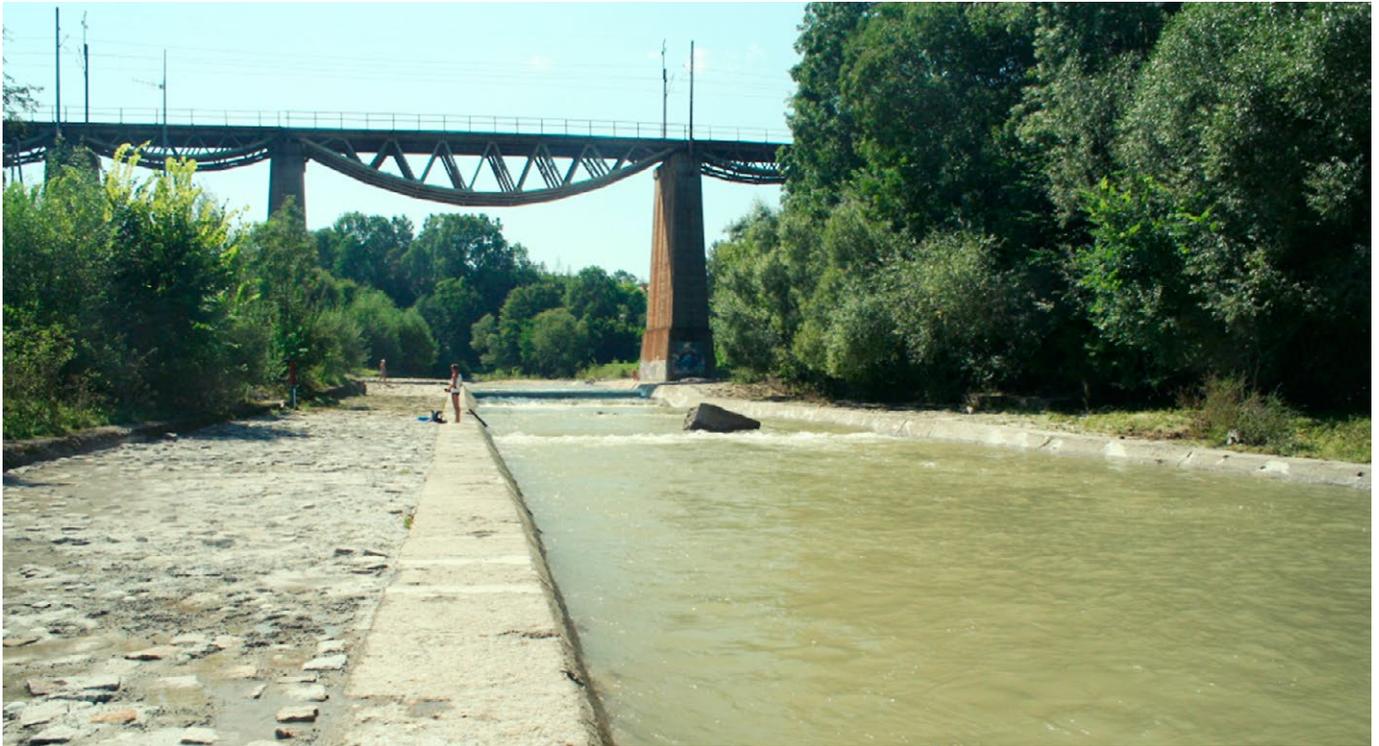
At the beginning of the 20th century, the railway and road bridges located in the centre of Grybów were secured (Fig. 36). These were concrete weirs to slow down the water flow and concrete boulevards supporting the banks for a length of 300 m. Part of these concrete weirs below the road bridge were converted into a fish ladder during the first stage of the project in 2013. The remaining part of the protection, a cascade of six weirs stabilising the channel under the railway bridge (72.050 km), was rebuilt during

Fig. 36. The weir cascade before reconstruction. View upstream.

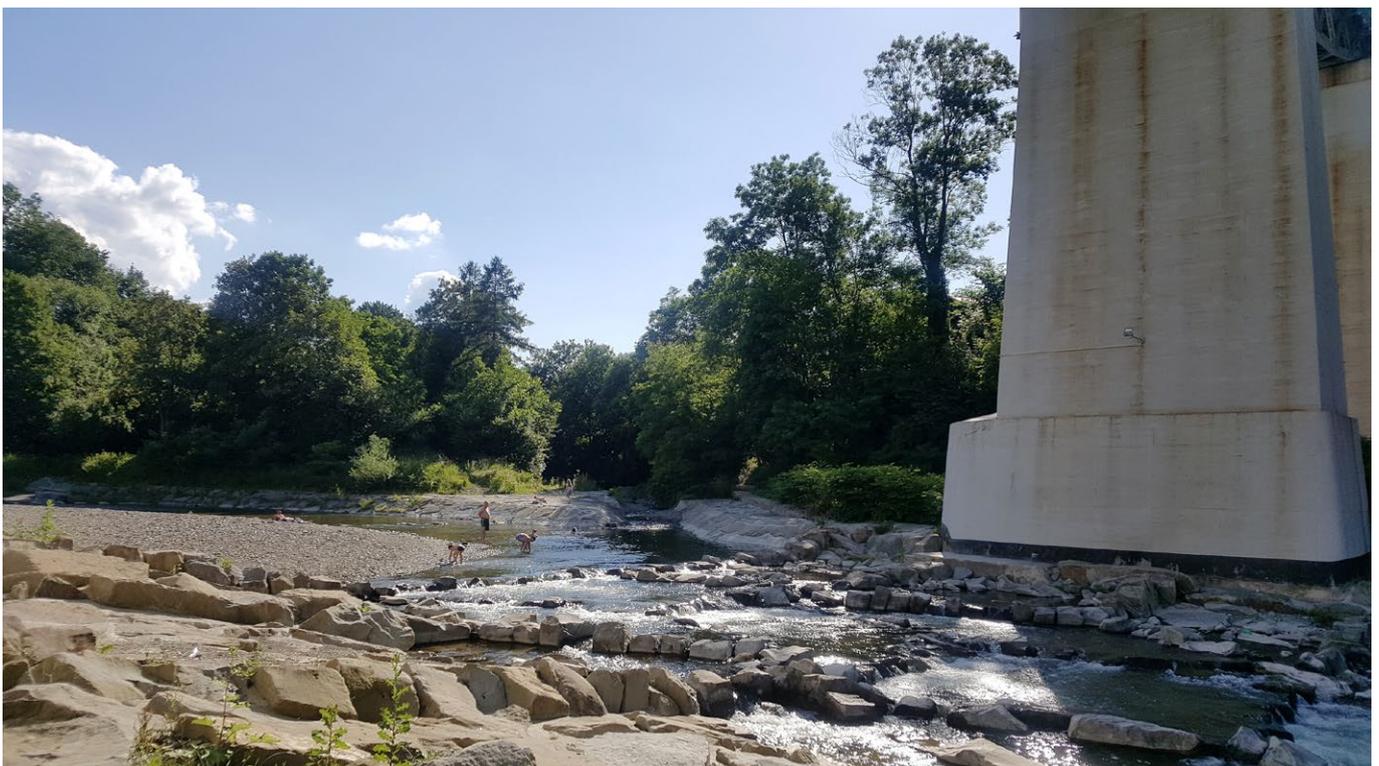
Fig. 37. Reinforcement of the left bank and mouth section of the tributary before the bridge.

the second stage of the project. The old concrete bank reinforcement was left in place, the weirs were removed and a close-to-nature fishway in the form of a honeycomb was constructed in their place (Figs. 37, 38, 39, 40).

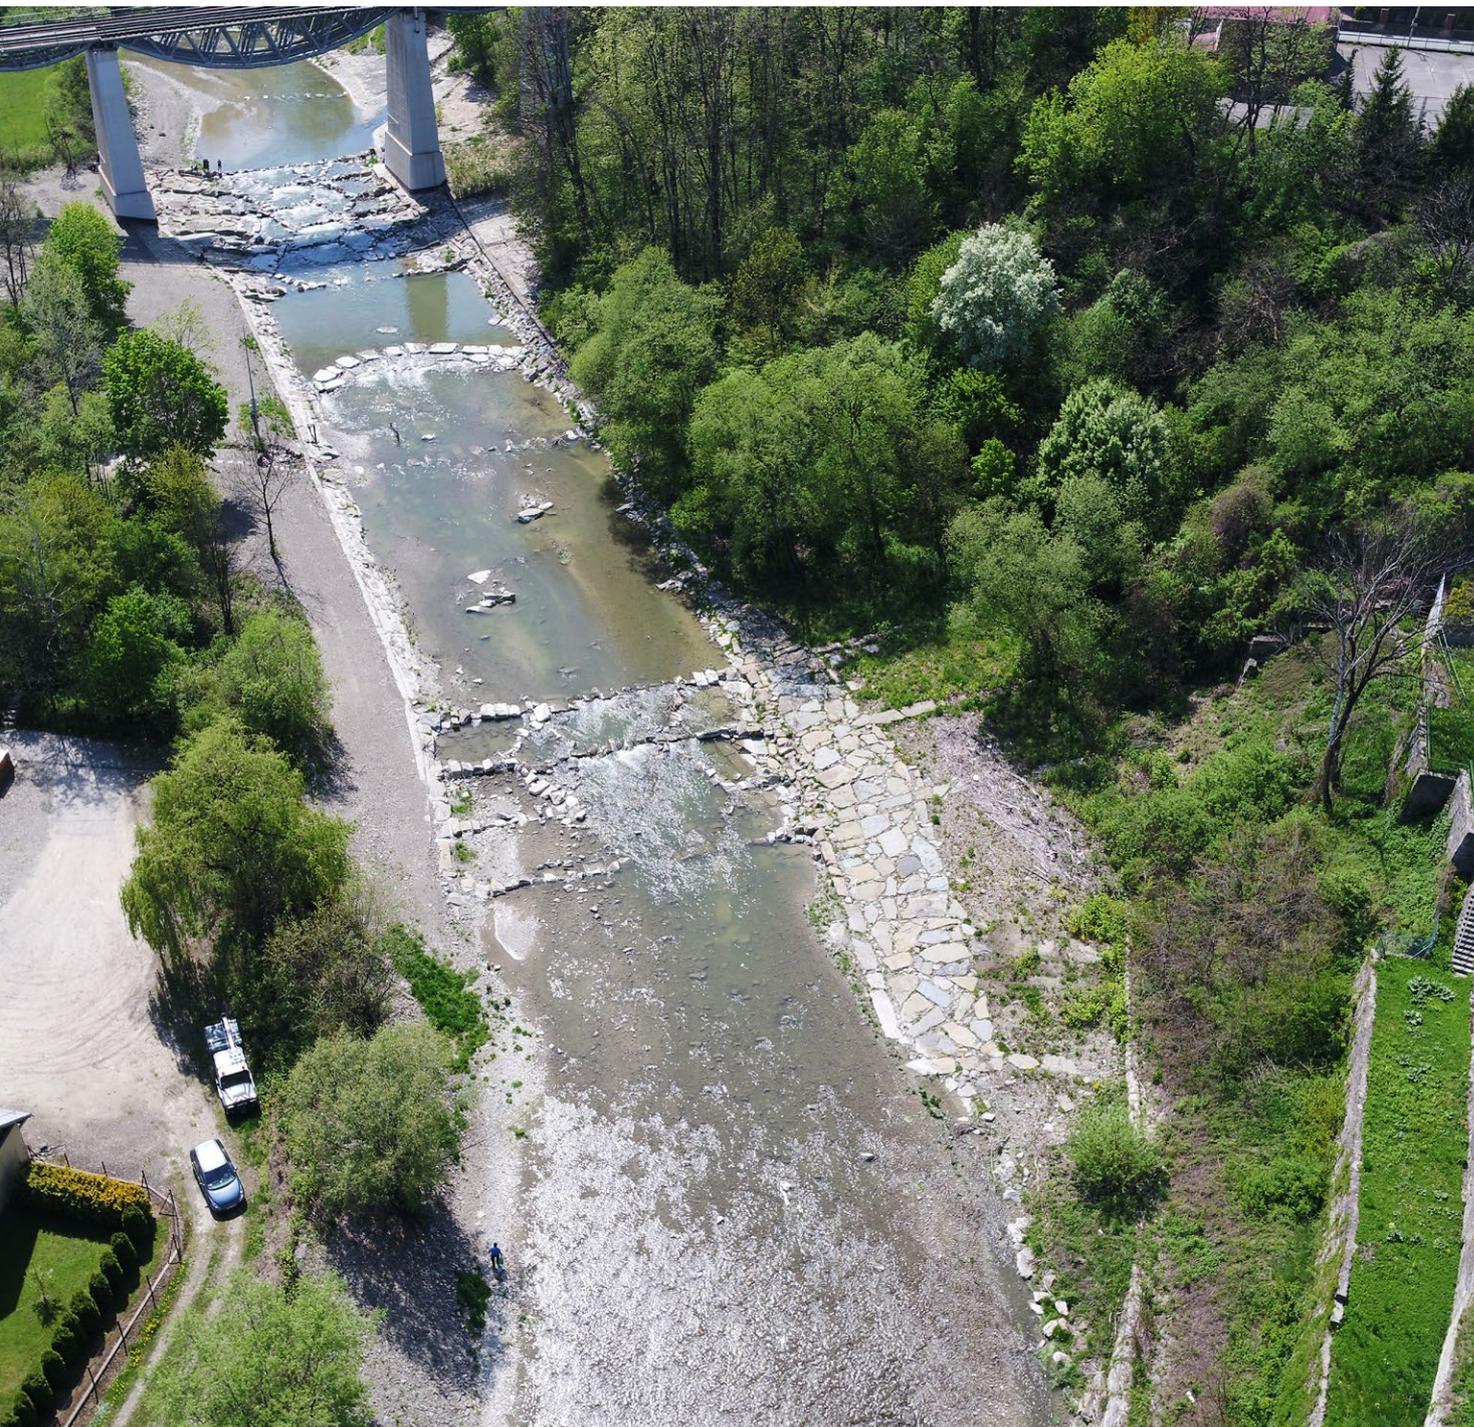
Fig. 40. General view of the fishway.

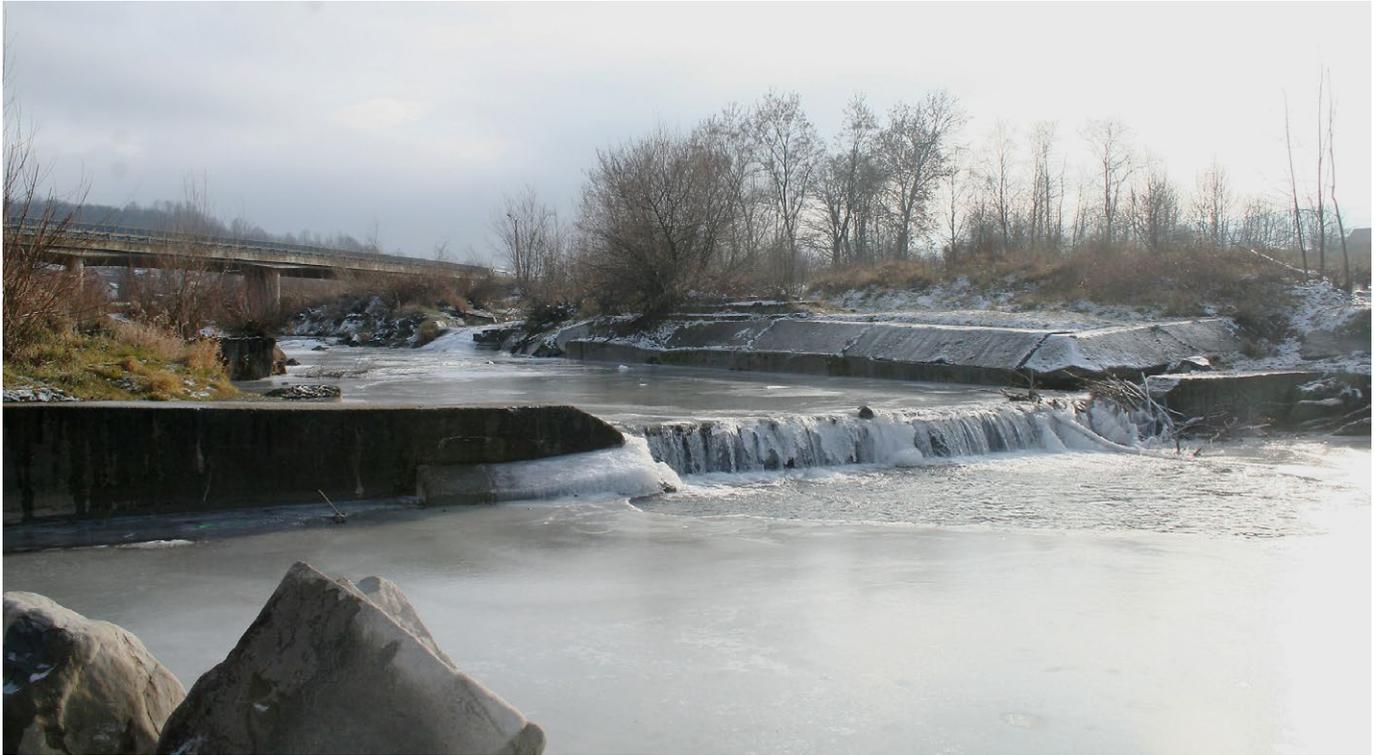
Many years ago, a cascade of weirs was built here to secure the road bridge (Fig. 41). Above, the left-bank tributary of the Pławianka stream flows into the Biała. This stream, in its lower course, was regulated in the form of a concrete culvert. As part of the modernisation, the cascade of weirs on the Biała and the mouth section of the Pławianka were rebuilt. Some of the concrete weirs were removed, cut-outs for low water were made and a close-to-nature honey-comb fish ladder was added below (Figs. 42 and 44). The

Fig. 41. Weir before reconstruction (visible mouth of the Pławianka River).
