# REPORT

## RESTORATION OF ECOLOGICAL CONTINUITY AND ACTIVITIES IMPROVING FUNCTIONING OF THE FREE MIGRATION CORRIDOR OF THE BIAŁA TARNOWSKA RIVER

National Water Holding Polish Waters  
Regional Water Management Board in Kraków

2022

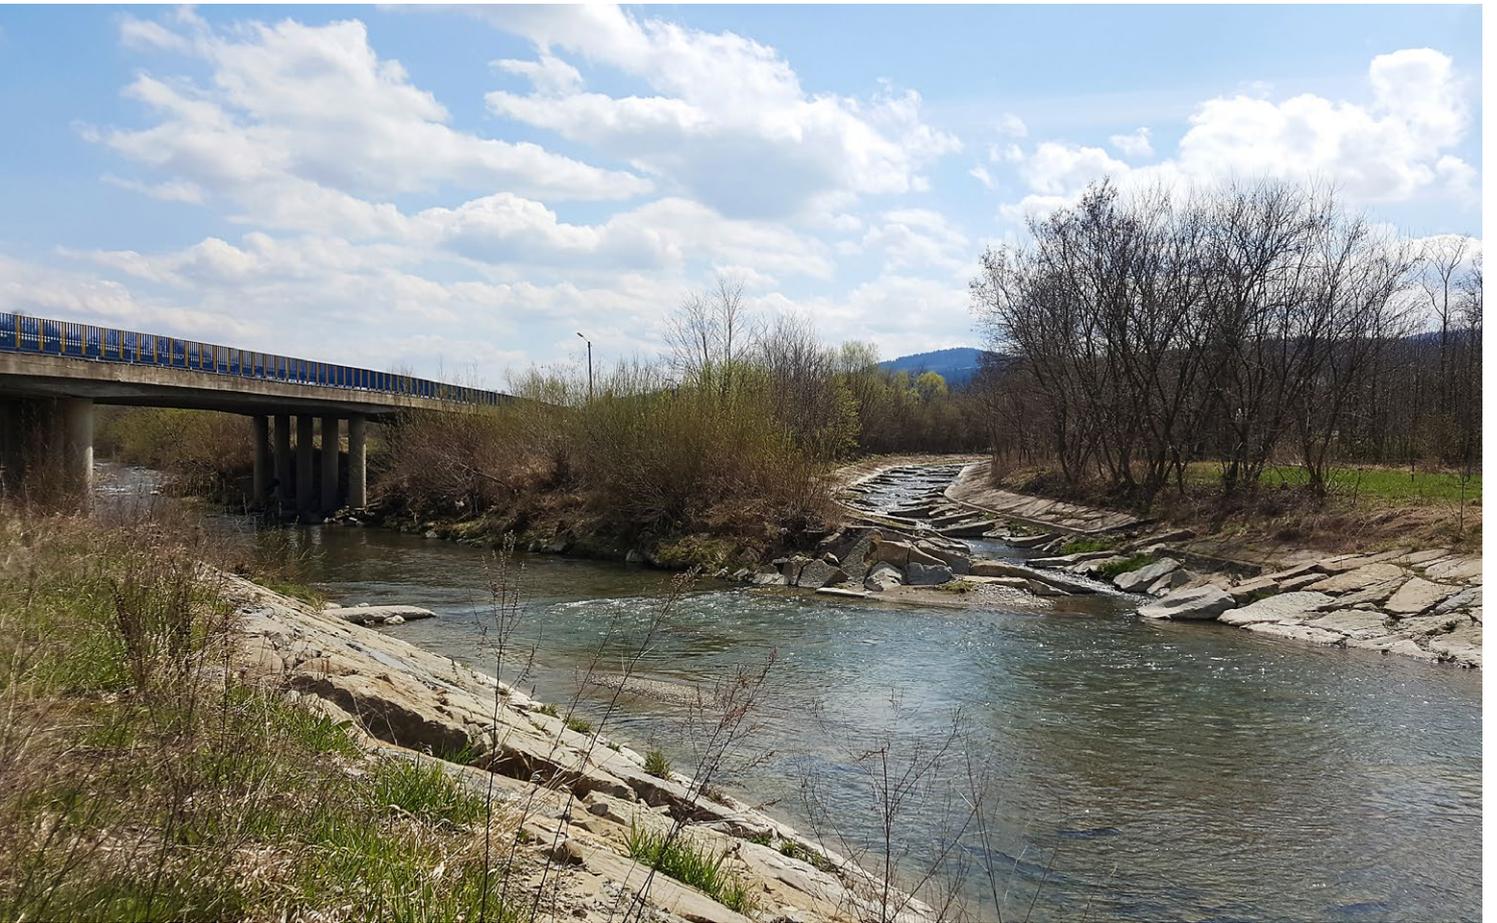
Fig. 43. The mouth of the Plawianka stream after reconstruction.

concrete-liner at the mouth of the Pławianka River was dismantled, and boulders were installed between concrete bank reinforcements, creating a meandering channel with a natural gravel bottom (Fig. 43).

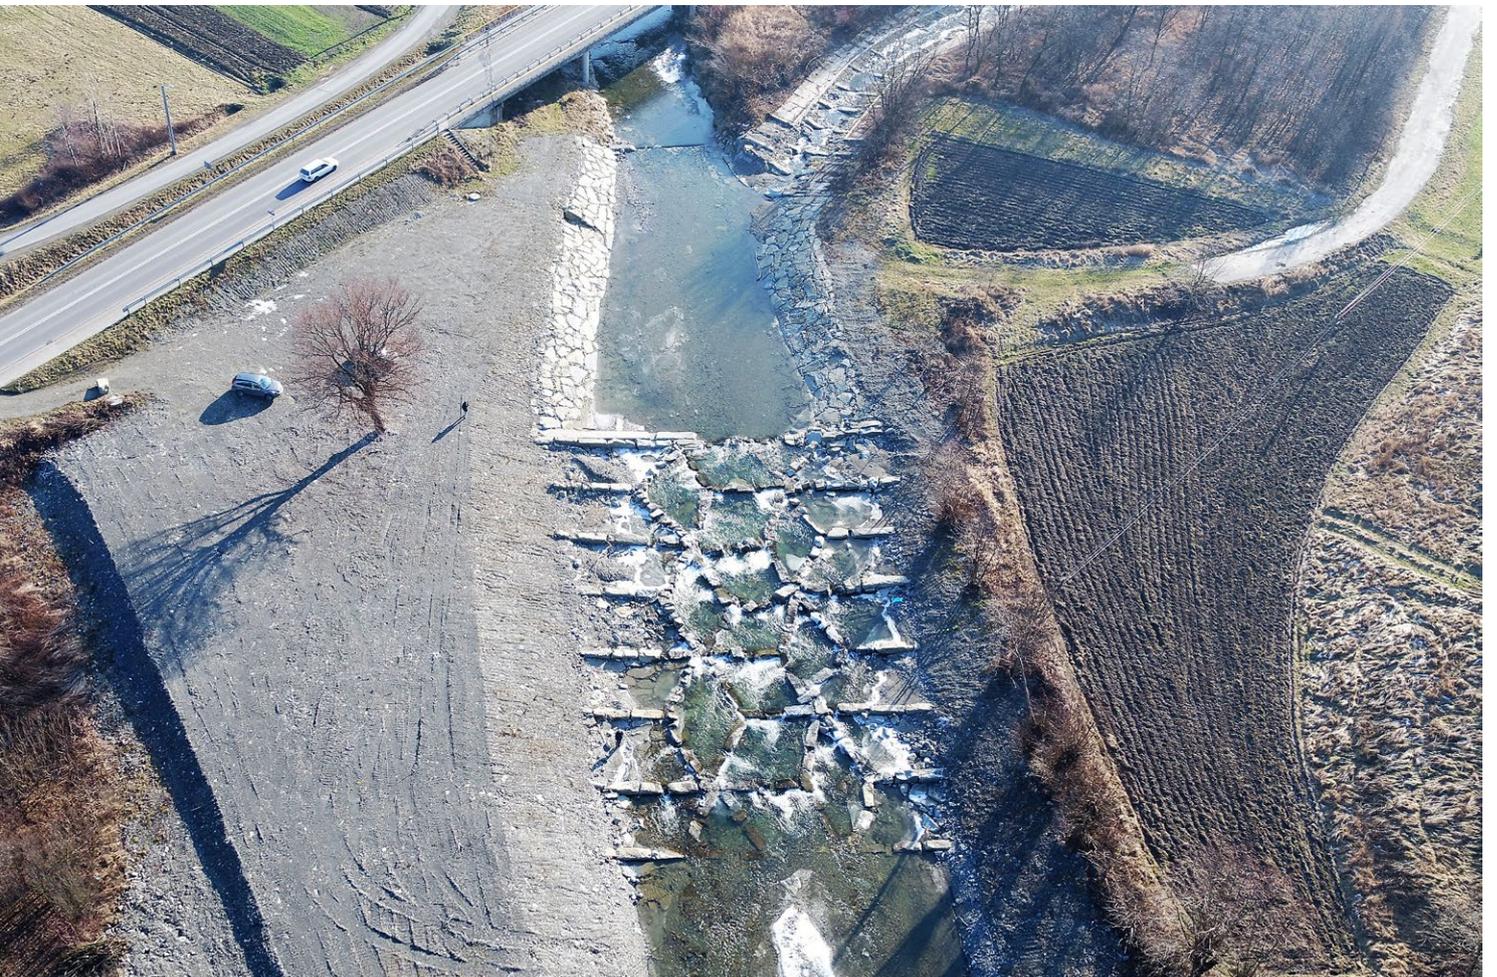
Fig. 44. View of the fish ladder and mouth of the Plawianka River after reconstruction.

Many years ago, a cascade of weirs was built here to secure the road bridge (Fig. 41). Above, the left-bank tributary of the Pławianka stream flows into the Biała. This stream, in its lower course, was regulated in the form of a concrete culvert. As part of the modernisation, the cascade of weirs on the Biała and the mouth section of the Pławianka were rebuilt. Some of the concrete weirs were removed, cut-outs for low water were made and a close-to-nature honey-comb fish ladder was added below (Figs. 42 and 44). The

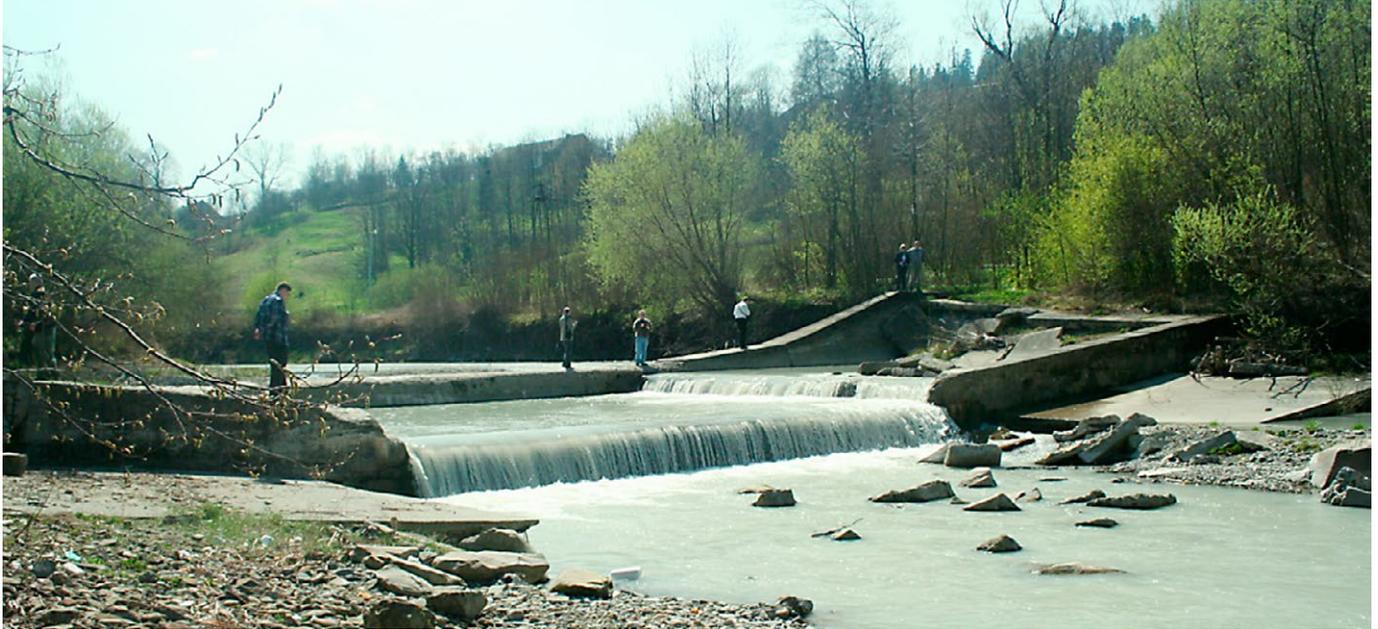
At this location, there was an old, dilapidated weir that no longer served any function (Fig. 45). As part of the redevelopment in Phase I of the project, the weir was demolished. Within a few years, the river returned to its natural gradient at this location with a small rapid and a riffle below (Fig. 46). As part of Phase II, a stone rapid was added here, and the left bank with a landslide was reinforced by a stone embankment (Fig. 47).

Fig. 45. Weir before decommissioning.

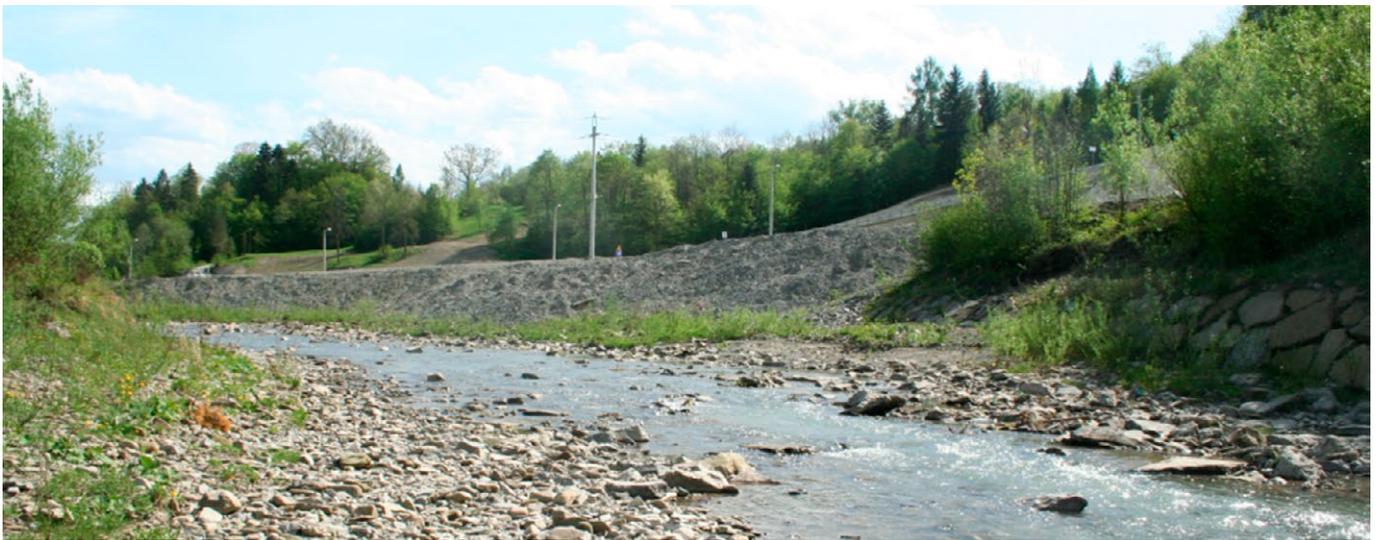
Fig. 46. View of the renaturalised river after the removal of the weir.

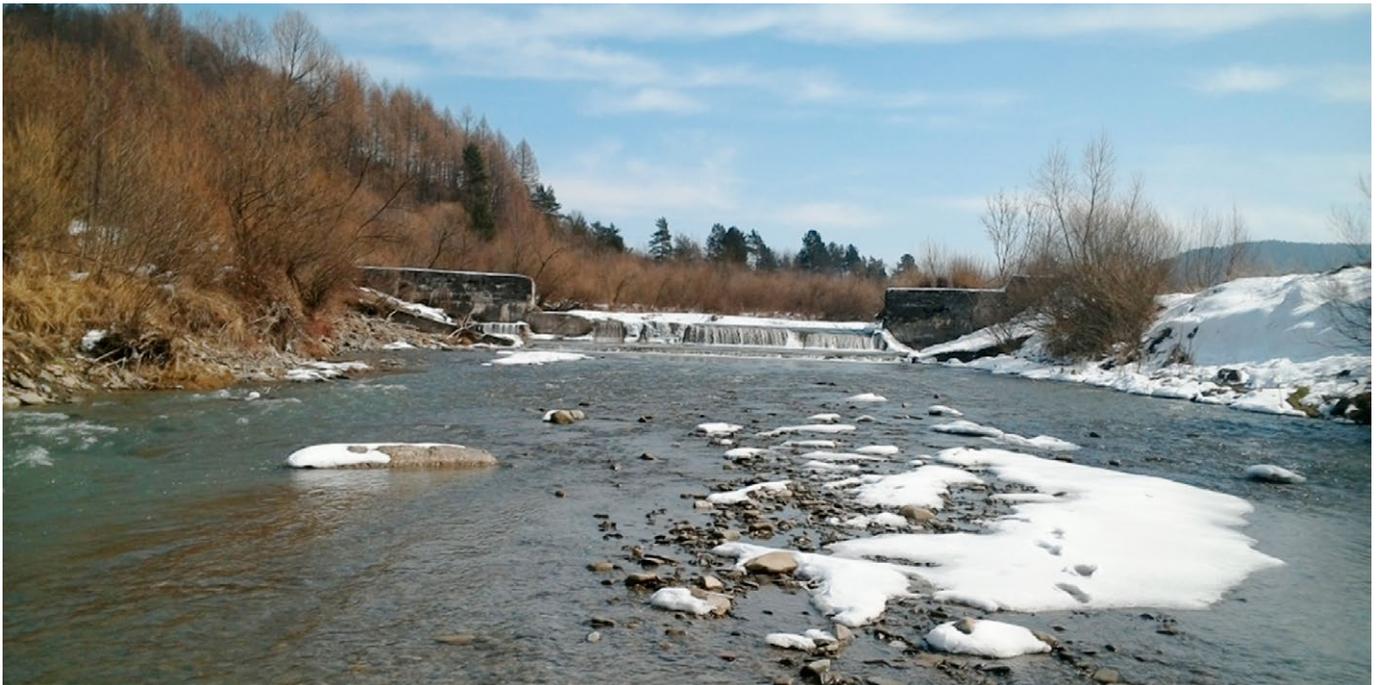
Both structures are located close to each other at a distance of 224 m. The upper weir (Florynka II), with a height of 1.75 m, was built in the middle of the 20th century by a private investor in order to dam up water for a planned hydroelectric power plant or a sawmill. It was a classic anti-rubble dam. This purpose was never realised (Fig. 48). The task of the lower stage (Florynka I), with a height from the bottom of 1.25 m, was to support the anti-rubble dam

Fig. 48. The Florynka II weir before reconstruction.

(Fig. 49). The technical condition of both weirs was very poor, and these low-head dams constituted an impassable barrier for fish. As part of the modernisation, the rebuilding of both weirs was planned so that fish migration would be possible while maintaining the damming ordinate. At the Florynka I, the whole weir was left together with the stilling basin. The upper weir crest was lowered, and a close-to-nature honeycomb fish ladder was built on the downstream side (Figs. 50 and 52). In the upper weir (Florynka II), the stilling basin was eliminated, and on the downstream side, a close-to-nature honeycomb fishway was added (Figs. 51 and 52). Above the weir crest three gourds were constructed to protect the ford.

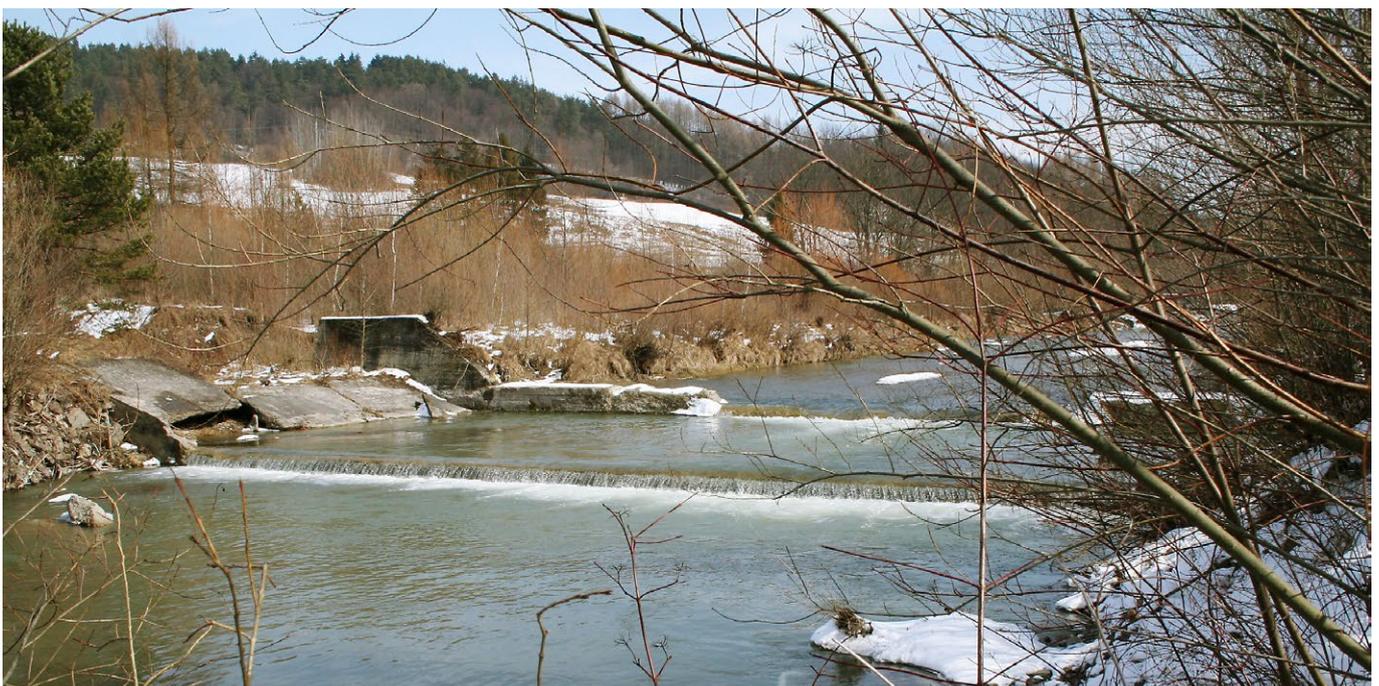
Fig. 49. The Florynka I weir before reconstruction.

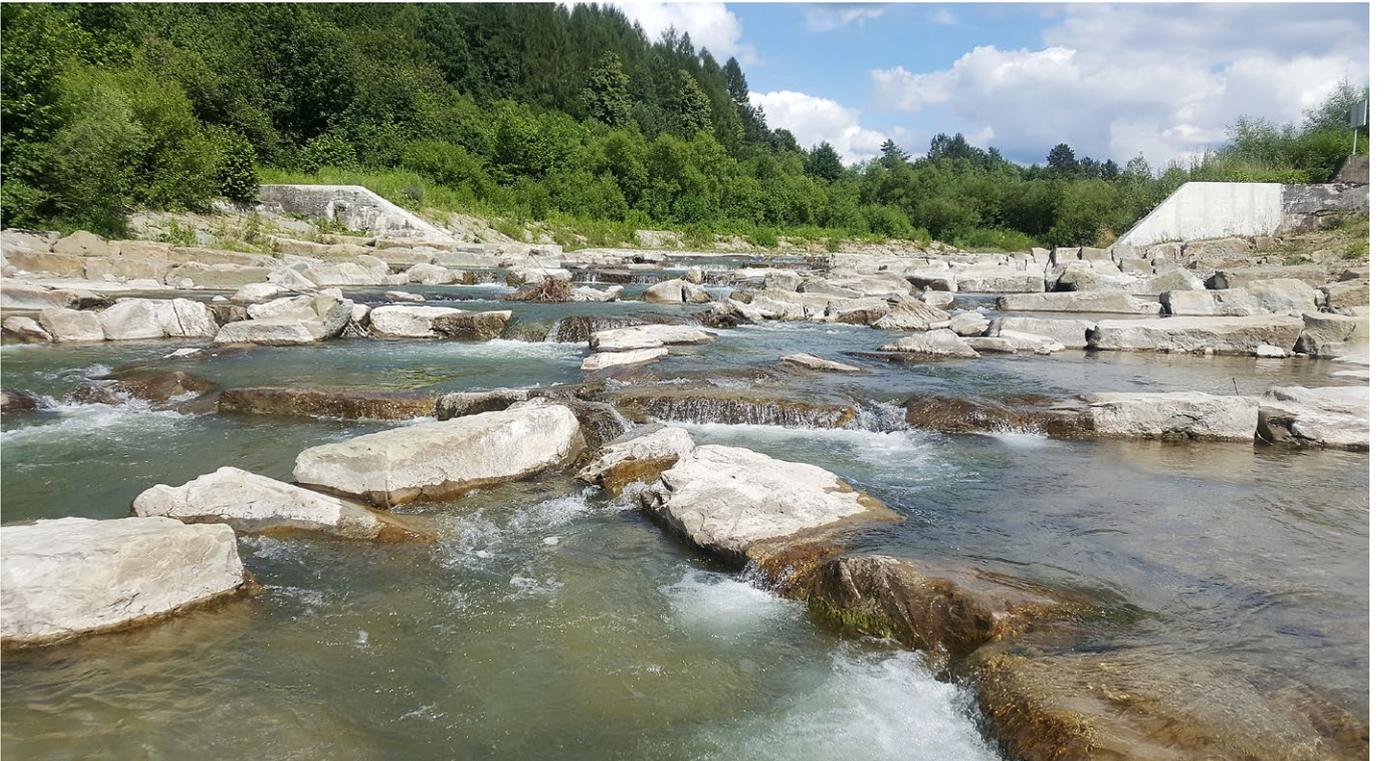
Fig. 51. The Florynka II weir after reconstruction.

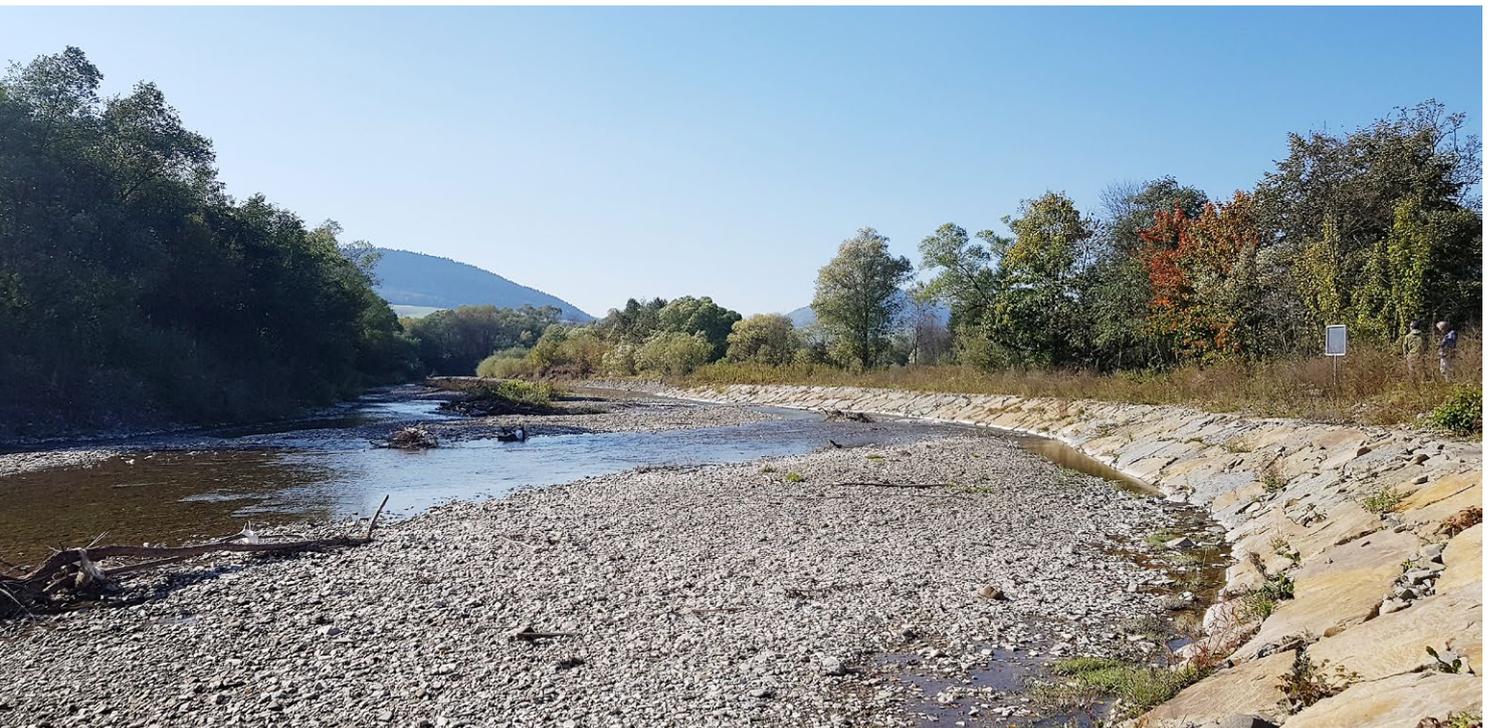
Fig. 56. Biala River after the weir's decommissioning.

In 2000, the construction of a small hydroelectric power station was started in this section. Construction was completed in 2009. The power station operated until 2010, when a flood flooded the turbine and generator room, and was not rebuilt. The river bypassed the damming weir and over time practically cover with gravel the spillway of the weir (Figs. 53 and 54). The right bank at the step was washed away by flood waters. As part of the reconstruction, the weir was removed, and six rows of boulders were inserted into the bottom of the riverbed. The right bank was reinforced with a stone embankment (Figs. 55 and 56).

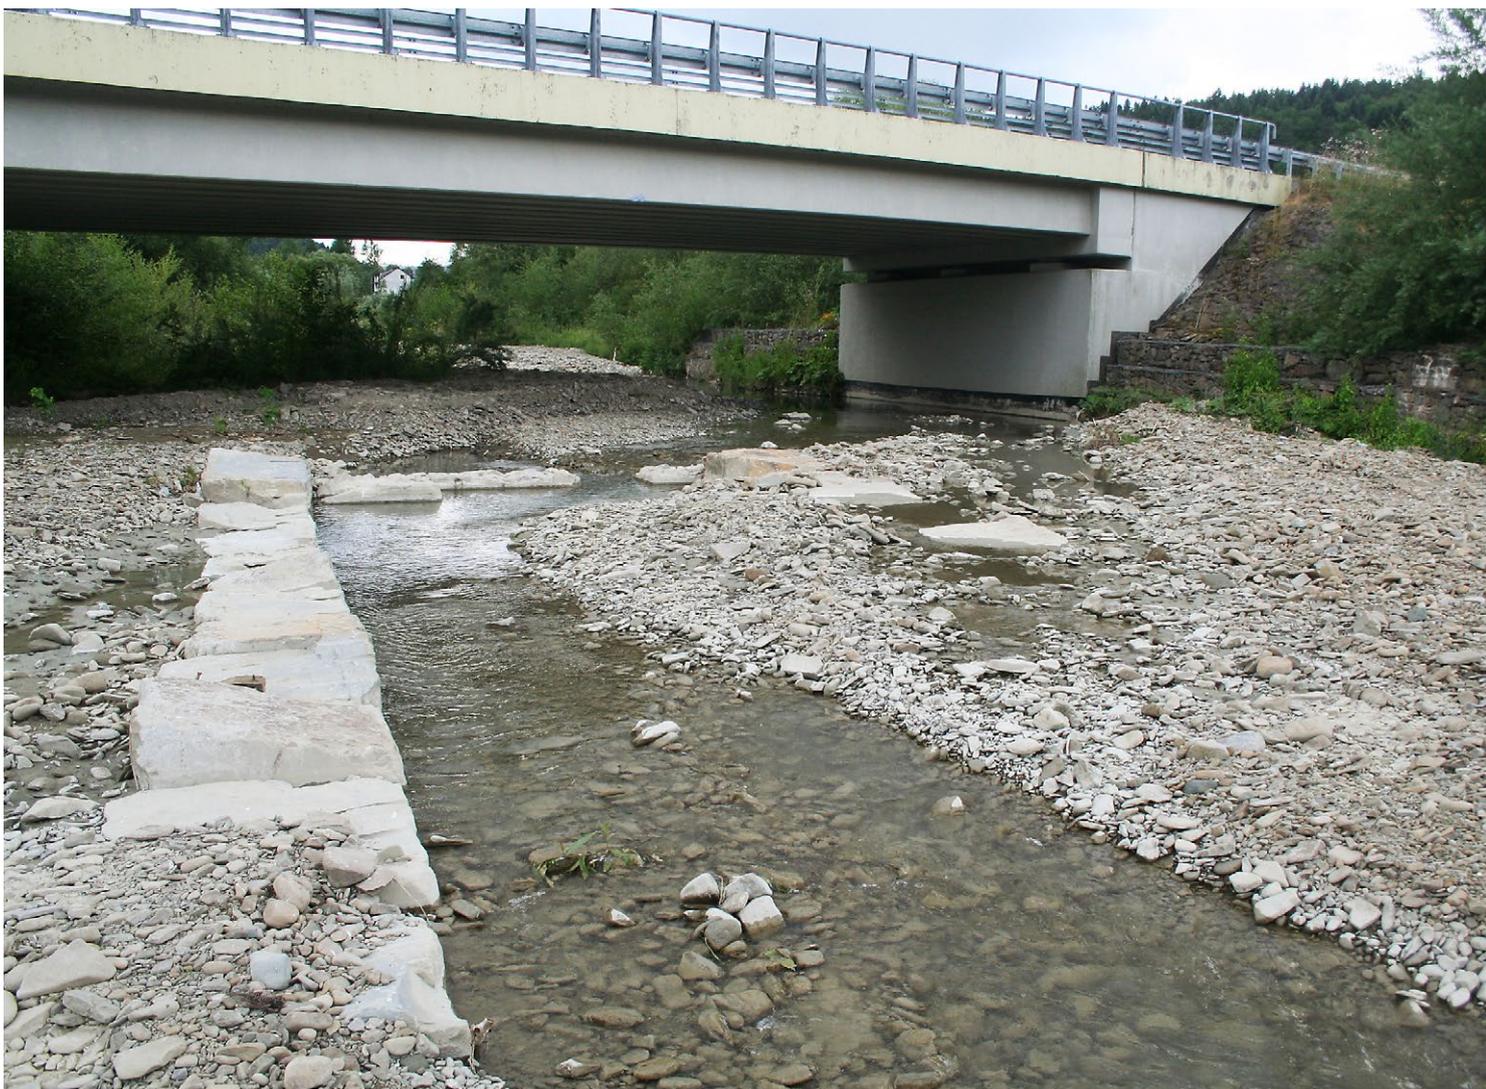
Fig. 58. Micromeander in cutting out reinforcement partially backfilled with gravel.

The retrofitted reinforcement of the bed of the channel under the bridge was made to protect this new single-span bridge. The concrete-and-stone reinforcement resulted in a small waterfall that no fish could traverse (Fig. 57). The decision was made to leave this reinforcement in place and use the difference in height to build a fish ladder. A 2-m-wide and 0.8-m-deep trench was cut in the old bottom reinforcement under the bridge, and several stone deflectors were installed. This resulted in a micro-mandrel effect (Fig. 58). After one year of operation, the river backfilled these micromanders with gravel. A fan-shaped fish ladder was constructed below. Each of these fans has a cut-out for small water (Figs. 59 and 60).

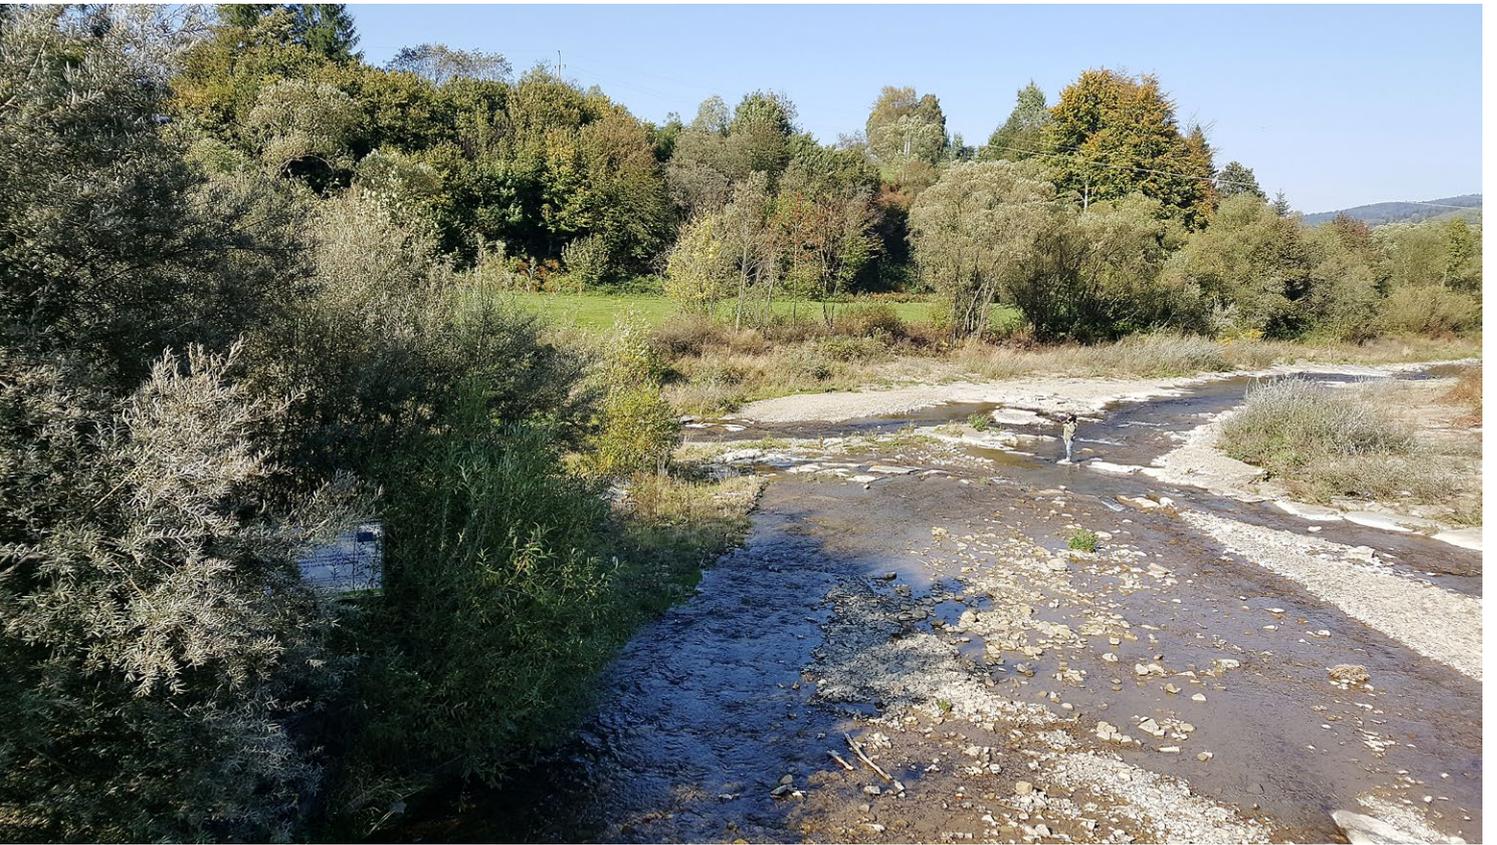
*Fig. 59. View of the fish ladder.*

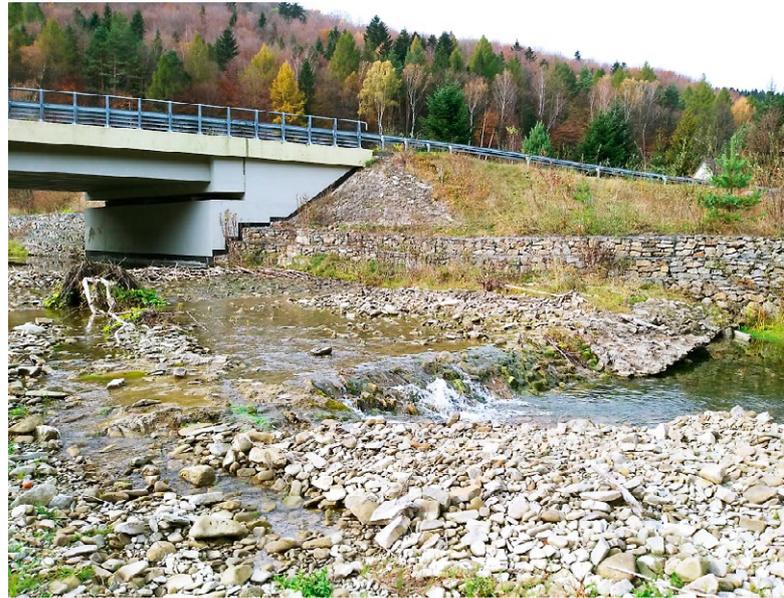
Similar to the bridge at Śnietnica I, the upgraded concrete riverbed reinforcement was made to protect the road bridge (Fig. 61). A cut was made in the bottom reinforcement under the bridge, into which stones were inserted to form several small meanders (Fig. 62). A fish ladder with several pools was added below (Figs. 63 and 64). After a year of operation, the cut in the reinforcement under the bridge was slightly backfilled with gravel. The lack of gravel in this section of river causes severe erosion. For this reason, the last elements of the fish ladder were washed out after the floods. The problem was solved by adding additional concrete and stone shafts to stabilise the riverbed at the necessary height.

Fig. 61. A waterfall under the bottom reinforcement under the road bridge.

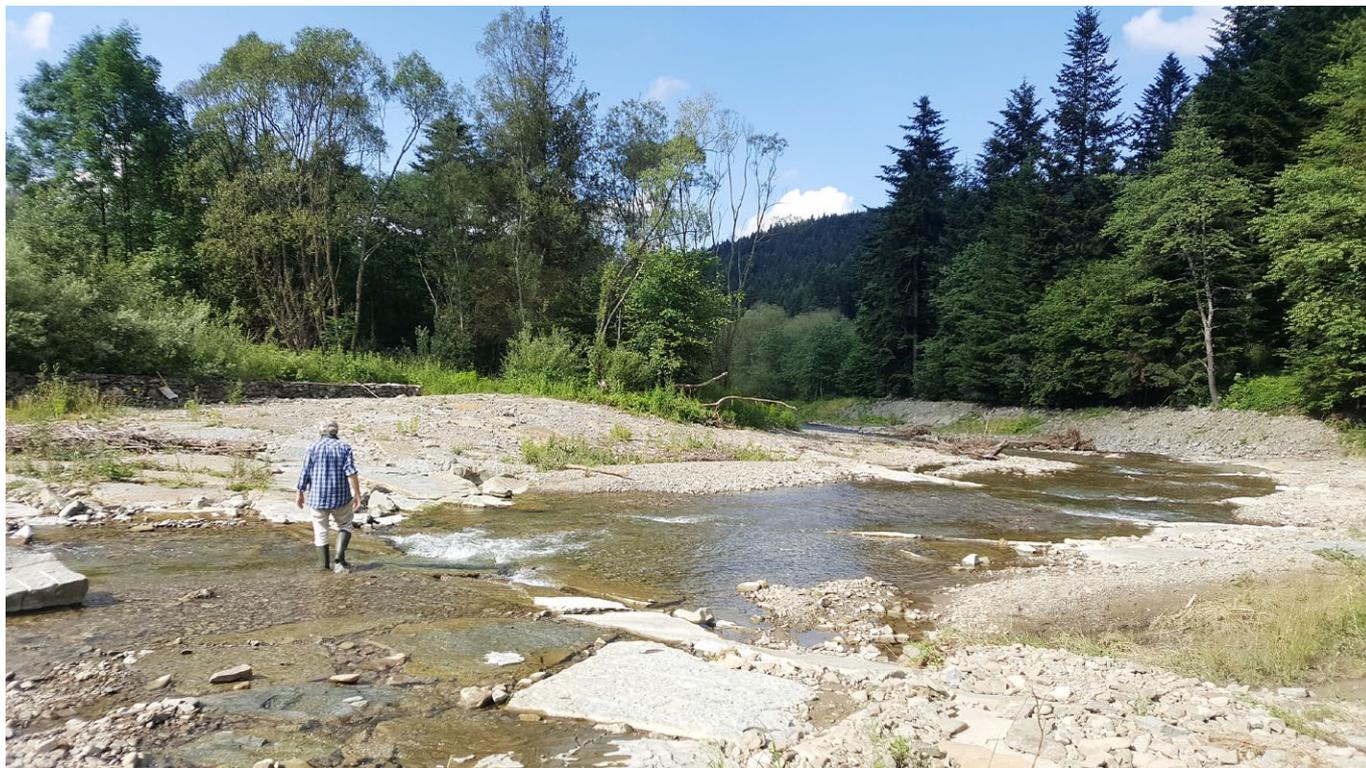
Fig. 63. View of the Šnietnica II fish pass after the completion of construction.

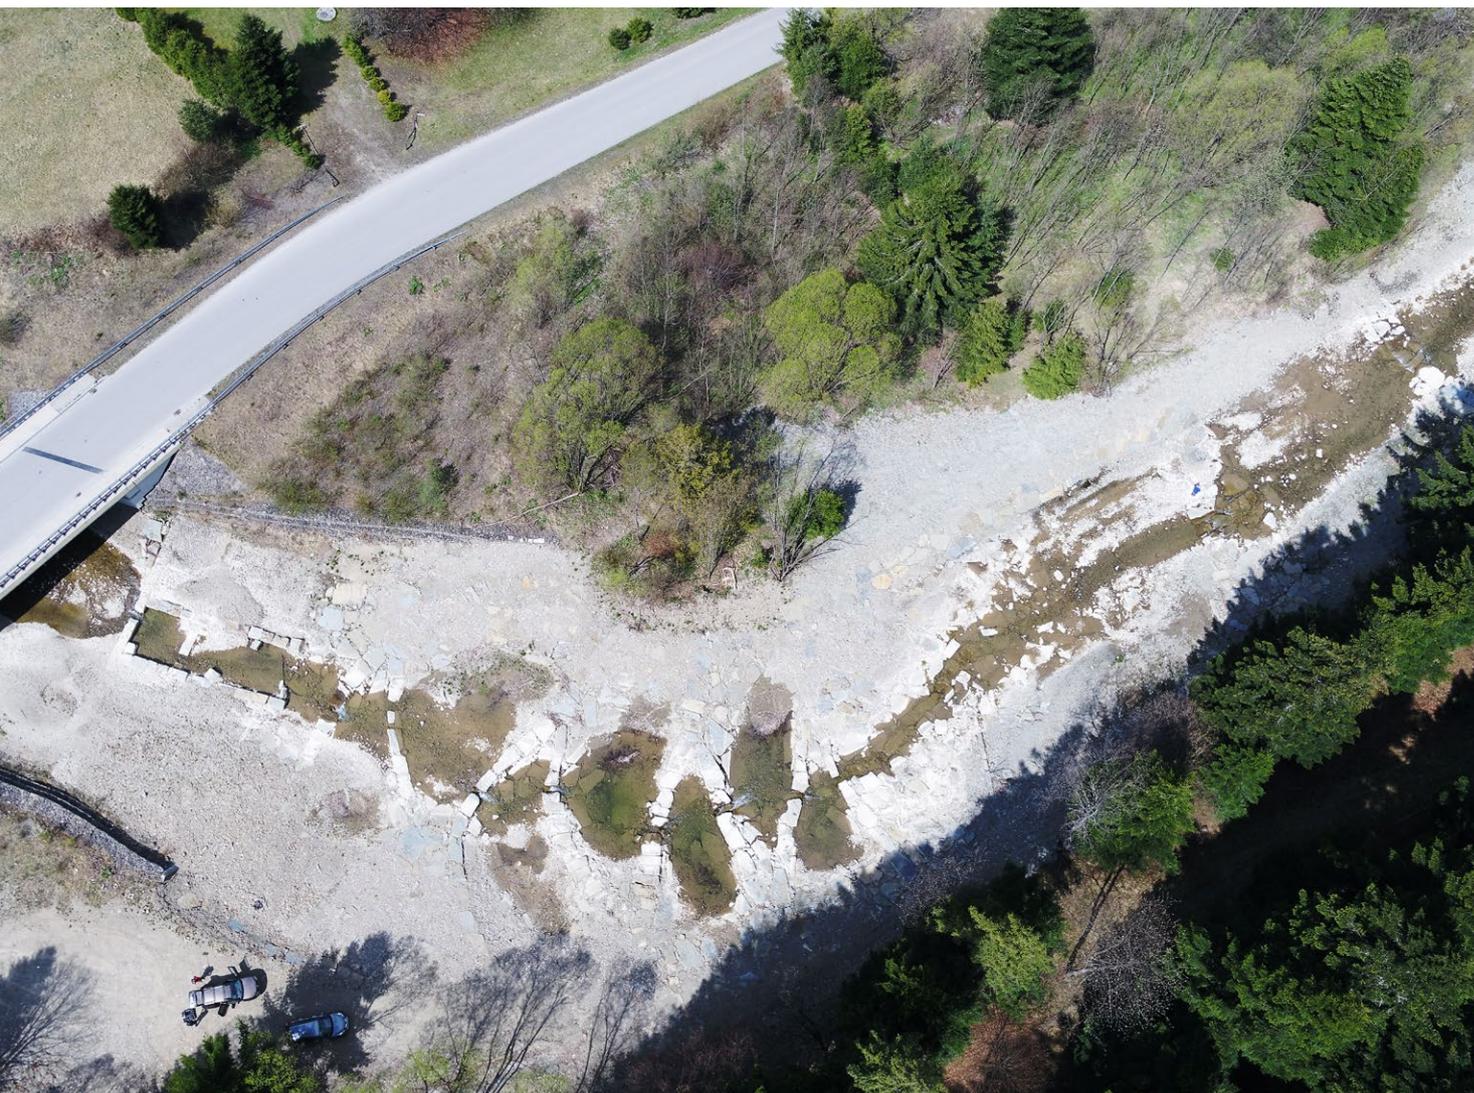
Fig. 64. General view of the fishway after construction.

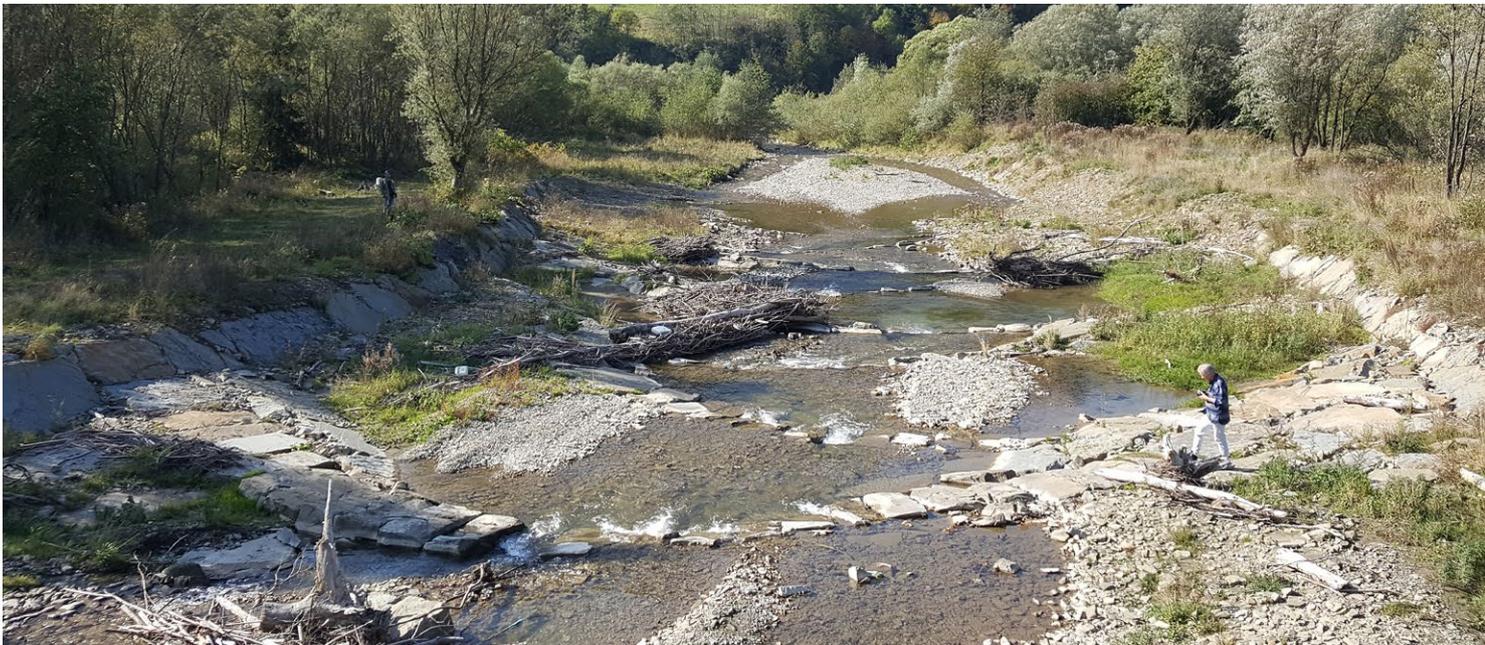
Fig. 66. The fishway after construction.

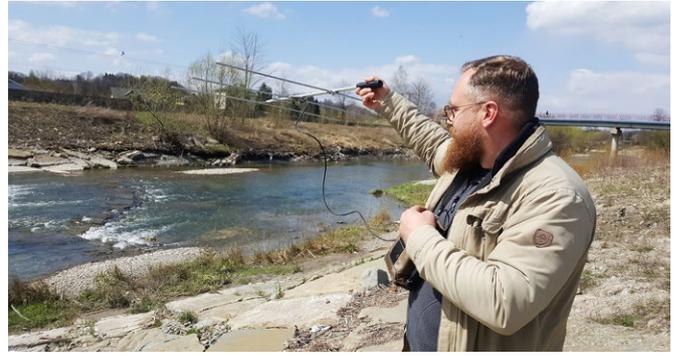
Fig. 69. Directional antenna for locating fish.

In Jankowa, two methods of migration survey were applied: radio telemetry and fish traps. Ten out of 29 tagged and released nases (*Chondrostoma nasus*) and chubs (*Squalius*

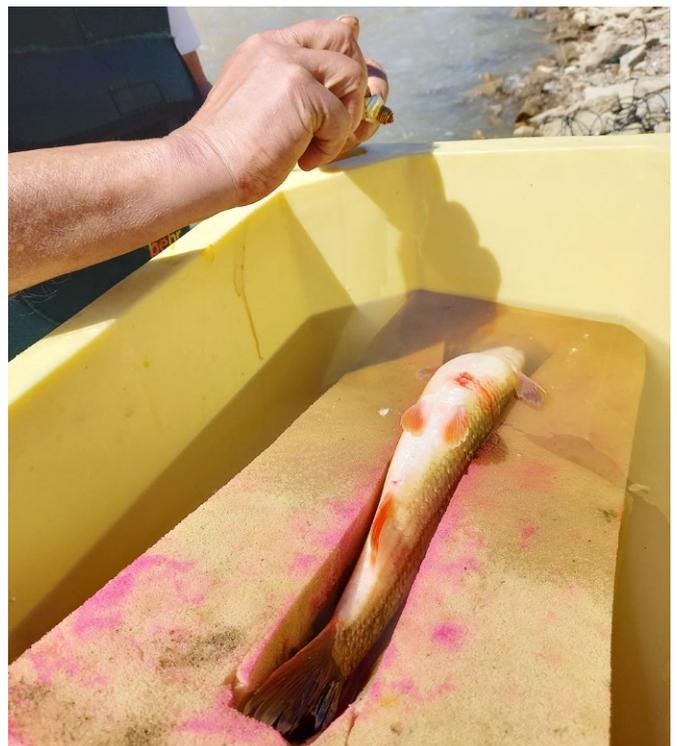
Fig. 71. Transmitter implantation.

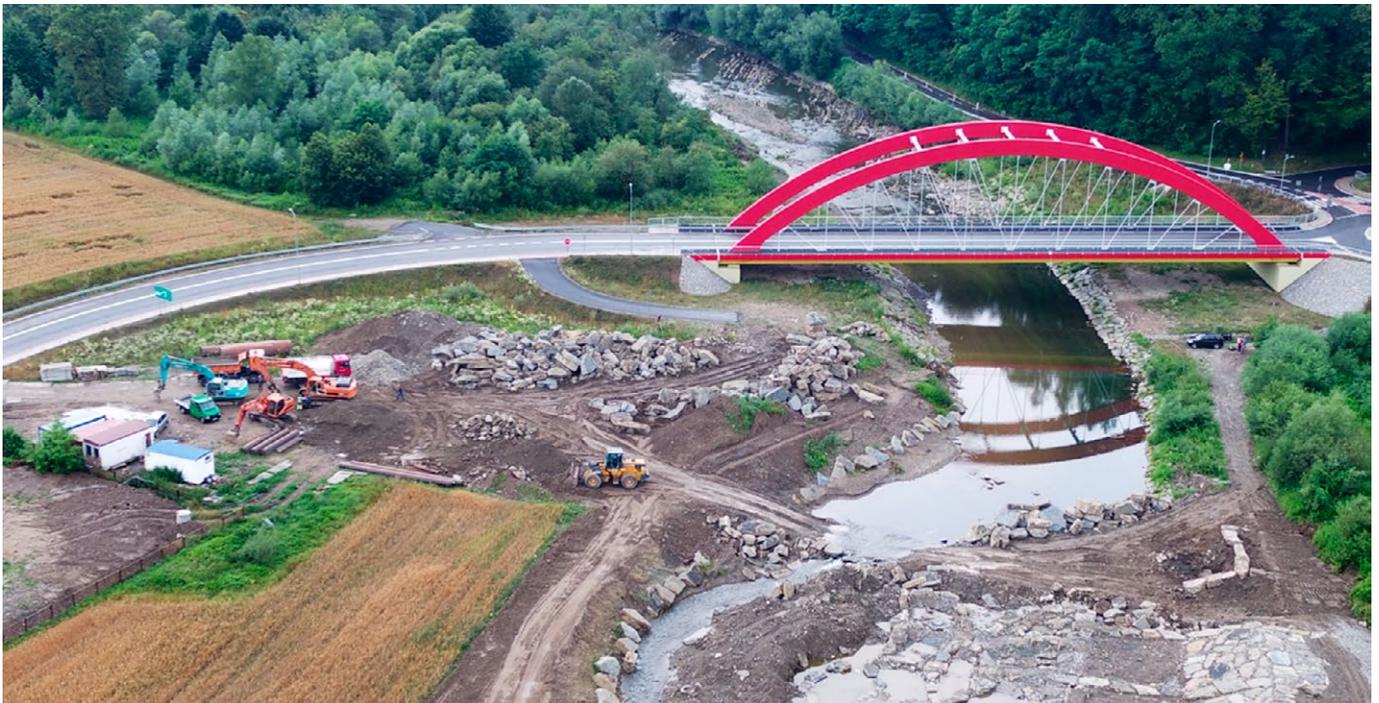
Fig. 92. Example of construction site organisation (Jankowa).

For setting up equipment and the construction office, contractors always chose environmentally neutral sites, which are already heavily degraded (Fig. 92). Upon completion of the work, these sites were cleaned up. The timing of hydro-

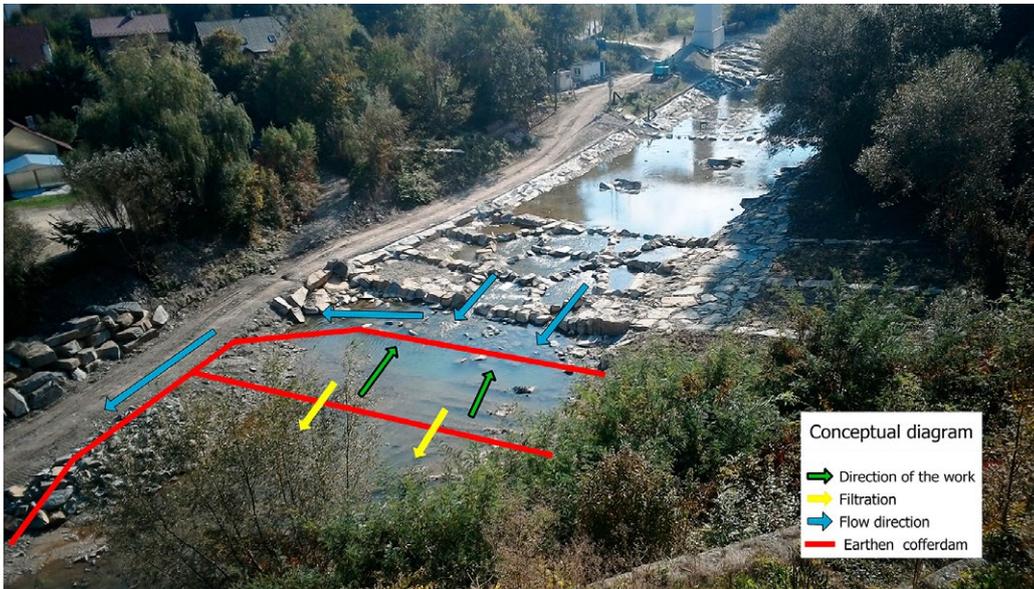
Fig. 95. Scheme of cofferdam construction in a specific situation (Grybów).

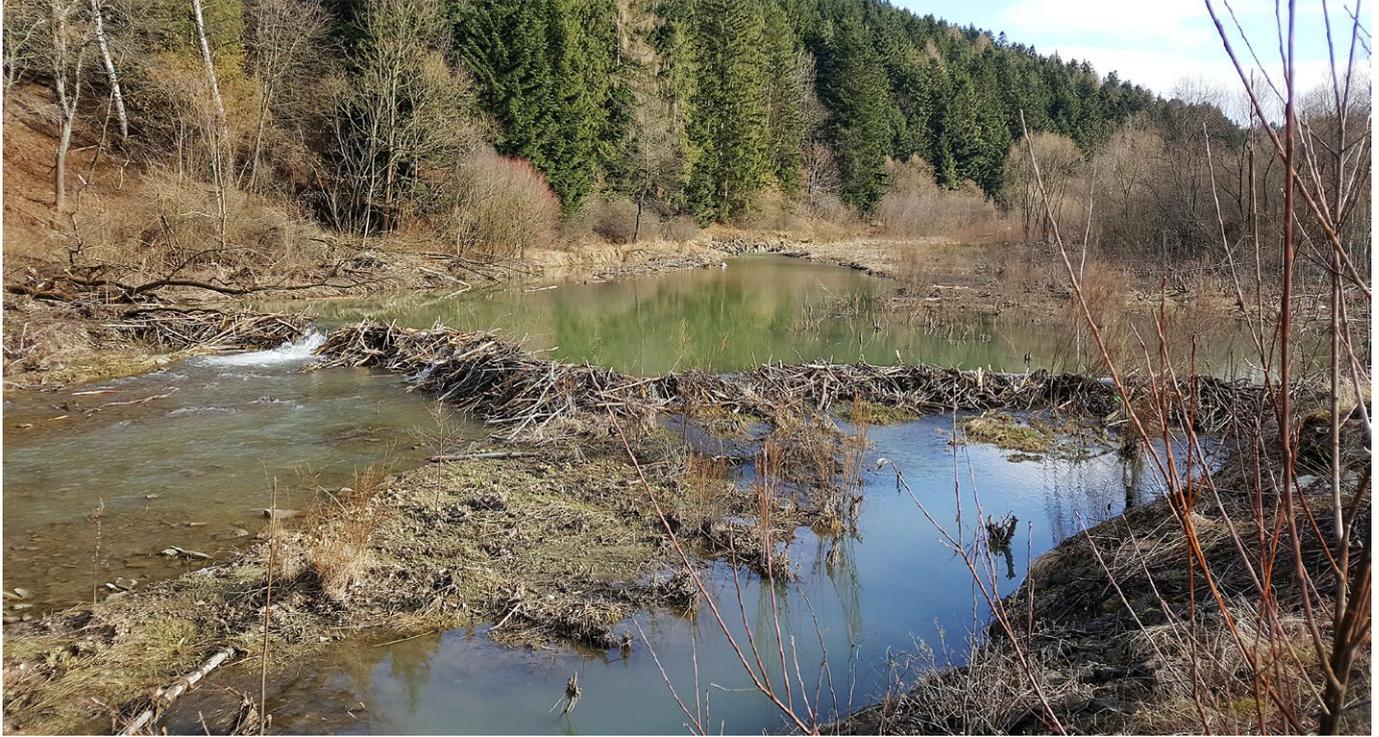
Fig. 97. Beaver dam on the Biała river at Śnietnica.

Dams built by beavers are also natural migration barriers. However, these are periodic: beavers abandon them after a few years of use, and larger river surges eventually destroy them, restoring river continuity (Figs. 97 and 98).

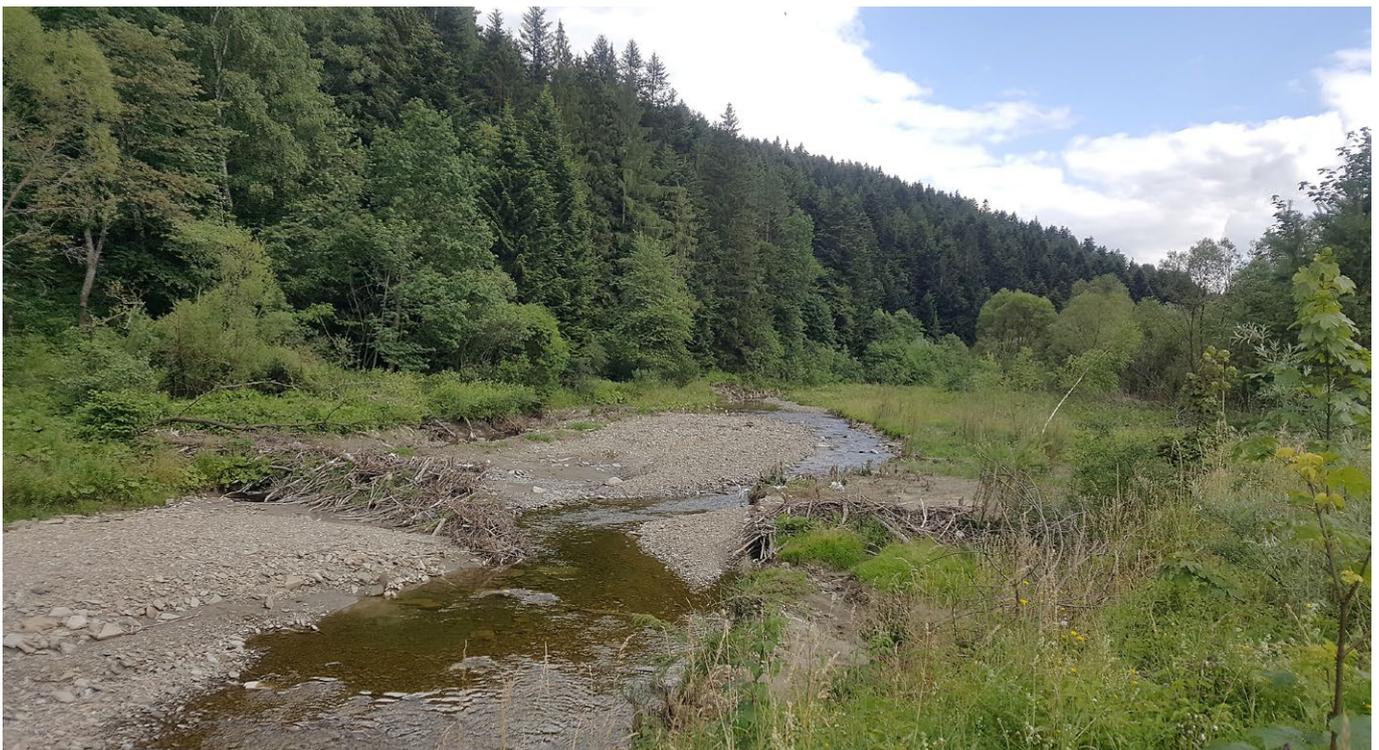
Fig. 98. The same dam after a flood event.

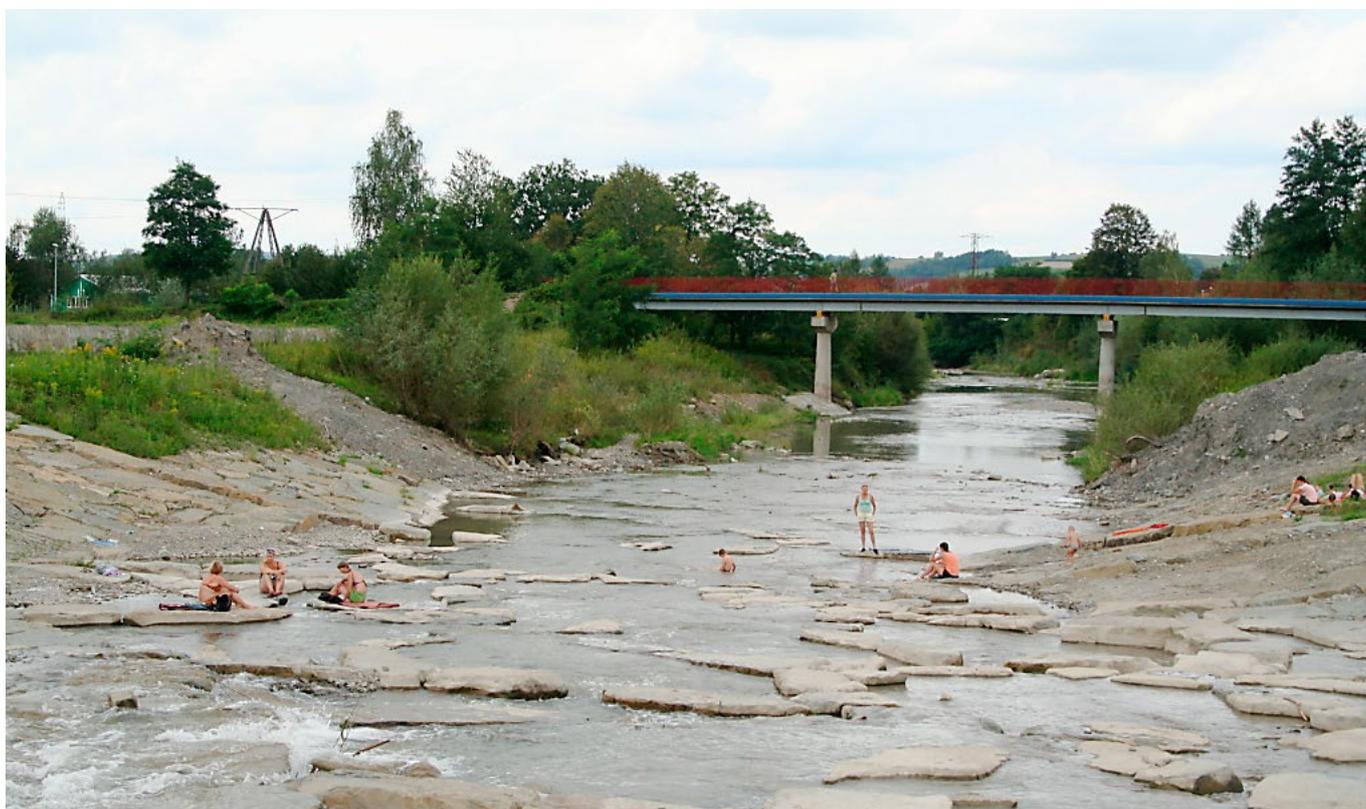
Fig. 103. The fish ladder in Stróże.
