# REPORT

## RESTORATION OF ECOLOGICAL CONTINUITY AND ACTIVITIES IMPROVING FUNCTIONING OF THE FREE MIGRATION CORRIDOR OF THE BIAŁA TARNOWSKA RIVER

National Water Holding Polish Waters  
Regional Water Management Board in Kraków

2022

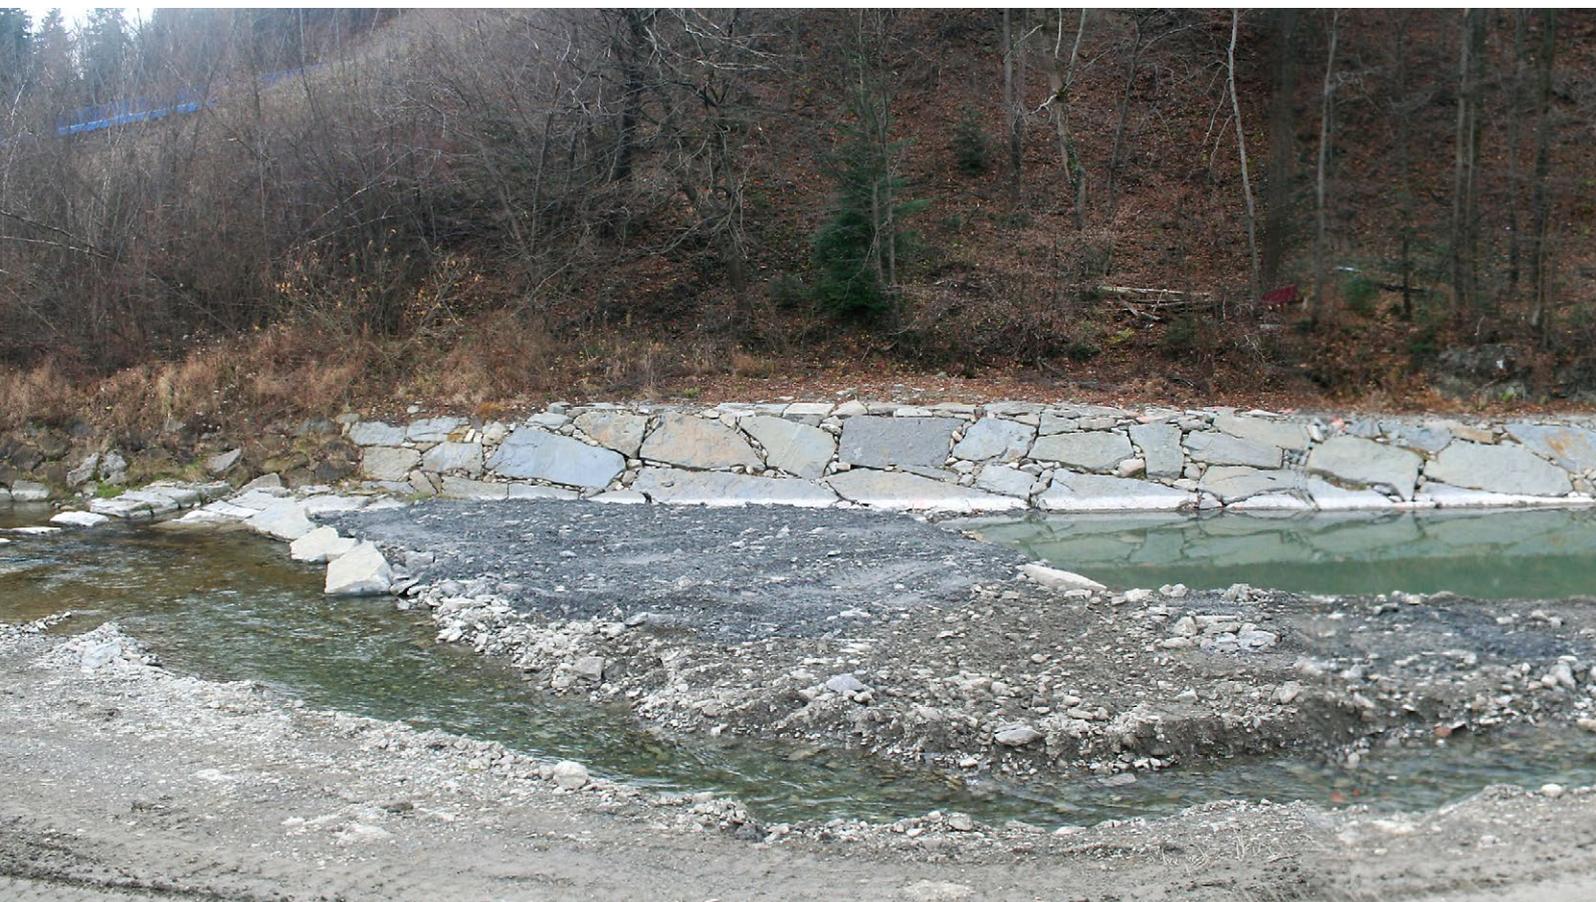
Fig. 108. Base for construction of deflector, stone rip-rap in the background.

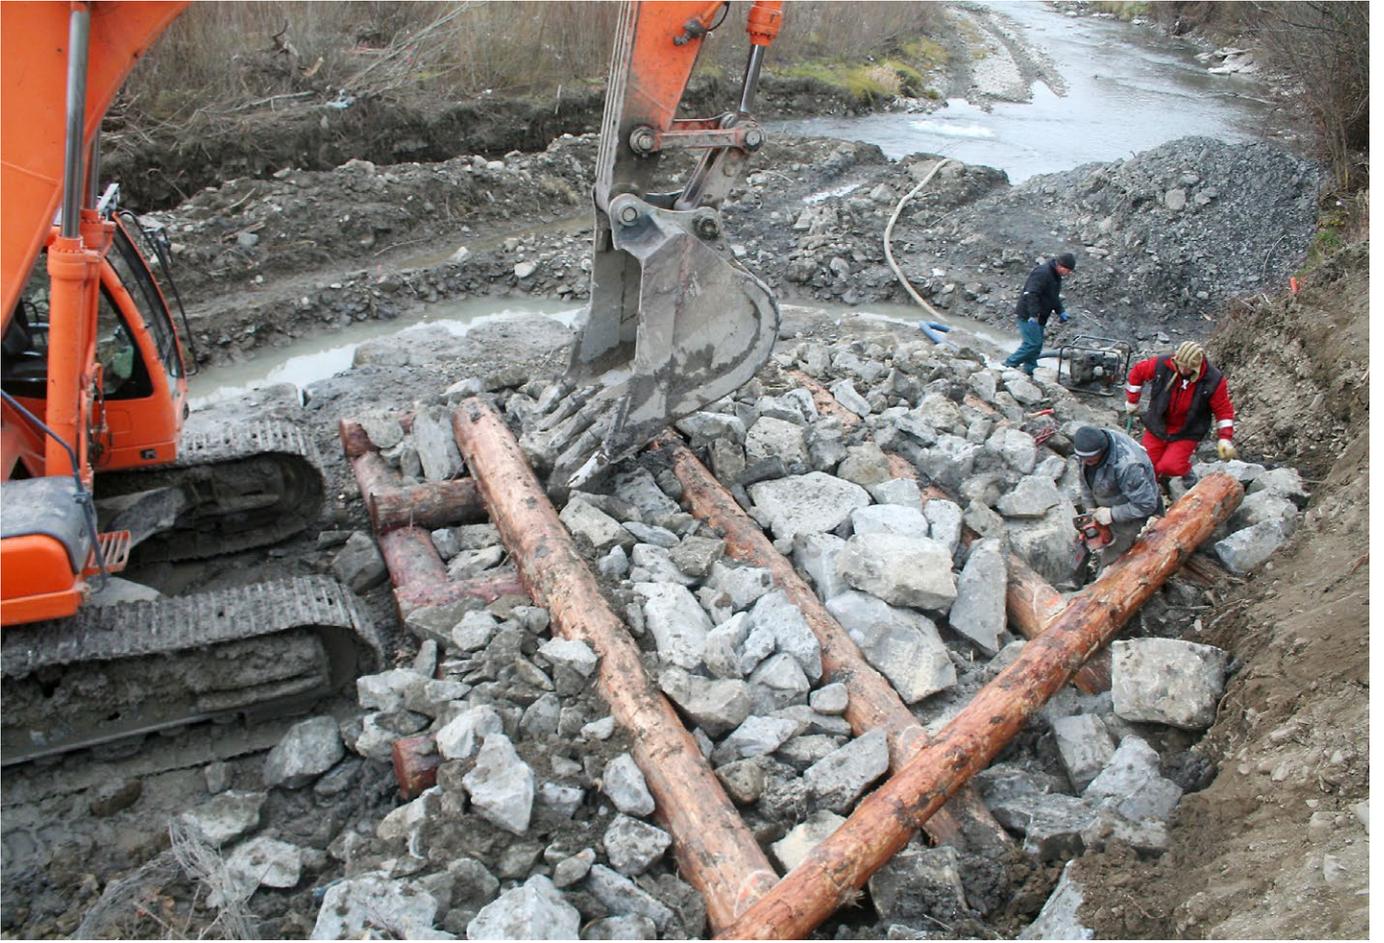
*Fig. 109. Construction of the deflector. Visible timber crib filled with stones.*

The timber for the construction of the crib must be impregnated by means of a long-lasting cold bath, with agents certified for use in an aquatic environment. Due to the morphology of the trough, two types of deflectors differing in crown length were designed with the following parameters:

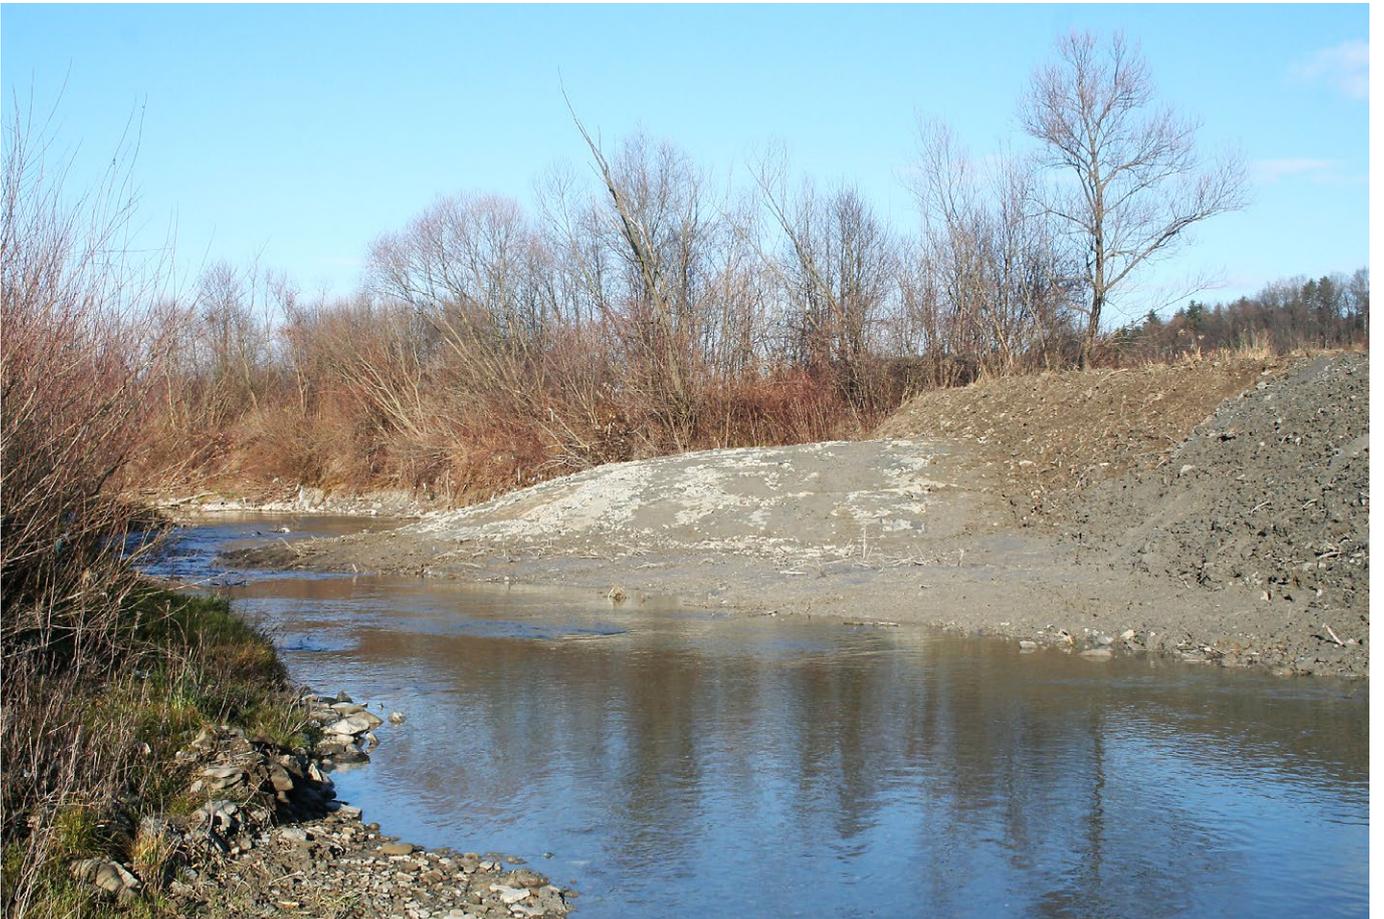
*Fig. 110. Finished deflector.*
