WISŁOKA WITHOUT BARRIERS

Report on the implementation of the project „Removal of migration barriers for aquatic organisms on the Wisłoka River and its tributaries - Ropa and Jasiołka”

Removal of migration barriers on the Wisłoka River and its tributaries - Ropa and Jasiołka

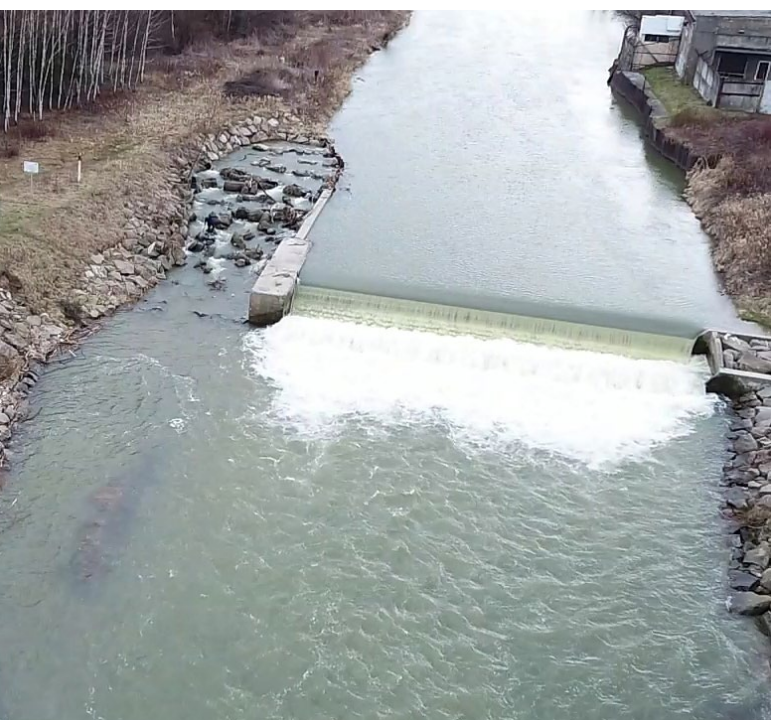
Fish pass of a rapid type next to the existing weir - Jasło I

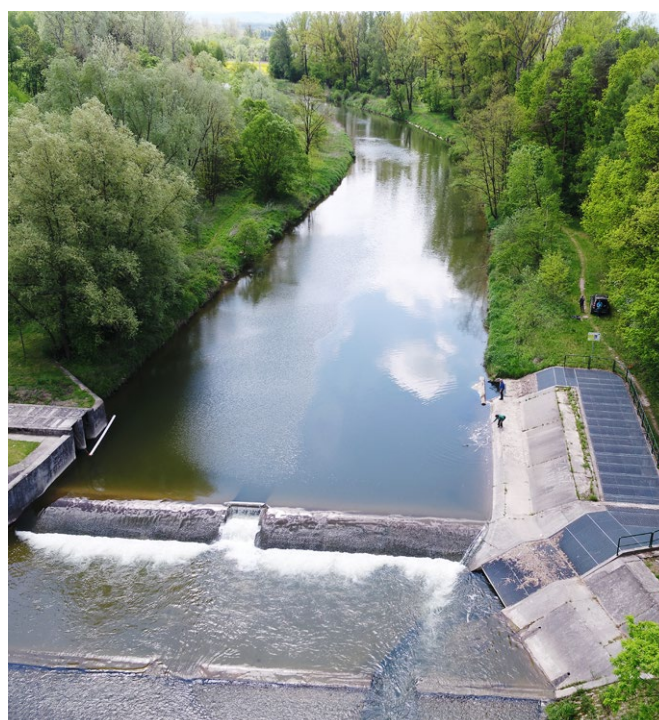
Two vertical slot fish pass next to the existing weir - Jasło II

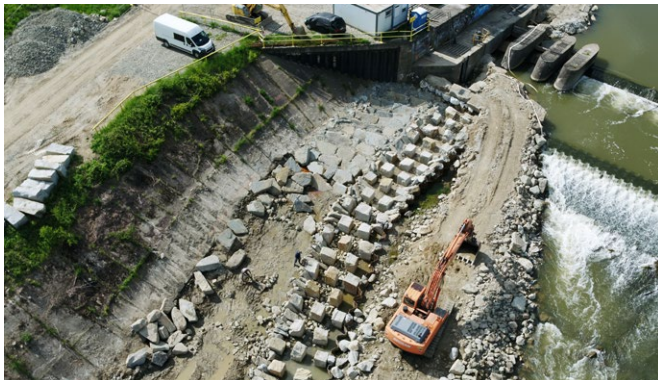
Laying a rock ramp below the technical fish pass

During the construction of the rock ramp, an innovative method of arranging boulders in the stone ramp below the body of the weir was proposed - the texture of the arranged boulders of the stone ramp between the right bank and the main channels of the fish ladder was changed. The change consisted of, instead of a flat surface, a saw-tooth shape surface of overlapping stone slabs about 0.5 m thick was made. The boulders were arranged in a "herringbone" pattern on the ramp plan. This arrangement of slabs has resulted in the self-creation of baffles and pools (i.e., lateral areas with lower water velocities, which provide opportunities for 'weaker' or smaller fish species to pass the ramp).

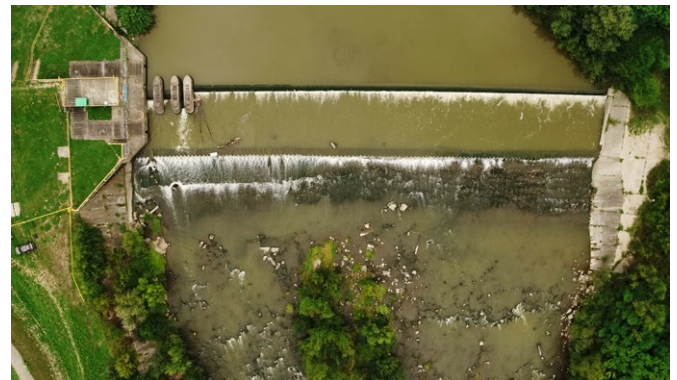
The barrage in Dębica before the modernisation of the fish pass

Reason for Modernisation. In order to stabilise the water table at the intake for Tire Company Dębica S.A., a 100 m long damming weir was built many years ago, damming the water up to a height of 2.2 m. The upper weir has a Creager spillway that is 11 m below the upper weir is a second and the lower weir was made as a Larsen wall. On the right bank, there is a water intake and an almost 40 m vertical slot fishway. Over time, the fish ladder has ceased to function due to bottom erosion.

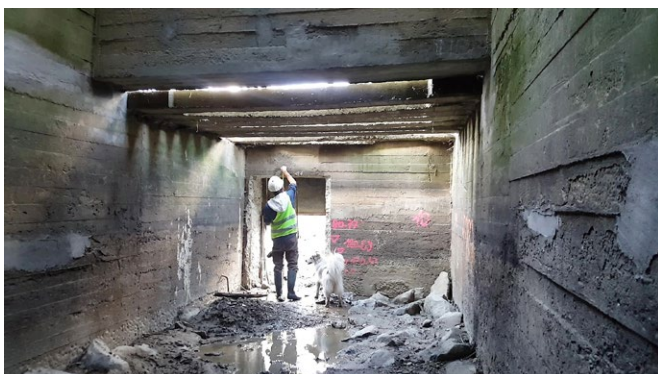
The interior of the technical fish pass on the right bank

Fish Ladder Description. As part of the investment, the existing technical fishway was modernised and a rocky ramp was added to it at the right bank right below the existing second weir. The reconstruction of the slotted fish pass consisted of widening the slots, lowering the bottom in its chambers, and forming a constant slope of 2.29%. The entrance to the fish ladder (from the lower water side) is currently a reinforced concrete ramp with a stone lining. The rock ramp has a quadrant circular plan with a radius of 40 m and a gradient of 1:20. The inlet of the fish ladder channel on the downstream side has been carved into the closing dike. In order to enable fish migration from all areas of the riverbed, two inde-

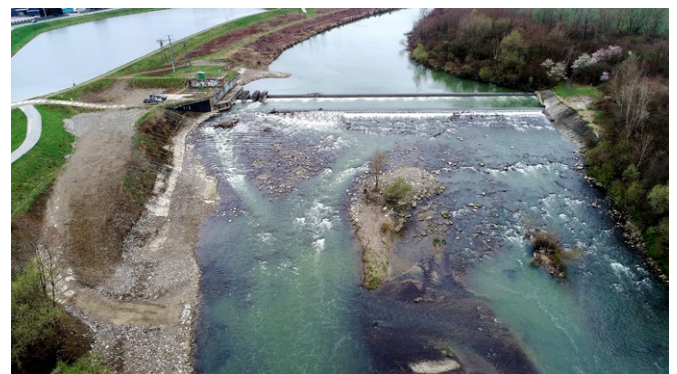
Rock ramp in Dębica after realisation

pendent channels were constructed in the ramp body, concentrating most of the water during low flows. These channels are directed from the slotted pass, oblique to the river axis.

In order to dissipate the energy of the water flowing over the existing weir and to protect the rock ramp from icefloes, a reinforced concrete slab with concrete chute blocks was constructed in the middle of the weir.

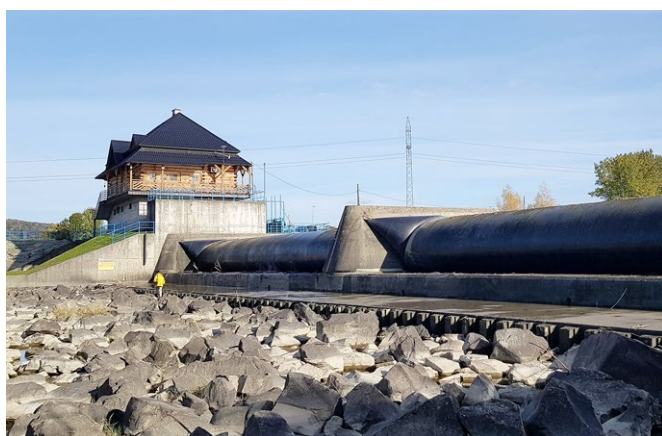
Weir in Mokrzec with small hydroelectric power plant before construction of new fish pass

Reason for Modernisation. In order to rehabilitate the areas devastated by gravel extraction, a rubber sheeting weir was built in Mokrzec. The water dammed up by the weir covered the excavations, creating a 230 ha reservoir used for recreation. The weir allows for changes in damming height from a minimum crest level of 1.9 m to a damming level of 4.5 m with a water-filled rubber bladder. Until the construction of the small hydroelectric power station at the weir on the right bank, there was, and still is, a pool pass on the left bank. Due to poor design, the entrance to the fish ladder was above the water surface. Stopping the transport of dragged sediment through the reservoir caused bottom erosion below the dam. This fishway has never operated.

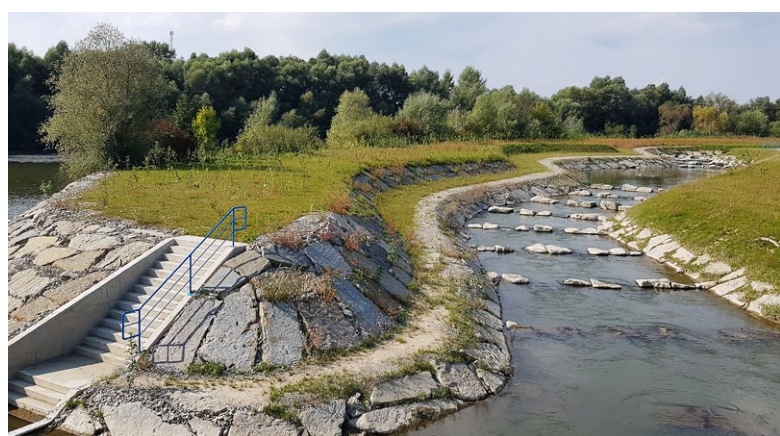
Final downstream section of the fish pass

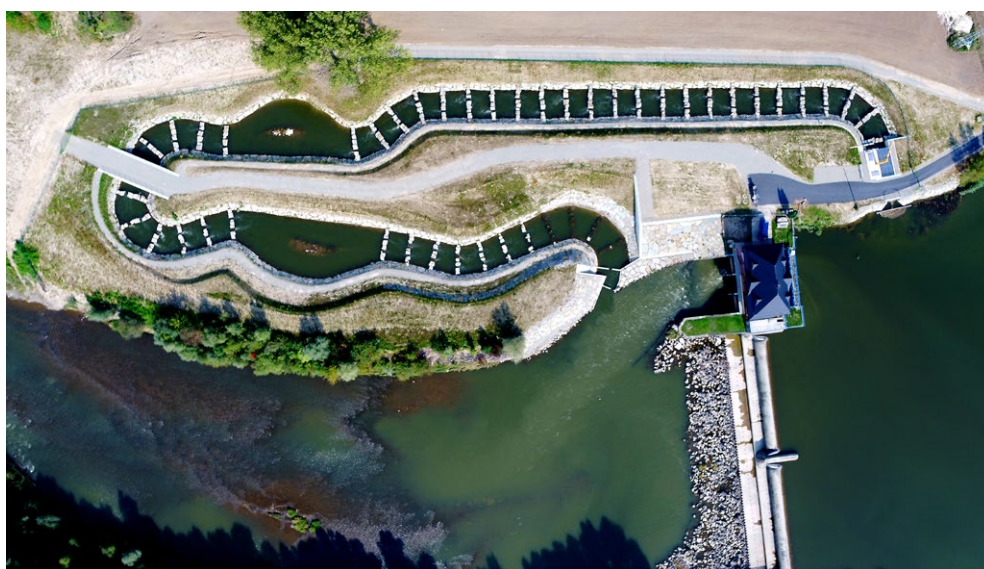
Bypass channel with fishway passage in Mokrzec weir after realisation

Fish Ladder Description. The 430 m fishway bypasses a weir on the right bank of the river next to the Small Hydroelectric Power Station. It consists of 45 pools, two of which are 47 m in size, and a resting pool with a plated stone bed. The barriers of the pools are made of large boulders of different sizes. The average slope of the fishway is 1.6%. Before the exit of the fish ladder into the reservoir, a chamber with fish monitoring equipment was built. The entrance to the fishway on the downstream side is located at the discharge of water from the power plant. Thanks to this, a fish attracting water stream was achieved. The en-

trance to the fish ladder consists of a 4 m wide reinforced concrete dock with wings.

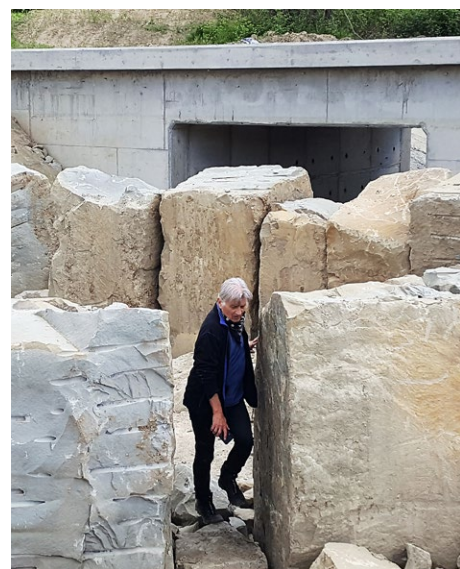
Multi-tonne huge boulders used to build the fish pass

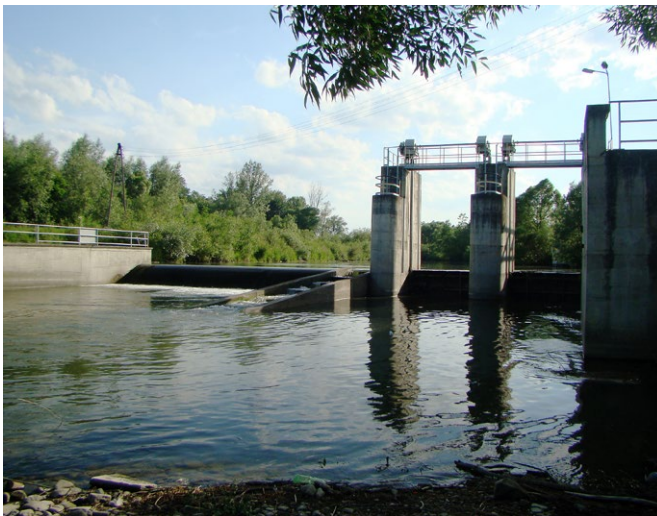
Weir in Gorlice (water intake) before modernisation

Reason for Modernisation. The fish pass is to ensure the passage of the fish through a concrete weir, which is to maintain a constant damming level in the water intake for industrial purposes. The weir was equipped with a malfunctioning concrete pool and orifice fish ladder located in its central part.

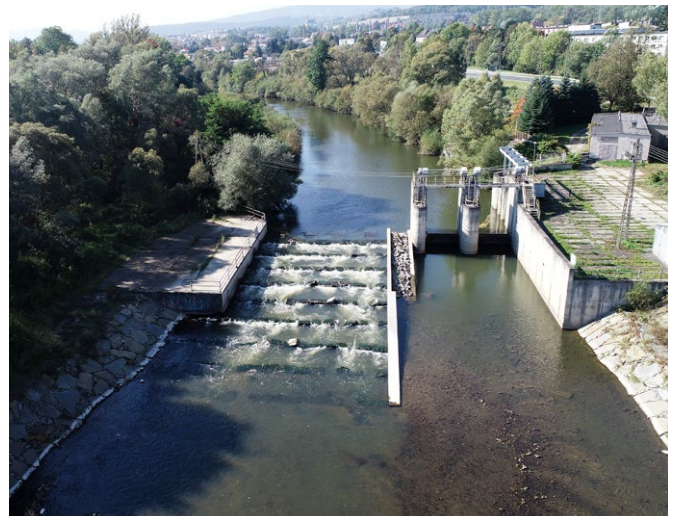
Fish passage in Gorlice

Fish Ladder Description. The modernisation consisted of the reconstruction of existing permanent concrete weirs located on the right bank and building a fish pass below it in the form of a cascade (half-timbered) rapids. The constructed rapids are 42 m long and entail a system of 3 m long pools. The spaces inside the pools were filled with wedged stone rip-rap. The bottom slope in this part of the structure is 1:25. The rock ramp fishway in the upper section is 14.8 m

wide, and in the lower section it widens to 19 m across the entire natural bed. The inlet to the fish pass from the upper water side was made by cutting slots in spillway crest. Below the rapids, the roughness of the bottom was additionally increased by the construction of a 15 m stone ramp - a stilling basin. At the end of the rapids and stilling basin, along the entire width of the river, large-sized boulders were made of stone, which stabilized both parts of the structure.

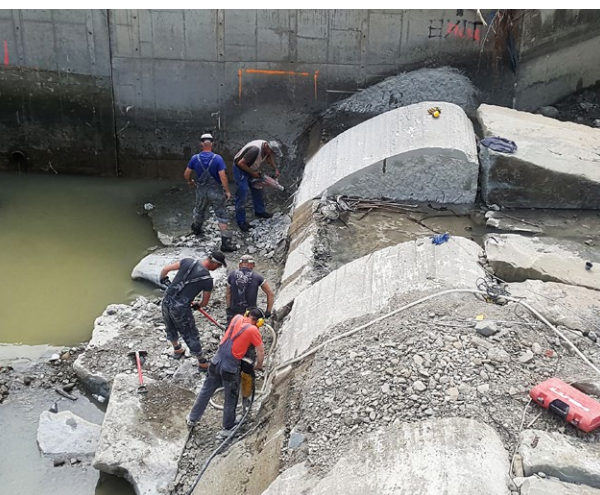
Cutting holes in the upper weir during construction

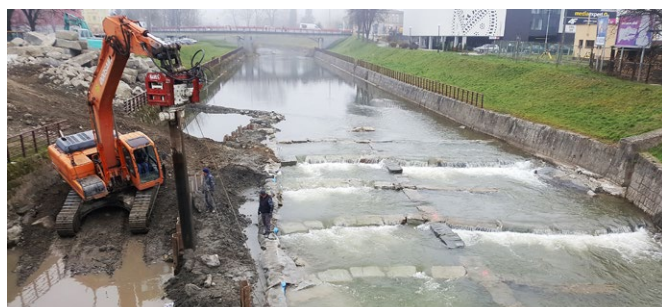
↓ Driving a Larsen-type sheet pile wall

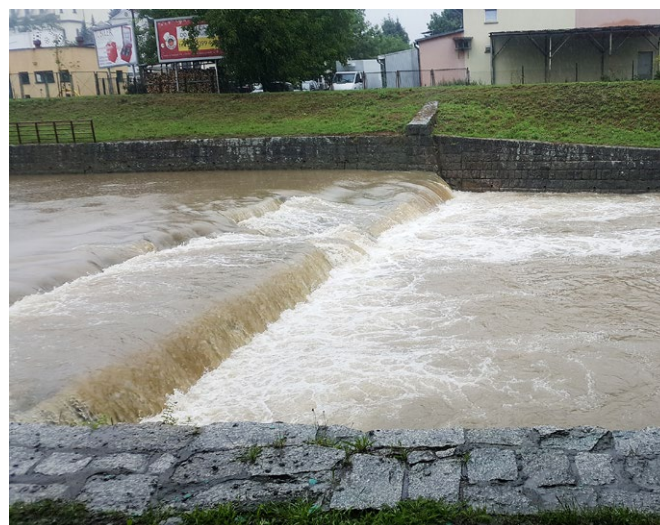
Weir in Gorlice before modernisation

Reason for Modernisation. There was a weir between two bridges in the center of Gorlice. The purpose of which were to stabilize the bottom, guaranteeing the safety of the bridges and two sewer lines crossing the Ropa riverbed at its bottom. Weir dammed water up to a height of 1.1 m and constituted a migration barrier.

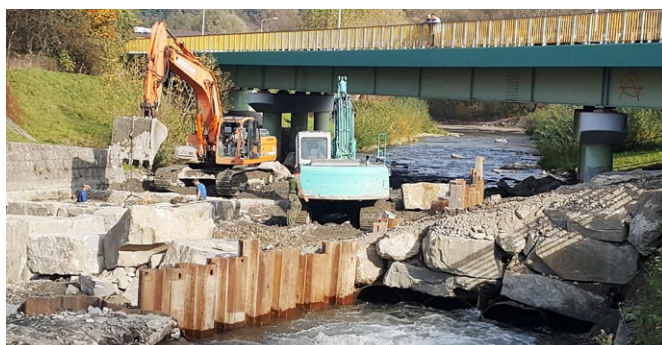
Construction site enclosed by sheet pile wall, access road laid on steel tubes

water turbidity were recommended, including various techniques for separating the construction area from the current so that the work can be carried out "dry". The photos show examples of the methods used - fencing off with sandbags (big bags), Larsen walls, and running the access road to the construction site on steel pipes to allow water to flow.

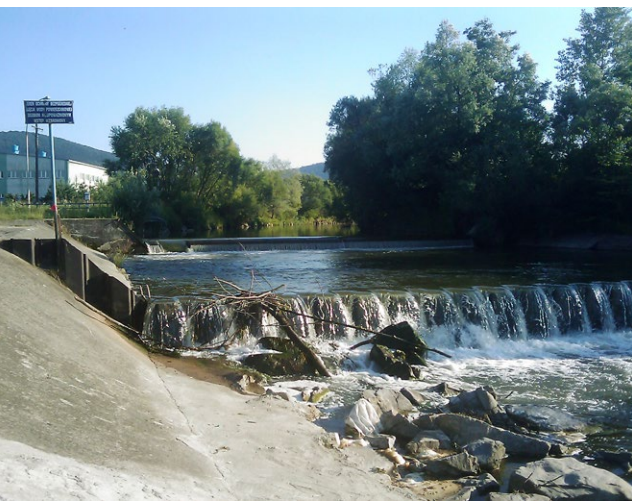
Weir in Ropica Polska before modernisation

Reason for Modernisation. Building nature-like fishways or bottom ramps does not give the same benefits of removing a dam, however, removing a dam is sometimes impossible. The weir in Ropica Polska was built to provide continuous damming at the water intake for industrial and drinking purposes for Gorlice. The difference of the water level between the designed head and tailwater was about 5 m.

The weir consisted of two steps and a bottom wall. The upper step was made of concrete, and the second and bottom step of Larssen sheet pile. The banks between the steps were protected by concrete slabs with a stone rip-rap below the lower step. This weir was an insurmountable obstacle for fish.

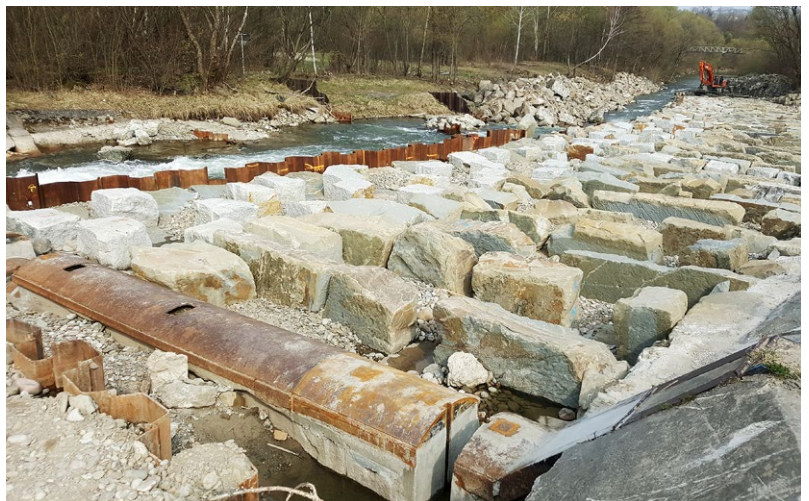
Construction of a fish pass on the right bank

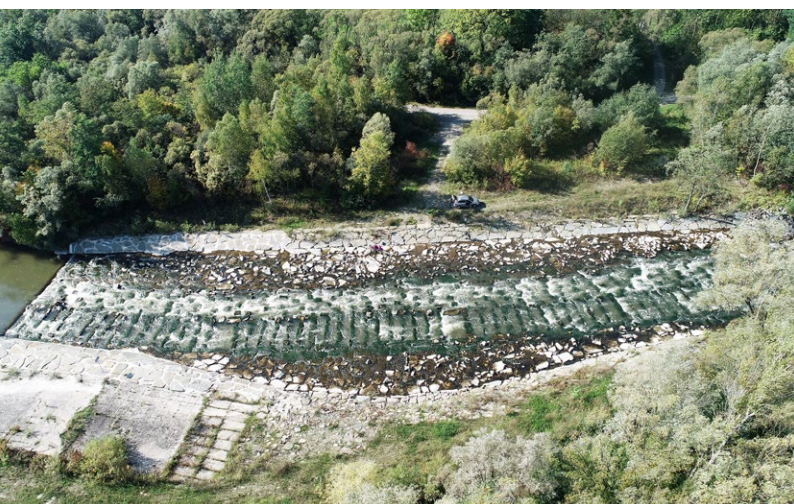
Rock ramp in Ropica Polska after completion

Description of the Fish Ladder. As part of the modernisation, only the upper stage was left from the old facility, with cut-outs providing a passage for fish during low water levels.

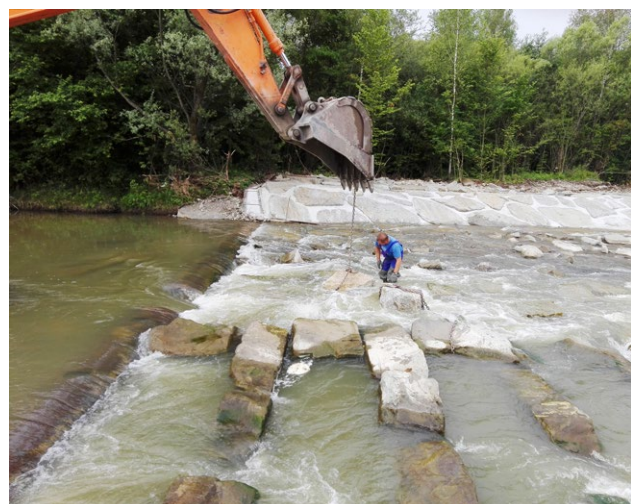
Adjustment of the upper part of the fish pass - adding boulders

Changes Made to the Project. The main correction involved limiting the excessively high flow velocity in the fish pass crevices in its upper part, which was found in the current measurements carried out by the environmental supervision. In order to improve the parameters, the shape of the inlet opening was changed, and a few boulders were added, which reduce the water velocity in the initial section of the rapids, at the same time extending the theoretical migration path. Other corrections concerned the technology of making the rapids, changing the material of the boulders from granite to sandstone and verifying the arrangement of the boulders, which was associated with an increase in their number. The fish-pass route was also changed and adjusted to the shape of the shoreline.

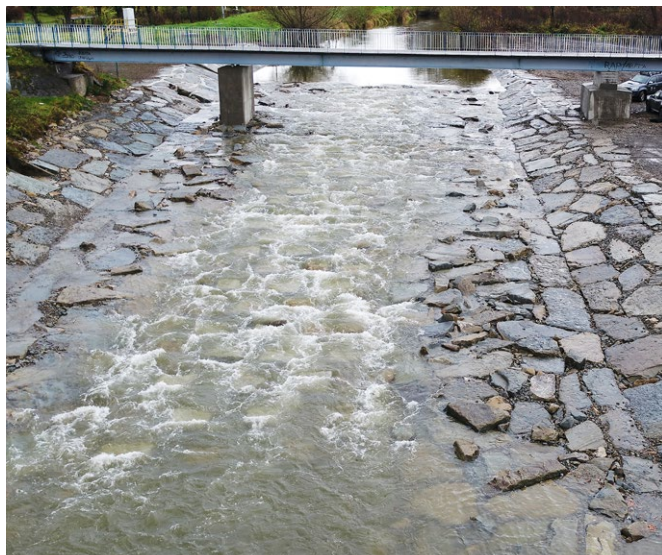
Rock ramp in Jedlicze after construction

Description of the Fish Ladder. As part of the modernisation works, a fish ladder was built as a rock ramp consisting of different sized boulders. The boulders dam up the water and reduce flow velocities, creating favourable conditions for the migration of aquatic organisms. A depression has been created in the central part of the fish ladder, concentrating flows at low water levels. The exit from the fish ladder (the upper water side) is through a cut in the existing concrete weir. An irregular spillway shape has been designed to concentrate low discharge. At the end part of the fish ladder, a stilling basin with the bottom going under

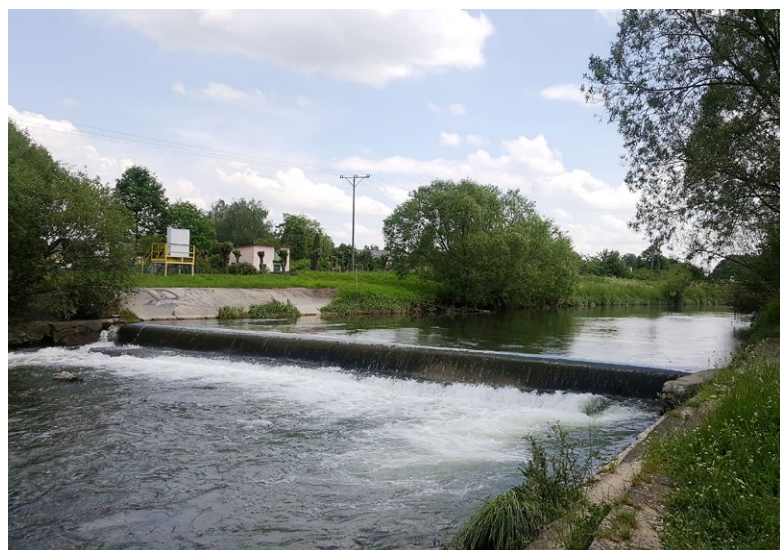
Weir in Jedlicze before modernisation

Reason for Modernisation. The modernised concrete threshold was built to stabilize the water level for the intake of Rafineria Nafty Jedlicze S.A. Theoretically, it formed a barrier about 0.5 m high, but due to erosion, the actual threshold was about 1 m high. Above the threshold, the right bank was reinforced with concrete slabs, and the left bank with a stepped retaining wall. The protection at the edges of the riverbed was made of small stones embedded in concrete and had already been badly damaged.

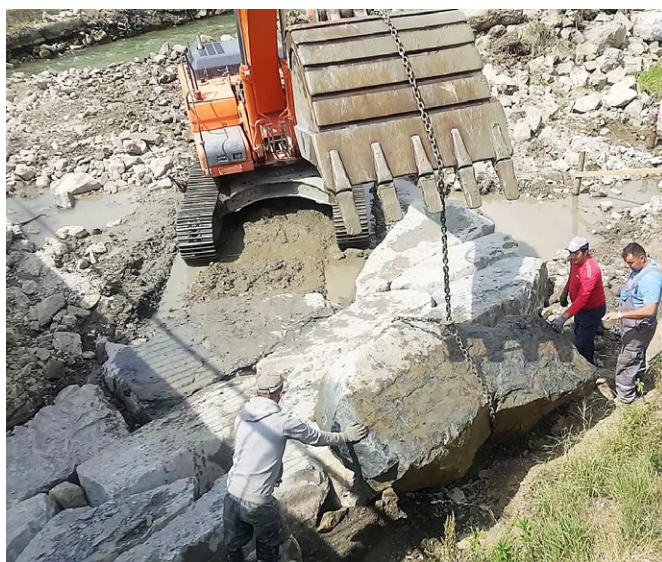
Arranging of boulders weighing several tonnes

Changes Made to the Design. In the course of the project implementation, the arrangement of boulders in the central part of the fish ladder was changed from irregular to regular. Additionally, the way of making the substructure of the fish ladder bottom was changed - instead of a reinforced concrete slab, a stone armouring placed on a geo-grid was made. The number of large stone boulders (granite) on the bottom of the slab was also increased.

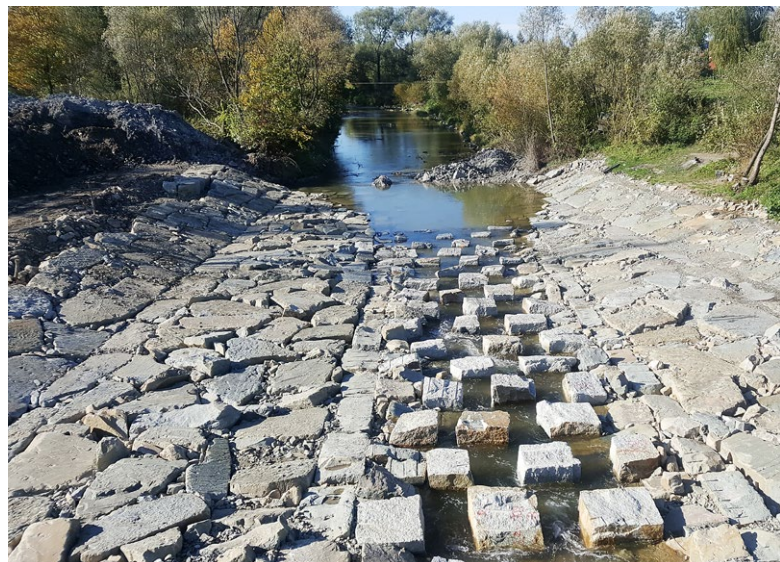
Arrangement of stones in the fish pass below the bridge

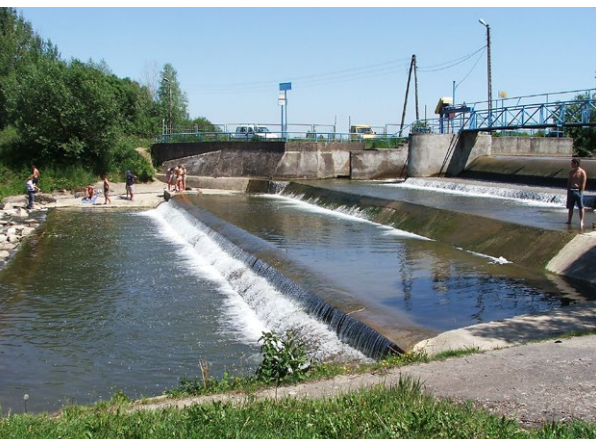
Weir at Szczepańcowa before the fish ladder was built

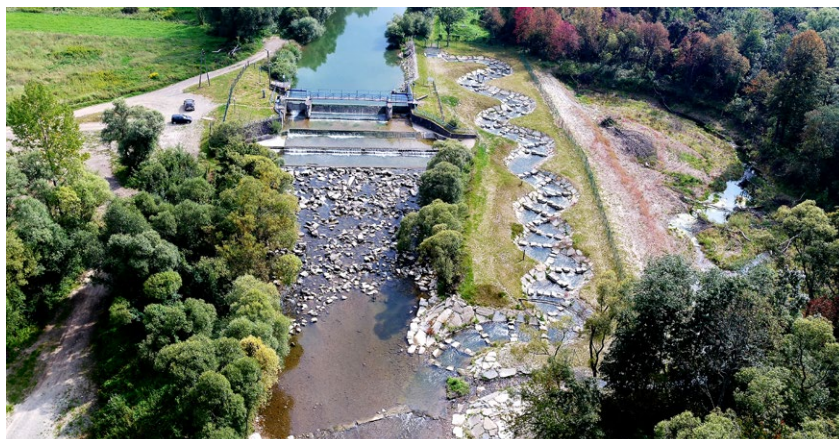
Bypassing the weir at Szczepańcowa after completion

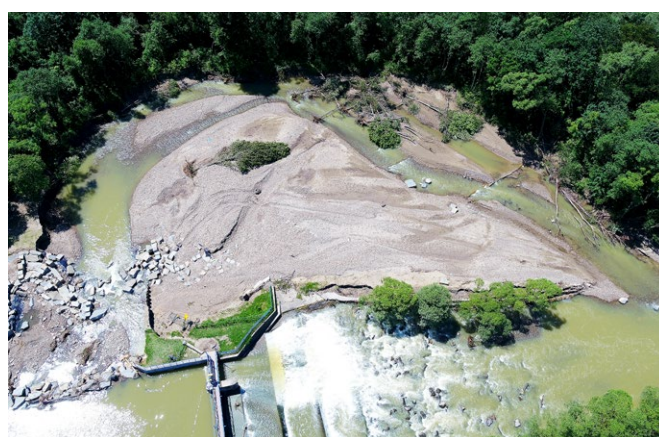
View of the damaged fish ladder after the June 2020 flood.

Changes Made to the Project. In June 2020, the almost ready fish pass was destroyed by the flood. The left bank between the weir abutment and the fishway outlet was washed out, the upper part of the weir was destroyed, and the remaining part was covered by gravel. It was necessary not only to repair the damage, but also to protect the fishway against similar events in the future. For this purpose, a steel sheet piling was made on the damaged shore, and a bank was armored by rip-rap.

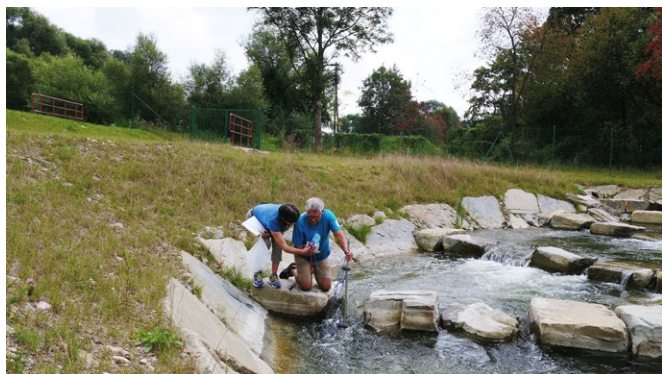
Flow velocity measurements at Szczepańcowa

water flow in the gaps was examined in terms of the ability of fish to overcome them. The second area involved direct research (i.e., biological monitoring). This consisted of monitoring if fish were able to pass the fish ladders, species present, time, etc.

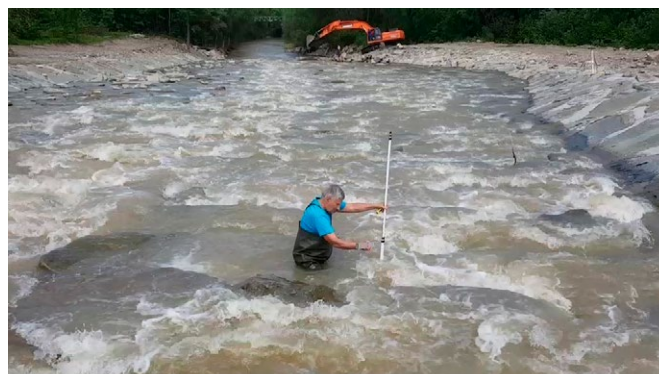
Flow velocity measurements in Ropica Polska

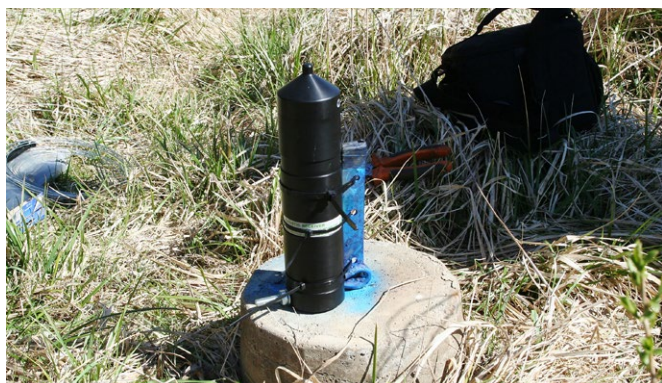
Hydrophone recorder

- ≈ Acoustic telemetry, Vemco hydrophones, and transmitters (180 kHz) were used
- ≈ Radio telemetry using passive methods (Oregon RFID receivers and transmitters)
- ≈ Non-invasive, visual techniques such as scanners and net traps.

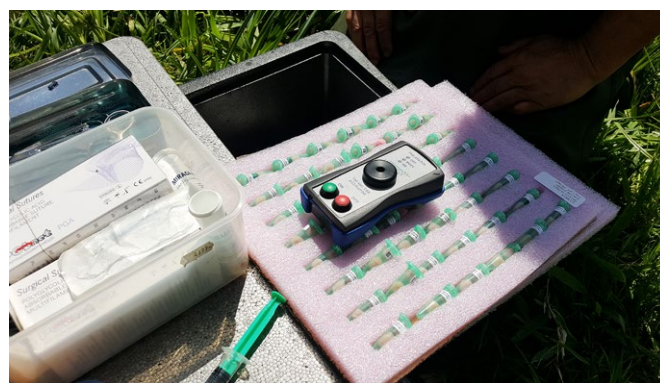
Set of acoustic transmitters for fish tagging

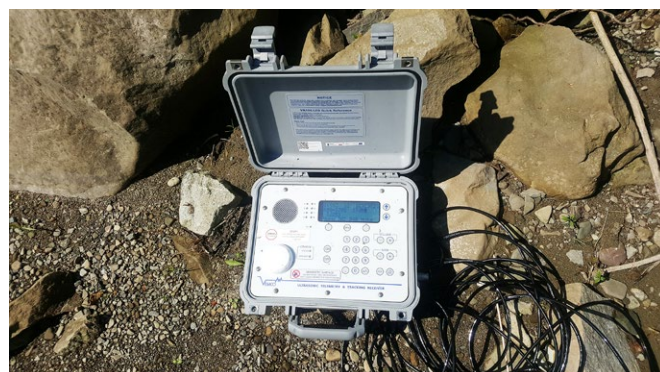
A mobile hydrophone

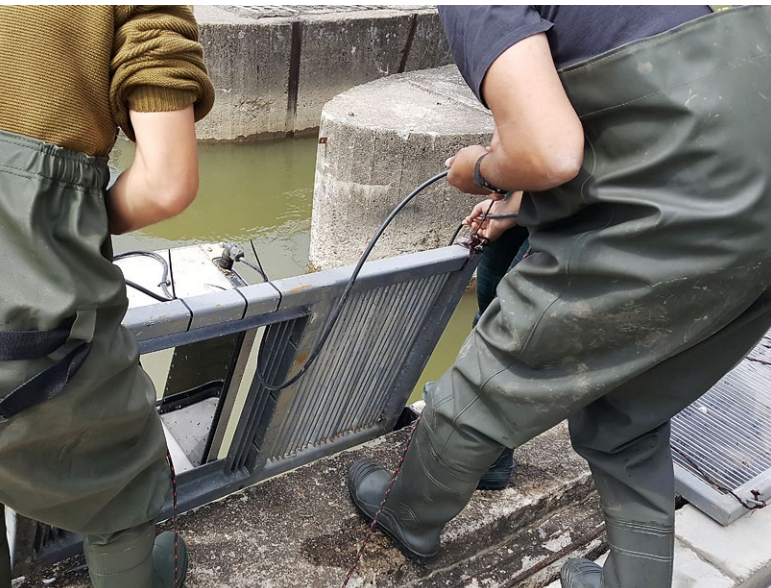
Installation of a scanner at the technical fish pass in Dębica

Automatic fish movement counters allow the non-invasive observation of fish migration. Motion sensors allow fish to be counted and allow a more nuanced assessment of the fishway functionality, including distinguishing the direction of migration. However, this method has the disadvantage that it does not distinguish between fish that pass through the fishway repeatedly and thus overestimates the results. Such a scanner has been installed on the fish ladder in Mokrzec and Dębica. A Vaki scanner with Winari specialist software was used.

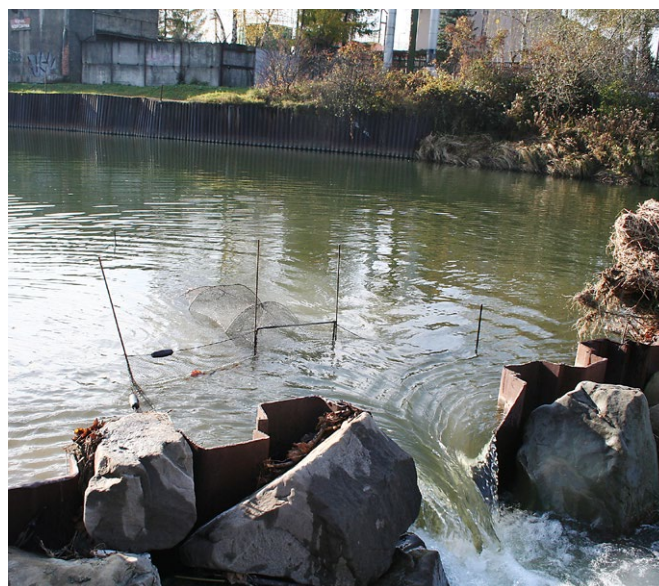
Fish trap to monitor upstream migration of fishes

This method was used to obtain data on fish crossing the structure and moving upstream. Fyke nets (i.e., traps made of 12 mm mesh netting placed at the upstream exit of the fish ladders) were used to catch fish moving upstream. The total trap exposure time at the fishway was typically 3 days and was sufficient to confirm migration. This method was used at the fish ladder in Szczepańska and in Jasło.

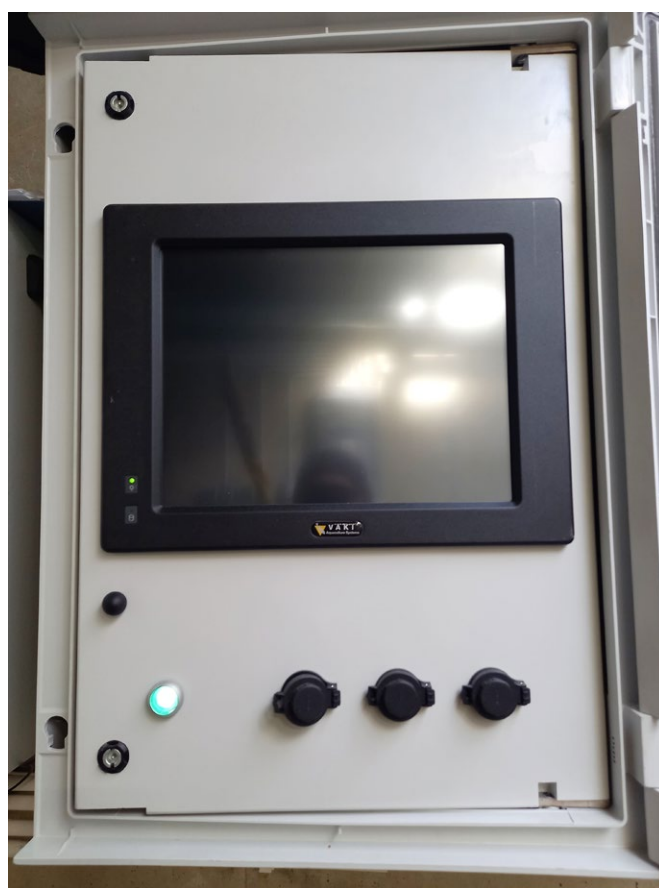
Vaki system scanner recorder (computer)

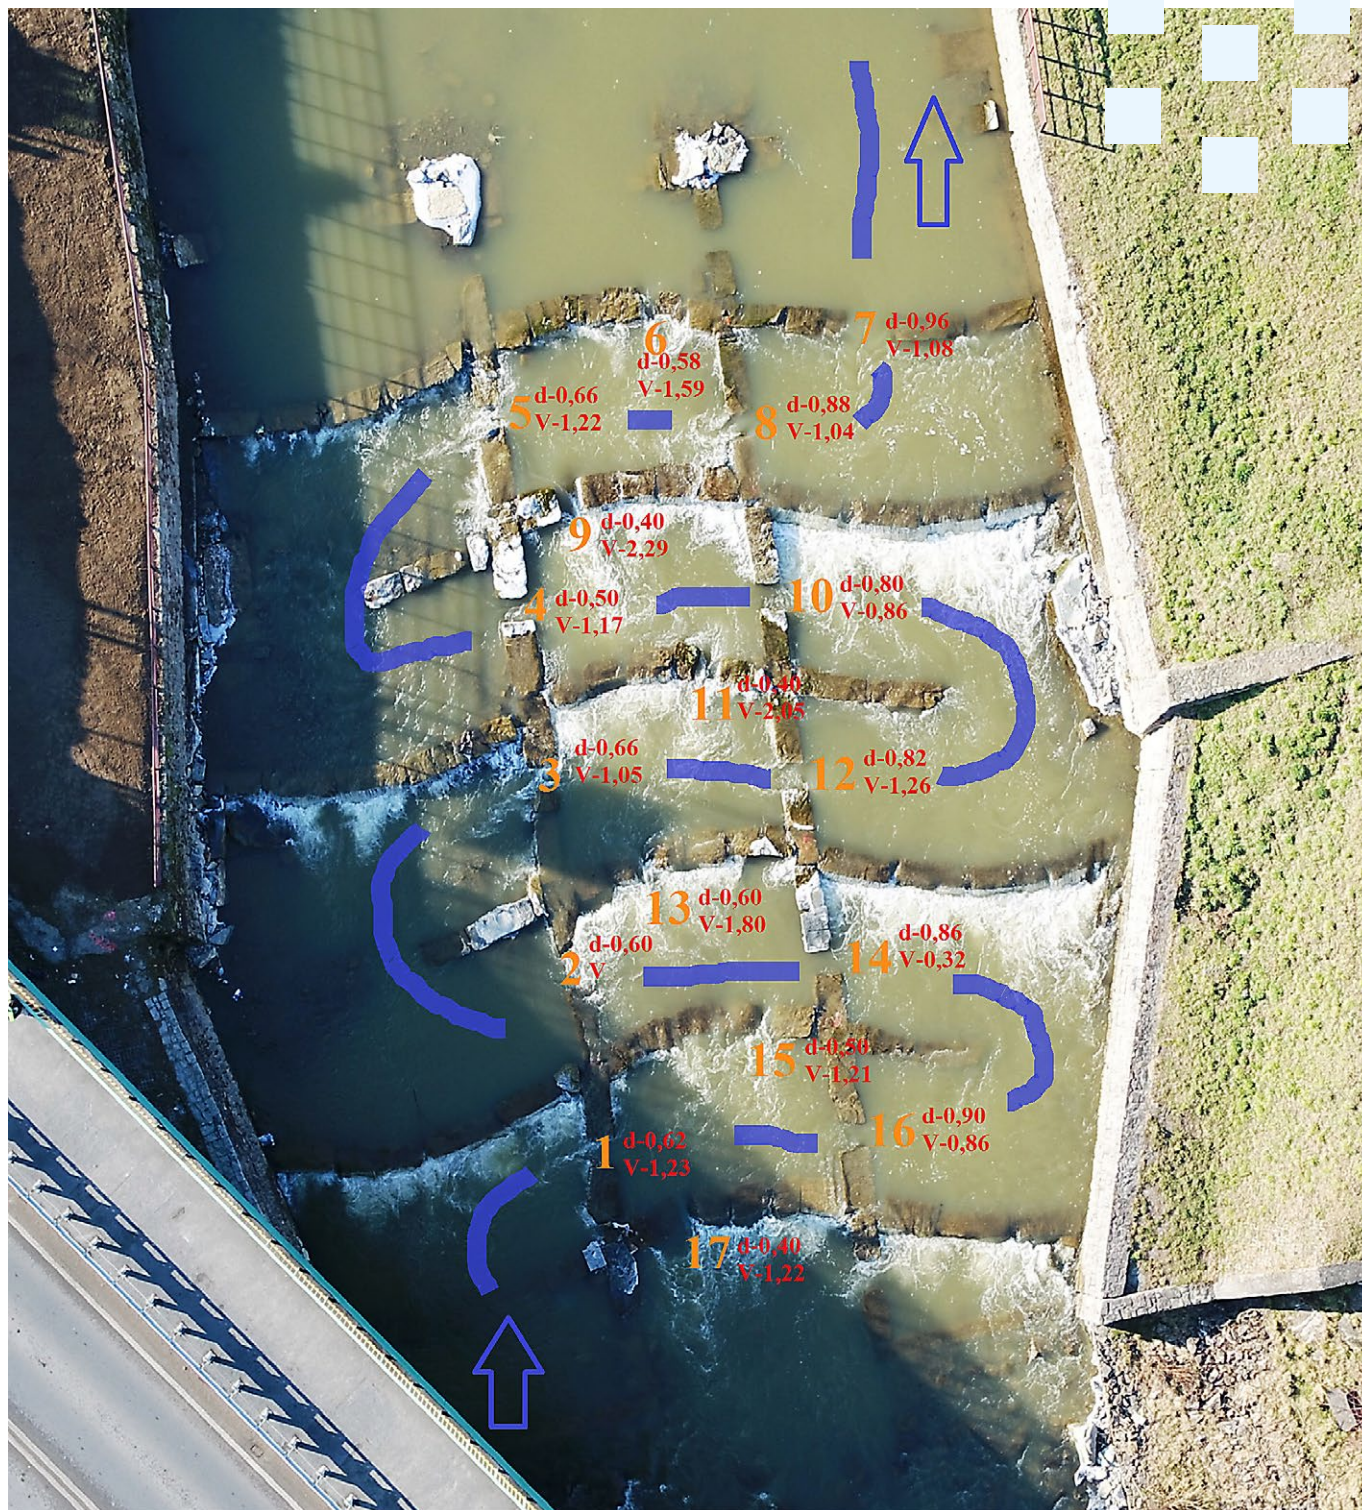
Results of water velocity measurements in the slots and the designed fish migration route in the Gorlice fish ladder (center)

a few cases, these high velocities were caused by clogging of the gaps near the bottom. After cleaning, the velocities decreased. The picture shows an example of the analysis of measurement results.

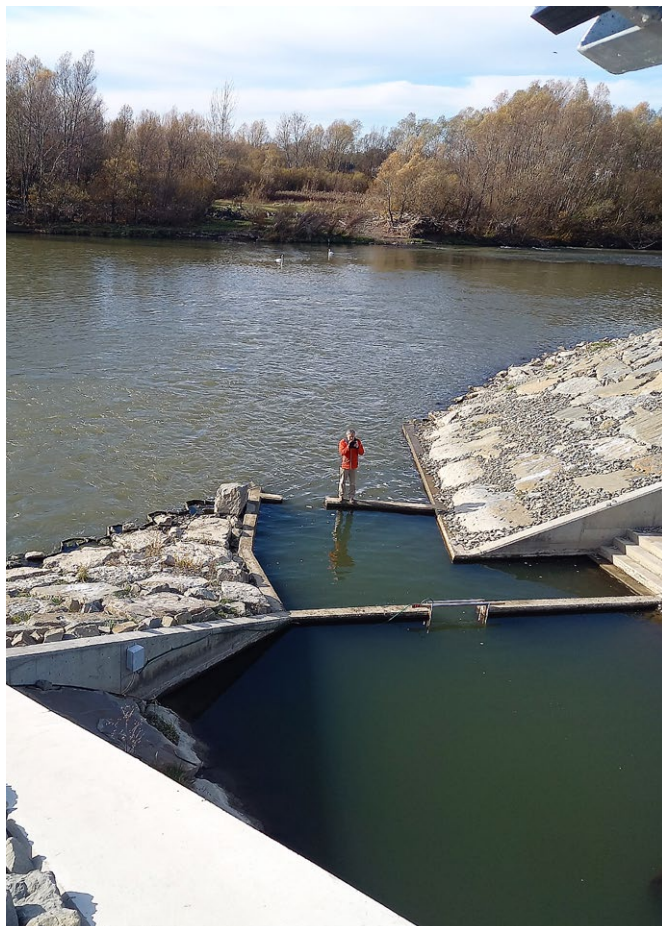
The antenna installed at the entrance to the fish ladder in Mokrzec (downstream)

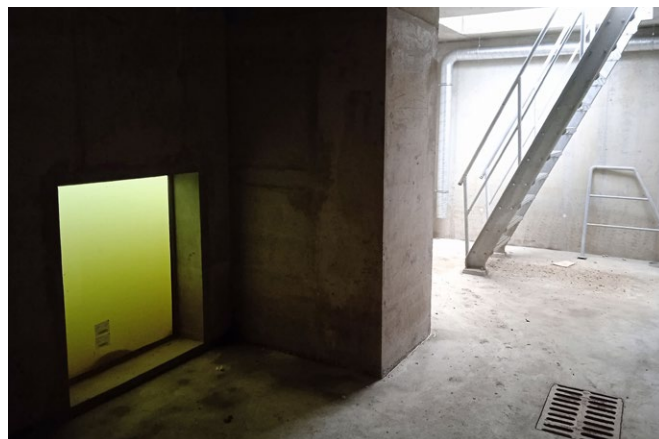
Interior of the observation chamber in the monitoring building at the fish ladder in Mokrzec

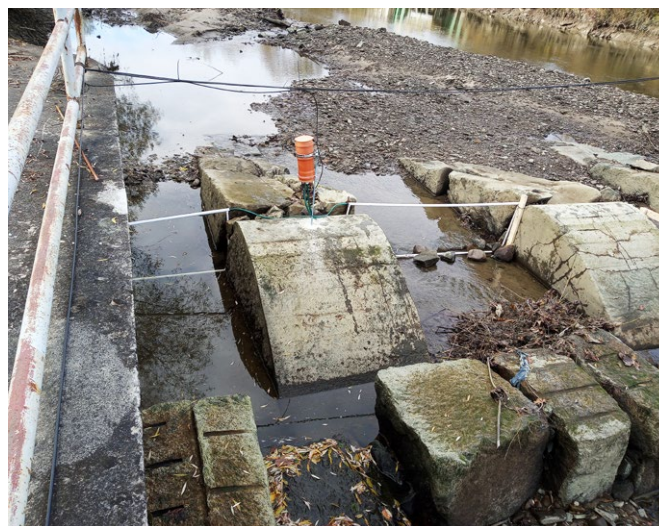
Antenna installed in the fish pass in Gorlice (water intake)

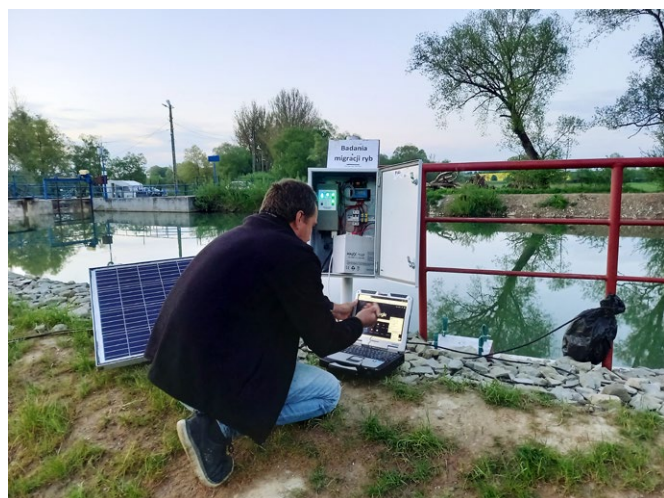
Migration recorder with the use of PIT tags at Szczepańcowa

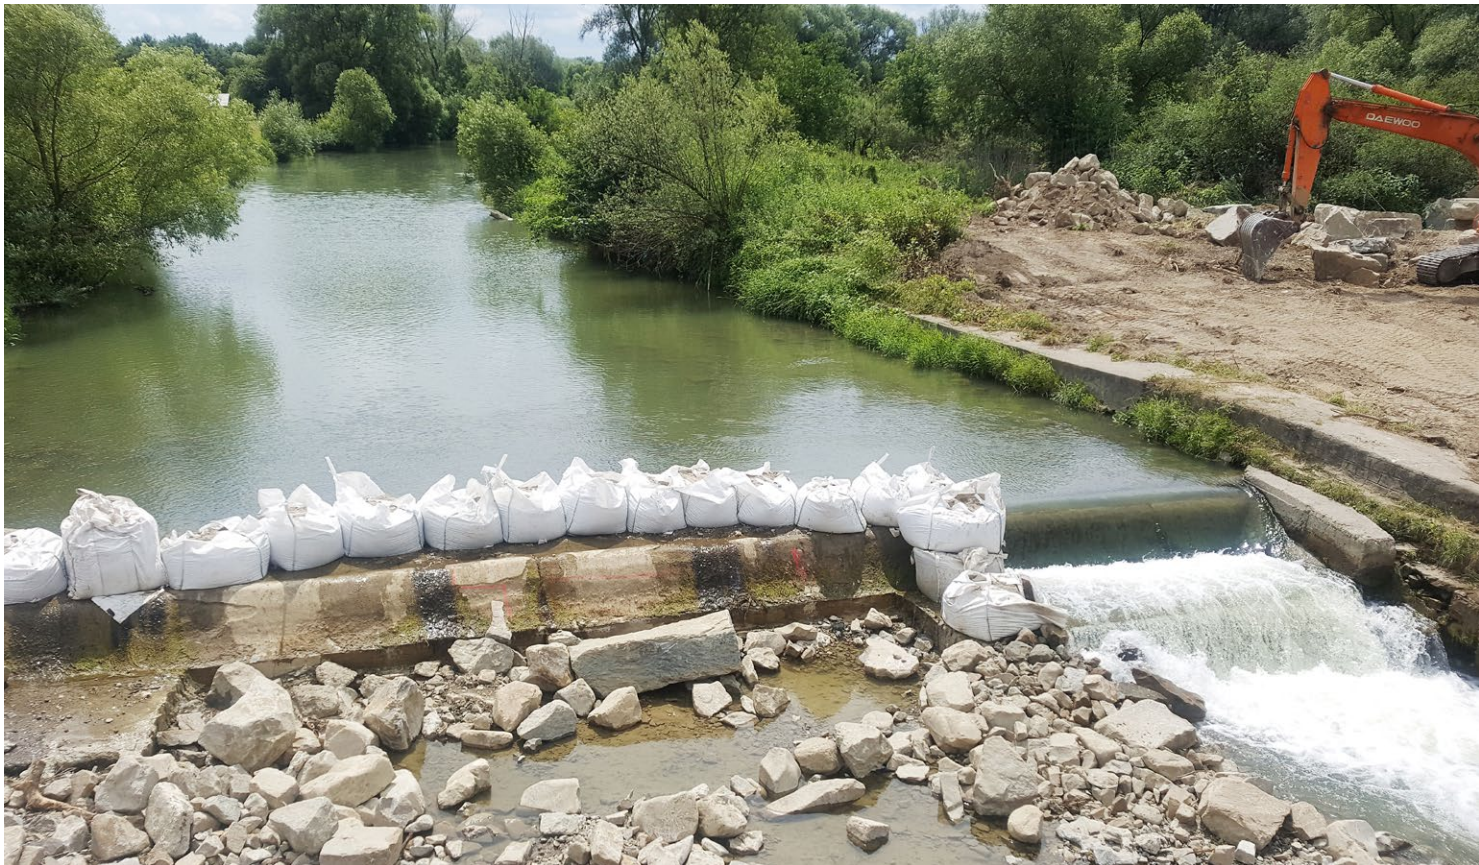
Protection against siltation by big bag in Jedlicze
