REPORT

on the implementation of the project

RESTORATION OF ECOLOGICAL CONTINUITY AND ACTIVITIES IMPROVING FUNCTIONING OF THE FREE MIGRATION CORRIDOR OF THE BIAŁA TARNOWSKA RIVER

2022

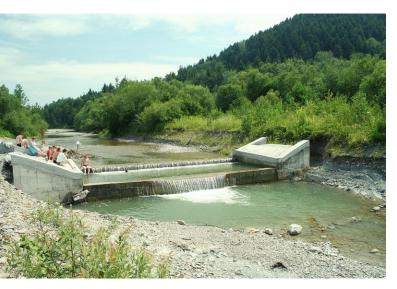
Fig. 13. The weir in Florynka before modernization. Reconstructed in the 2nd stage of the project.

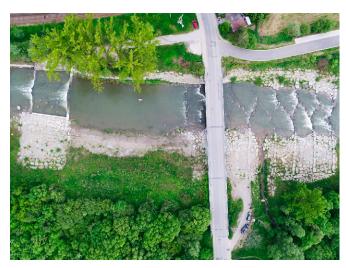
Fig. 19. The weir after reconstruction and new fish ladder.

The barrage was built in the 1950s (Fig. 16). The purpose of the barrage was to protect a three-span bridge and to create an accumulation of water for drinking purposes in Bobowa village. Before modernisation, the height of the dam from the river surface to its crest was about 0.9-1.0 m. Below it, there was a stilling basin to dissipate the energy of the flowing water. Before the reconstruction, the light of the bridge under the two spans was blocked by a thick layer of sediment deposited over decades. As part of the modernisation of the dam, these sediments were removed, thus increasing the free passage of floodwater. The damming weir itself was rebuilt. The damming height was lowered, and triangular cutouts for low water were added. The pool between the sills was fitted with boulders and wooden beams to provide temporary shelter for the fish (Figs. 17 and 20). Above the weir and bridge, a new fish ramp in the form of a honeycomb was built (Figs. 18, 19, 21, 22). More than 600 stones with a total weight of about 3,300 tonnes were used in the construction, with individual weights of up to 12 tonnes.

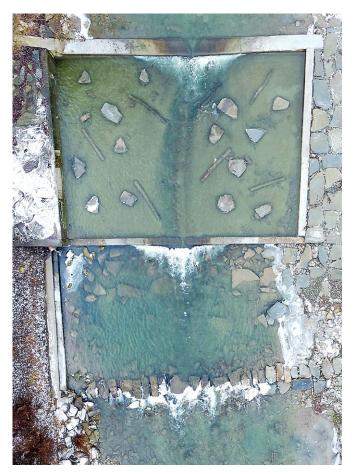
Fig. 20. The weir after reconstruction.

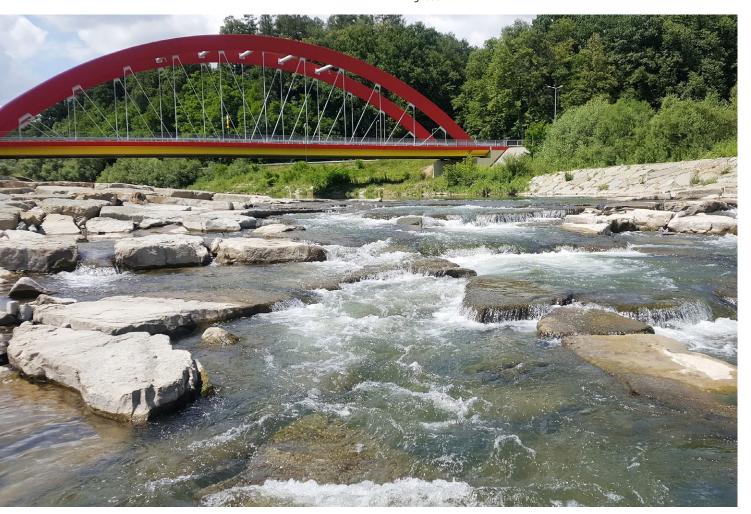
Fig. 25. Weir after reconstruction.

bridge itself posed a flood risk because the side spans were blocked by deposited material, vegetation and overhanging vegetation. In 2019, it was demolished and replaced with a new single-span bridge. As part of the upgrade of the weir below the bridge, a honeycomb fish ladder was built. At the same time, the deposited sediments that narrowed the riverbed and impeded the flow of high water were removed (Figs. 24 and 25).

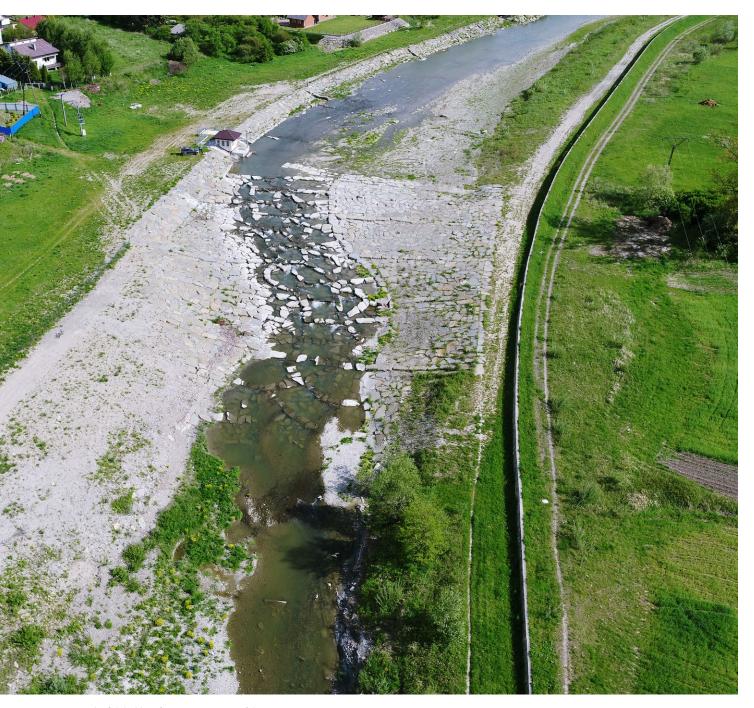
${\it Fig.\,30.} \ The \ fish \ ladder \ after \ reconstruction \ of \ the \ weir.$

The old weir in the form of a cascade of four dams dammed up the water for the town's water supply. Later, the construction of a small hydroelectric power plant was started but never completed. During the flood in 2010, the weir was heavily damaged (Fig. 26). As part of the modernisation of the weir, the power plant was demolished and the sill dismantled. The damming height was lowered by about 1 m. A new water intake was constructed in the form of a drainage intake from under the riverbed. The sill was replaced by a honeycomb fishway (Figs. 27 and 30). In addition, an observation room, equipped with a glass window, a fish coun-

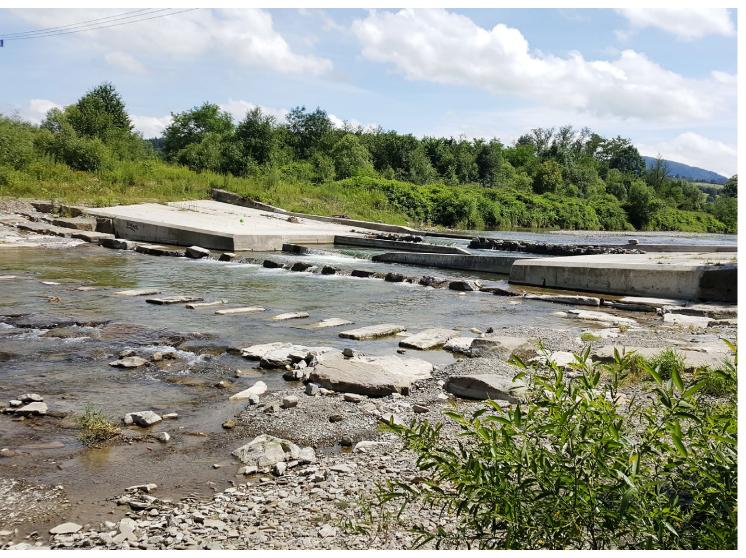
Fig. 35. Weir after modernization.

A concrete damming weir with a stilling basin was constructed in Biała Niżna to prevent channel incision (downcutting) (Fig. 33). The damming-up height was 1.2 m. The stilling basin was replaced by a fish ladder as part of the upgrade. Three concrete baffles with alternating triangular cuts were built across the basin. The whole stage was supported by a stone girder (Figs. 34 and 35).

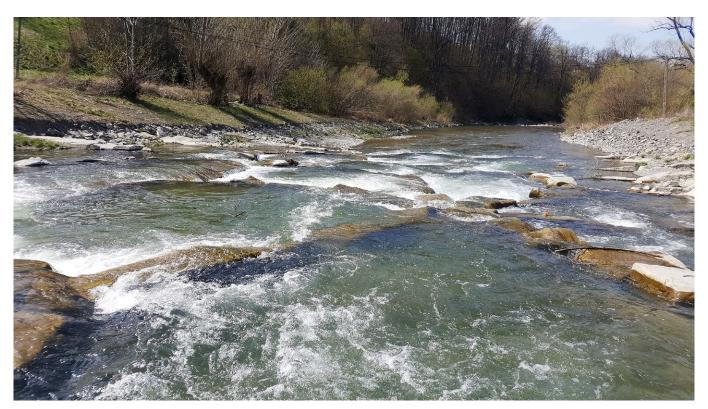
Fig. 42. Close-to-nature fishway after weir reconstruction.

Many years ago, a cascade of weirs was built here to secure the road bridge (Fig. 41). Above, the left-bank tributary of the Pławianka stream flows into the Biała. This stream, in its lower course, was regulated in the form of a concrete culvert. As part of the modernisation, the cascade of weirs on the Biała and the mouth section of the Pławianka were rebuilt. Some of the concrete weirs were removed, cut-outs for low water were made and a close-to-nature honeycomb fish ladder was added below (Figs. 42 and 44). The

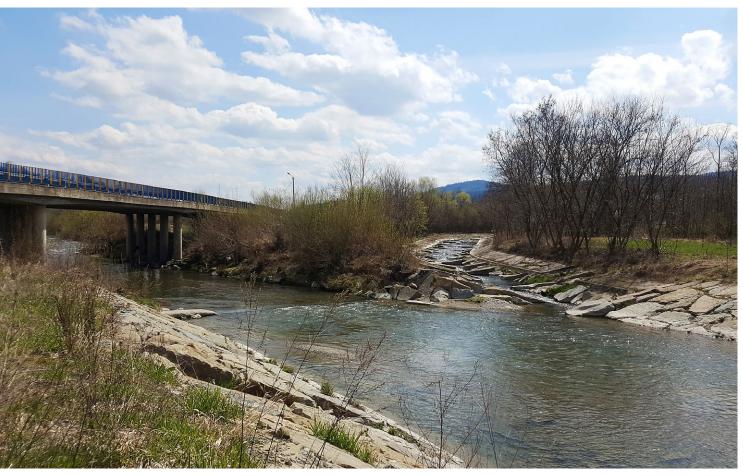
Fig. 43. The mouth of the Pławianka stream after reconstruction.

concrete-liner at the mouth of the Pławianka River was dismantled, and boulders were installed between concrete bank reinforcements, creating a meandering channel with a natural gravel bottom (Fig. 43).

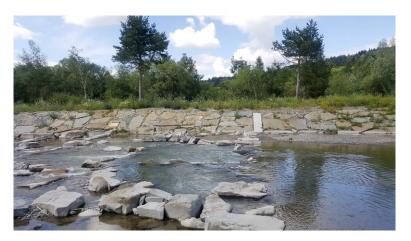
Fig. 50. The Florynka I weir after reconstruction.

(Fig. 49). The technical condition of both weirs was very poor, and these low-head dams constituted an impassable barrier for fish. As part of the modernisation, the rebuilding of both weirs was planned so that fish migration would be possible while maintaining the damming ordinate. At the Florynka I, the whole weir was left together with the stilling basin. The upper weir crest was lowered, and a close-to-nature honeycomb fish ladder was built on the downstream side (Figs. 50 and 52). In the upper weir (Florynka II), the stilling basin was eliminated, and on the downstream side, a close-to-nature honeycomb fishway was added (Figs. 51 and 52). Above the weir crest three gourds were constructed to protect the ford.

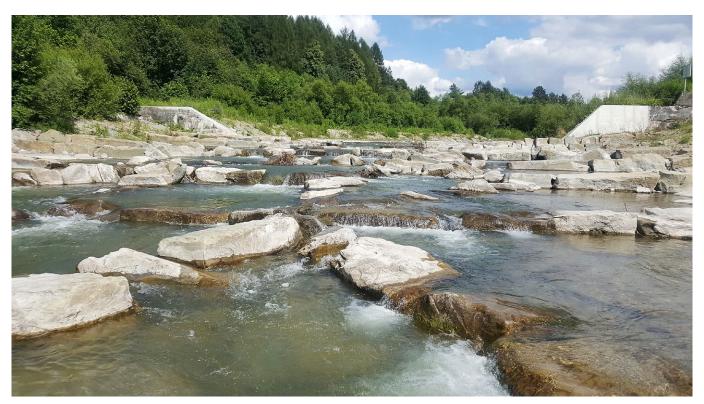
Fig. 51. The Florynka II weir after reconstruction.

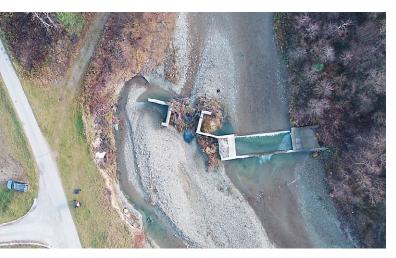
In 2000, the construction of a small hydroelectric power station was started in this section. Construction was completed in 2009. The power station operated until 2010, when a flood flooded the turbine and generator room, and was not rebuilt. The river bypassed the damming weir and over time practically cover with gravel the spillway of the weir (Figs. 53 and 54). The right bank at the step was washed away by flood waters. As part of the reconstruction, the weir was removed, and six rows of boulders were inserted into the bottom of the riverbed. The right bank was reinforced with a stone embankment (Figs. 55 and 56).

Fig. 54. The concrete left behind acted as a deflector and the river washed out the right bank.

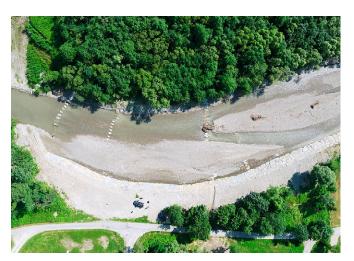
Fig. 55. A view of the stone shafts and bank reinforcement after a flood. The constructed stone shafts were backfilled with gravel.

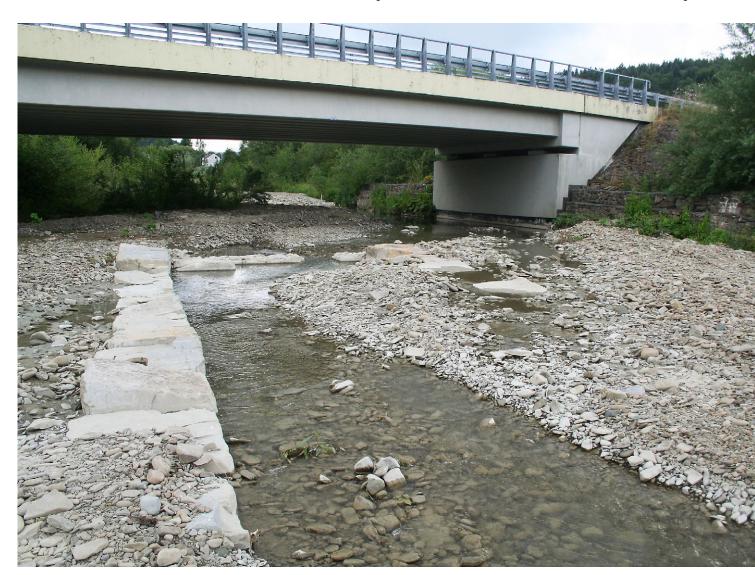
Fig. 58. Micromeander in cutting out reinforcement partially backfilled with gravel.

The retrofitted reinforcement of the bed of the channel under the bridge was made to protect this new single-span bridge. The concrete-and-stone reinforcement resulted in a small waterfall that no fish could traverse (Fig. 57). The decision was made to leave this reinforcement in place and use the difference in height to build a fish ladder. A 2-m-wide and 0.8-m-deep trench was cut in the old bottom reinforcement under the bridge, and several stone deflectors were installed. This resulted in a micro-mandrel effect (Fig. 58). After one year of operation, the river backfilled these micromanders with gravel. A fan-shaped fish ladder was constructed below. Each of these fans has a cut-out for small water (Figs. 59 and 60).

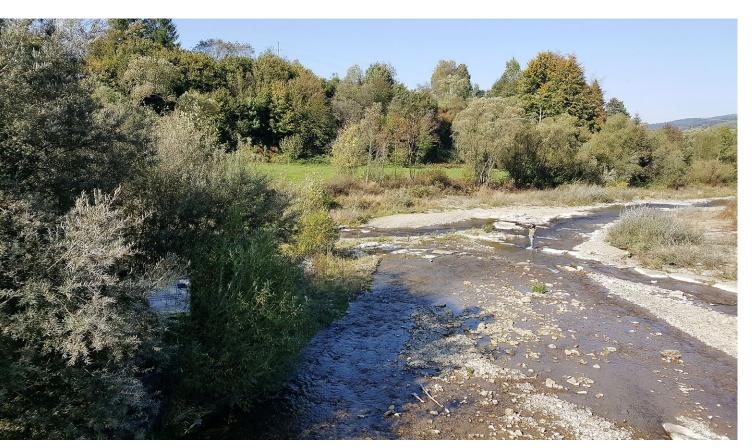
Fig. 59. View of the fish ladder.
